BCM and ECM Reflash Sequence

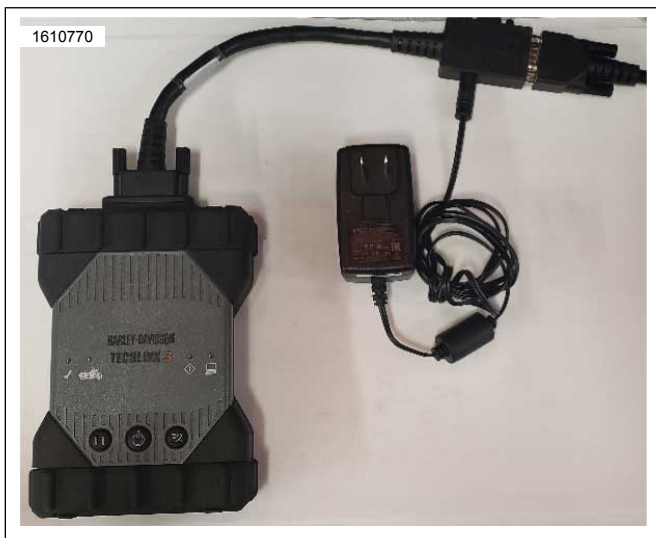
Figure 1. External Power Adapter

1. Connect battery tender directly to vehicle battery (not through battery tender lead).
 - a. Verify battery is fully charged before proceeding.
2. Connect external power to TL-3 appropriate power supply providing at least:
 - a. 12Voltage (V)
 - b. 1.2Amperes (A)

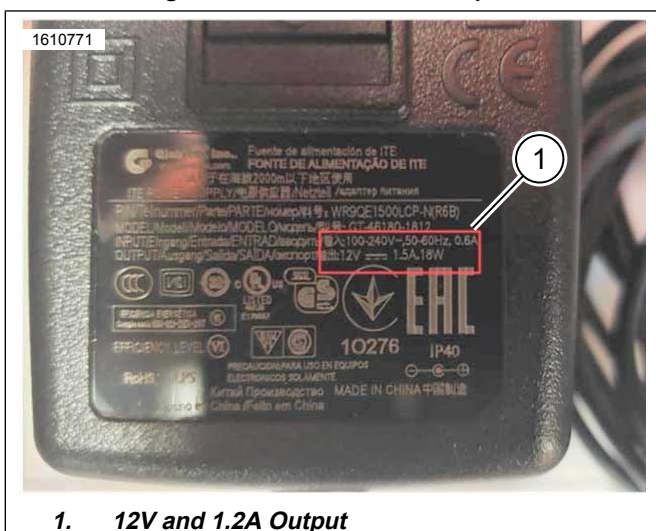
1. 12V and 1.2A Output

Figure 2. 12V and 1.2A Output

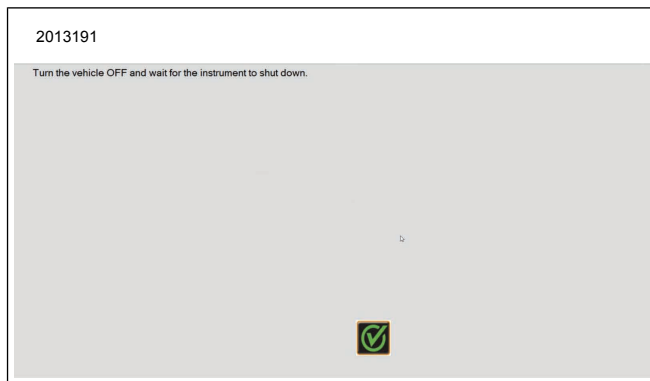
Figure 3. Power OFF Vehicle

An additional **ignition cycle** will be required and is part of the on-screen directions.

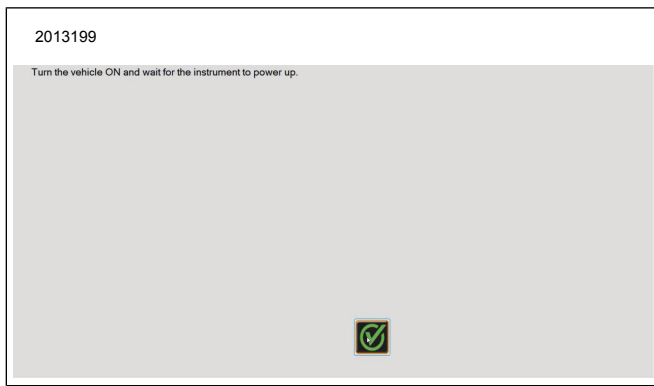
Figure 4. Power ON Vehicle
