## WMH0 - Re-Programming Various Control Units (Workshop Campaign)

Model Line: **Taycan (Y1A)**  
**Taycan Cross Turismo (Y1B)**

Concerns: **Re-program various control units**

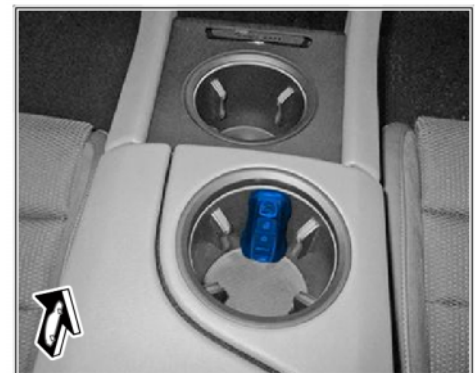
*Emergency start tray*

2 **Position the driver's key** with the back facing forward upright between the holding struts in the rear cupholder (**emergency start tray**) to guarantee a permanent radio link between the vehicle and remote control ⇒ *Emergency start tray*.

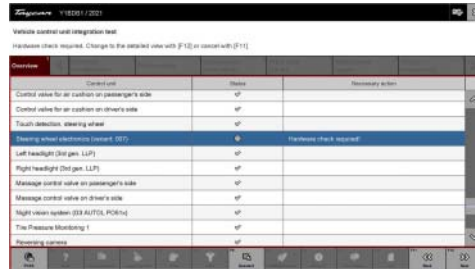
Hardware check required

13.2 The result list is displayed to the technician after the check has been completed. This shows if control units are not yet at the required software version ⇒ *Programming required* or a hardware check is required in accordance with the Spare Parts Catalogue (PET)⇒ *Detailed view of integration test - Hardware*.

- 13.3 Click on the affected control unit to view further details and start programming  
 ⇒ *Detailed view of integration test - software version*. The step-by-step instructions then start.  
 The hardware check is performed against the Parts Catalogue ⇒ *Detailed view of integration test - Hardware*.

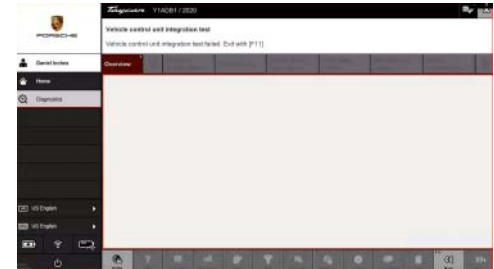
*Vehicle control unit integration test failed*

If the integration test fails, this is displayed as a result ⇒ *Vehicle control unit integration test failed*. Then complete the following steps:

- 13.6 In the Additional menu (F7), execute the "Maintenance of vehicle data with PIWIS ONLINE" function and write the current vehicle data record from the online system into the vehicle.
- 13.7 Carry out the integration test again.
- 13.8 In the event of a further fault, contact Technical Support.

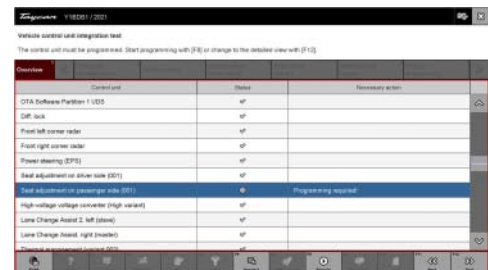
*Programming required*

9.2 The result list is displayed to the technician after the check has been completed. This shows if control units are not yet at the required software version ⇒ *Programming required* or a hardware check is required in accordance with the Spare Parts Catalogue (PET) ⇒ *Detailed view of integration test - Hardware*.

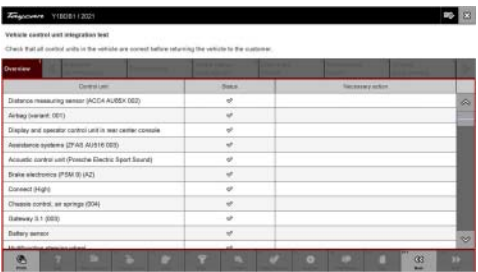
| Control unit | Status | Necessary action |
| Distance measuring sensor (PCDA-AUBX 082) | OK | |

- 9.4 When programming or hardware testing is complete, backup documentation including the joint test is performed again.  
All affected control units should now be re-programmed or checked in the control unit overview and their status. To do this, repeat Steps 2-4 until all control units are free of faults ⇒ *Vehicle integration test complete*.

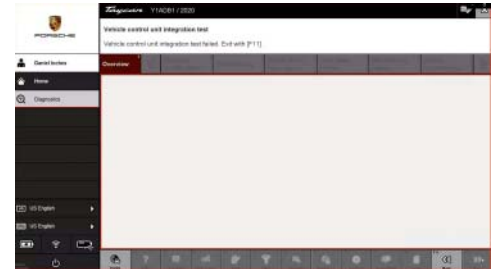
*Vehicle control unit integration test failed*

If the integration test fails, this is displayed as a result  $\Rightarrow$  *Vehicle control unit integration test failed*. Then complete the following steps:

- 6.6 In the Additional menu (F7), execute the "Maintenance of vehicle data with PIWIS ONLINE" function and write the current vehicle data record from the online system into the vehicle.
- 6.7 Carry out the integration test again.
- 6.8 In the event of a further fault, contact Technical Support.

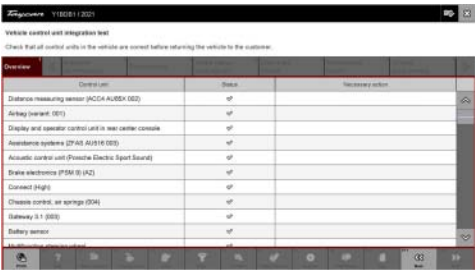
Vehicle integration test complete

- 13.4 When programming or hardware testing is complete, backup documentation including the joint test is performed again.  
All affected control units should now be programmed or checked afterwards in the control unit overview and their status. To do this, repeat Steps 2-4 until all control units are free of faults ⇒ *Vehicle integration test complete*.

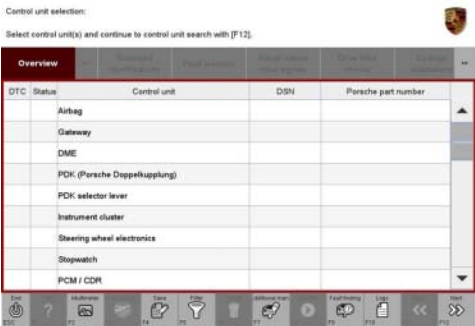
The system test is started automatically with the backup documentation process at the end of the process. Alternatively, the system test can also be started manually by pressing •F3. “

Control unit selection

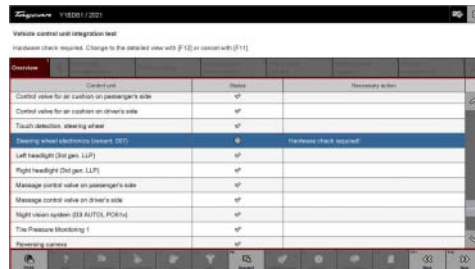
Hardware check required

- 13.3 Click on the affected control unit to view further details and start programming  
 ⇒ *Detailed view of integration test - software version*. The step-by-step instructions then start.  
 The hardware check is performed against the Parts Catalogue ⇒ *Detailed view of integration test - Hardware*.

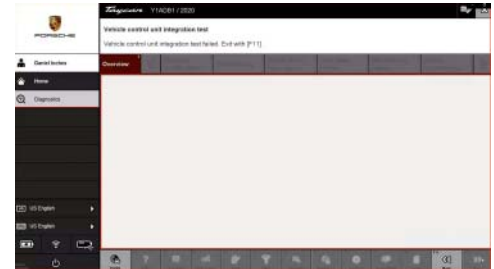
If the integration test fails, this is displayed as a result ⇒ *Vehicle control unit integration test failed*. Then complete the following steps:

*Vehicle control unit integration test failed*
