# Technical Service Bulletin

GROUP <b>CAMPAIGN</b>	NUMBER <b>25-01-060H</b>
DATE <b>SEPTEMBER 2025</b>	MODEL(S) <b>TUCSON (NX4M)</b>

**SUBJECT:** DCU SOFTWARE UPDATE  
(SERVICE CAMPAIGN TDFB)

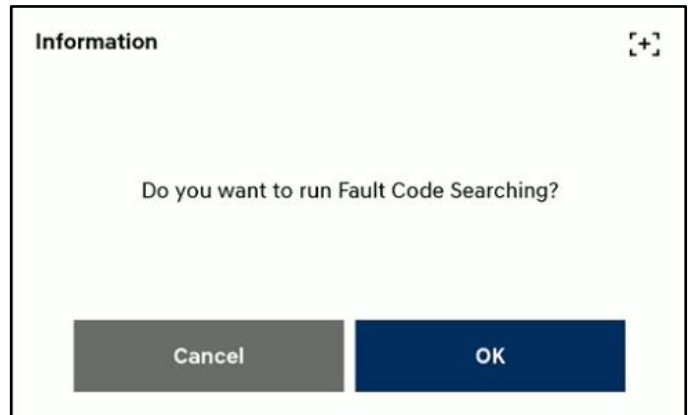
6. Perform an **All Systems Fault Code** search and erase DTC history that had incidentally occurred from the ECU update.
