TSB & SI Local	Model	TUCSON(NX4) (ALL) , TUCSON hybrid(NX4 HEV) (ALL) , TUCSON PHEV(NX4 PHEV) (ALL) , SANTA CRUZ(NX4A OB) - For Mexico (ALL) , TUCSON(NX4A) (ALL) , TUCSON(NX4m) (ALL)
	Group	Body Electrical System (92)
	TSB No.	HCE25-92-E770-NX4 OB PE/NX4 PE/NX4 PE HEV/NX4 PHEV/NX4a PE/NX4m PENX4
Subject DCU UPGRADE - NX4 OB PE/NX4 PE/NX4 PE HEV/NX4 PHEV/NX4a PE/NX4m PE DCU LOGIC IMPROVEMENT - (OTA) (Ethernet)	TSB Type	Service Action
	Published	2025-09-05
Description

This bulletin provides information related to the DCU (DATA CONNECTIVITY UNIT) software engancement (OTA) for NX4 OB PE/NX4 PE/NX4 PE HEV/NX4 PHEV/NX4a PE/NX4m PE vehicles.

- Symptom: SW operation logic error (DCU internal timer initialization logic not implemented)

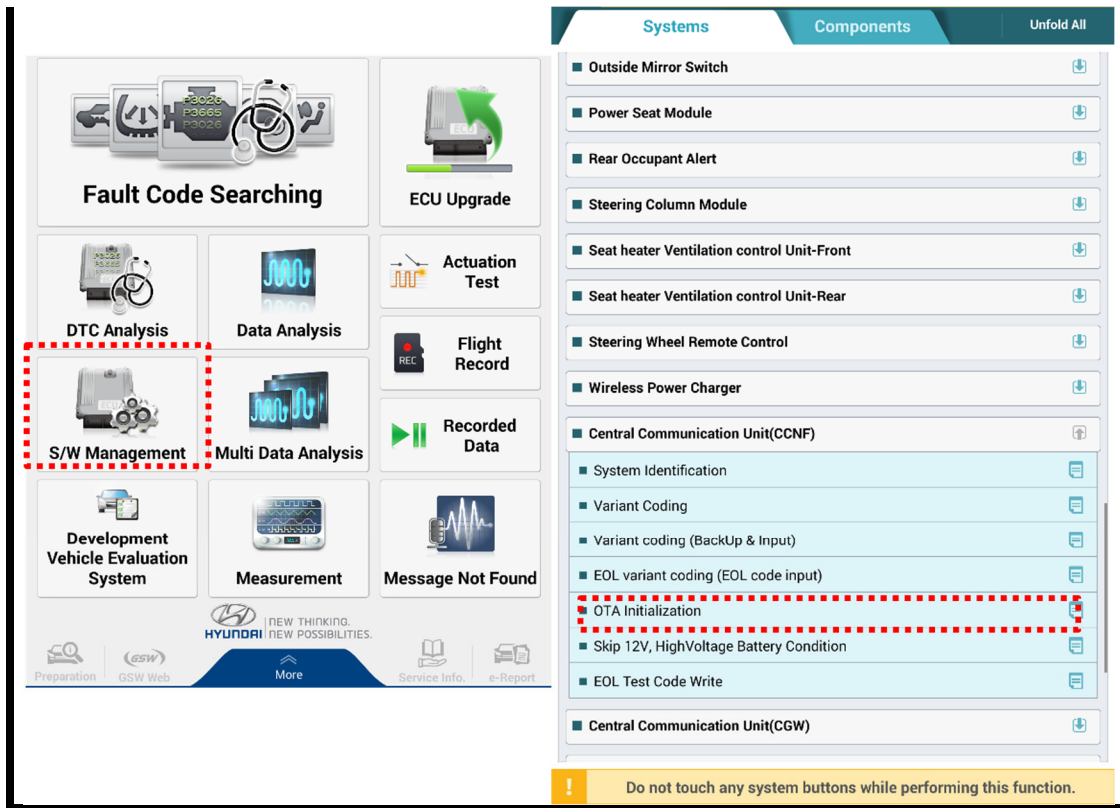
GDS-M/S

1. Connect the GDS-M.
2. Select the 'S/W Management'
3. Select the 'Central Communication Unit (CCNF)' and 'OTA Initialization'
4. Follow the instructions on the screen.

Connect the GDS-M. -> Select the 'S/W Management' -> Select the 'Central Communication Unit (CCNF)' and 'OTA Initialization' -> Follow the instructions on the screen.

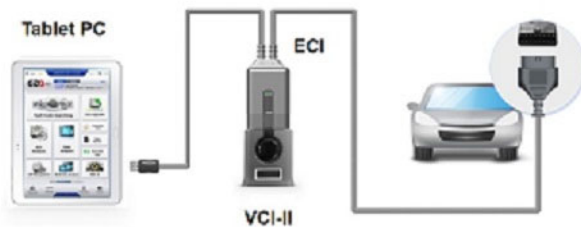
1. GDS (Global Diagnostic System)-Mobile & ECI (Ethernet Communication Interface) INSTALLATION PROCEDURE

- 1) Connect the ECI (Ethernet adapter) DLC cable to the OBD connector of the vehicle.
- 2) Connect the VCI-II DLC cable to the ECI.
- 3) Select the appropriate tablet cable (C-type, 5-pin) to the ECI.
- 4) Connect the cable to the tablet PC.

- The connection between the VCI-II and tablet PC is wireless, whereas the tablet PC is connected to the vehicle through the ECI (Ethernet adapter).

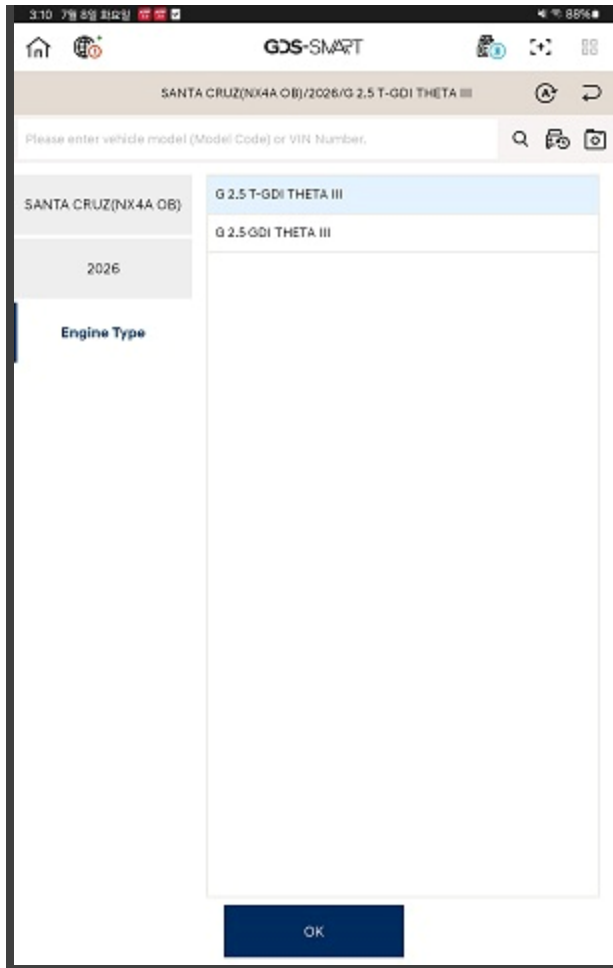
**#.NX4 OB PE/NX4 PE/NX4 PE HEV/NX4a PE/NX4
PHEV/NX4m PE (GDS-Smart)**

- 1) Select ECU Upgrade on the initial screen after entering the vehicle information.
- 2) Select Auto Mode and then tab the system.
- 3) Read information and tab ID check.
- 4) The GDS-Mobile will read the current ROM ID in vehicle and check the newest upgrade event.
- 5) Select the upgrade event,

5-1) "1296.NX4 OB PE/NX4 PE/NX4 PE HEV/NX4a PE/NX4m PE DCU LOGIC IMPROVEMENT (CA)"

5-2) "1297.NX4 OB PE/NX4 PE/NX4 PE HEV/NX4a PE/NX4m PE DCU LOGIC IMPROVEMENT (NA)"

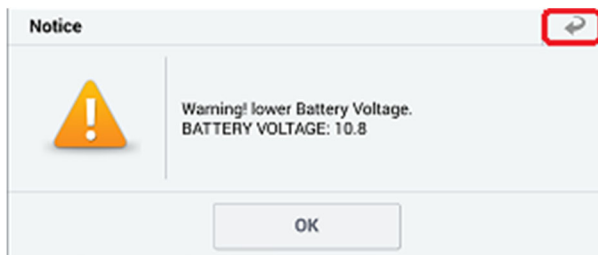
6) The vehicle battery voltage is checked to make sure it is at least 12 voltages to assure reliable upgrade results. Click OK if the results indicate voltage is ok.

- If battery voltage is below 12 voltages as below, click BACK and then run the engine to assure an adequate battery charge state for reliable upgrade results.

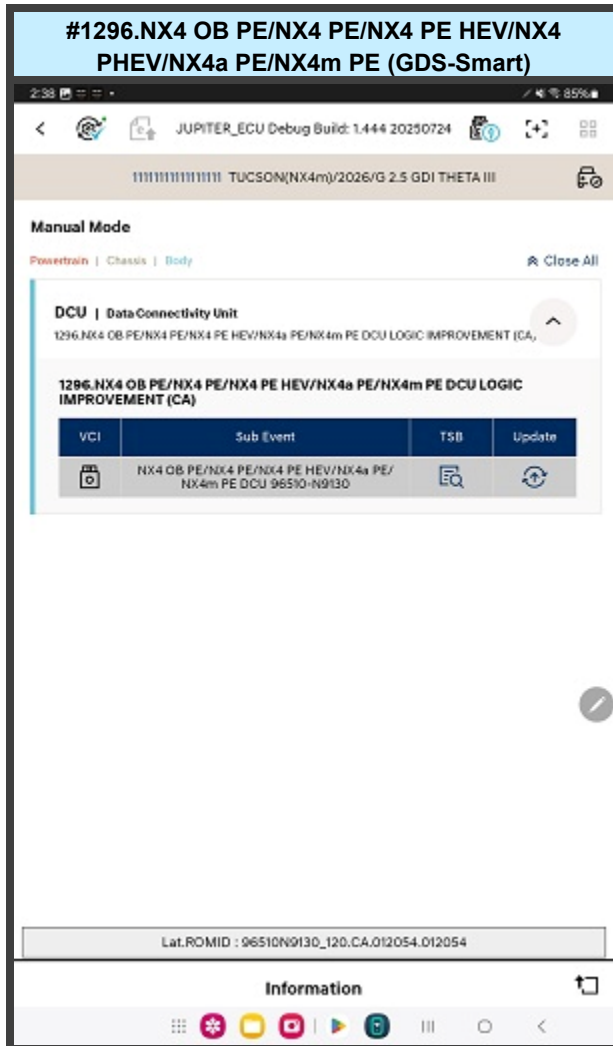
1) Within the upgrade screen, select Manual Mode, then select upgrade event.

2) Select the control unit part number with reference to the above ROM ID Information Table and tab OK.

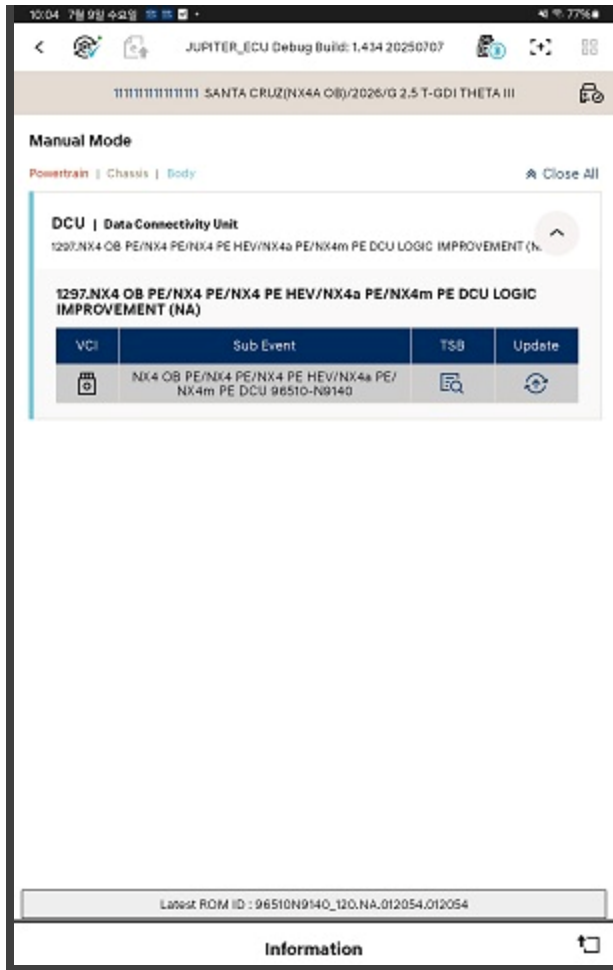
#1297.NX4 OB PE/NX4 PE/NX4 PE HEV/NX4 PHEV/NX4 PHEV/NX4a PE/NX4m PE (GDS-Smart)

3) Enter the password from the below table then touch OK.

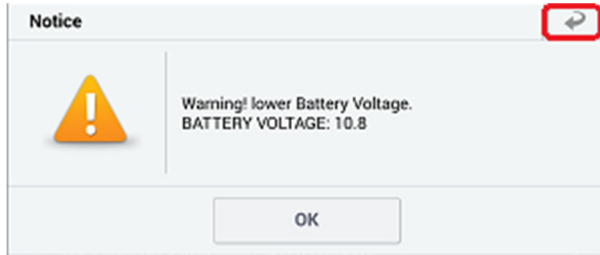
- If voltage is below 12 voltages as below, click BACK and then run the engine to assure an adequate battery charge state for reliable upgrade results.
