GROUP	MODEL
ELE	2024-2025MY EV9 (MV1)
NUMBER	DATE
398	September 2025

TECHNICAL SERVICE BULLETIN

SERVICE ACTION: SBW GEAR SELECTION LOGIC IMPROVEMENT (SA626)

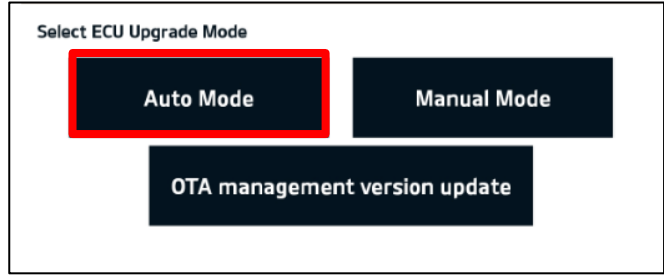
The required software must be installed by selecting the **'Auto Mode'** ECU Upgrade option.

Note: In some case, the 'Manual Mode' installation option may be required ONLY if the 'Auto Mode' function fails or is otherwise noted above.

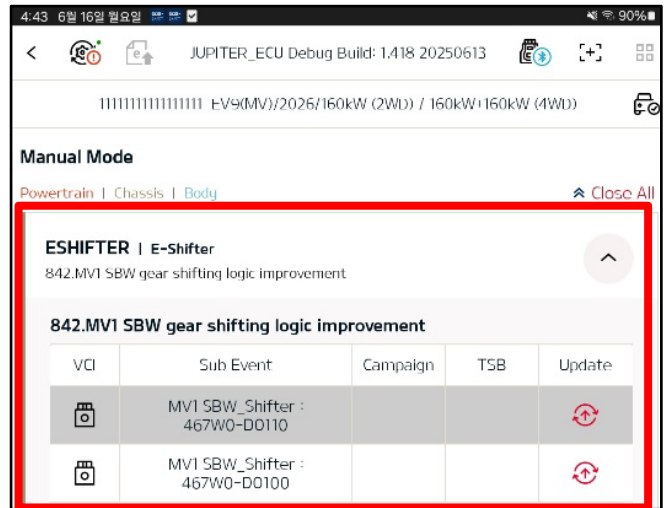
Select the applicable **'E-SHIFTER'** system module and the Event Group.

- **842.MV1 SBW Gear Shifting Logic Improvement**

Verify the affected vehicle Calibration Identification of the applicable ECU ROM ID and reference the Information Table on page 3 as necessary.
