GROUP	MODEL
	TRA	2025MY K5 (DL3) w/Theta III 2.5L GDI
	NUMBER	DATE
	115	September 2025

TECHNICAL SERVICE BULLETIN

**SUBJECT: SERVICE ACTION: 8-SPEED TRANSMISSION GEAR  
SHIFT LOGIC IMPROVEMENT (SA630)**

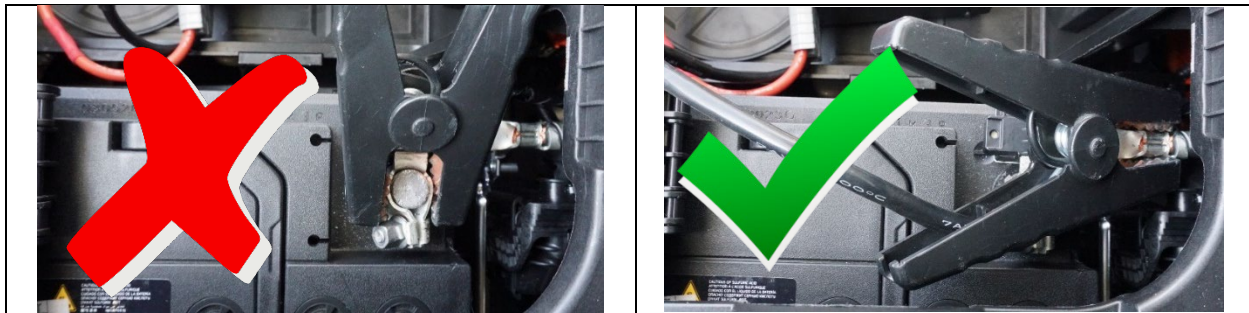
[Connect the negative \(-\) terminal to the battery as shown below.](#)

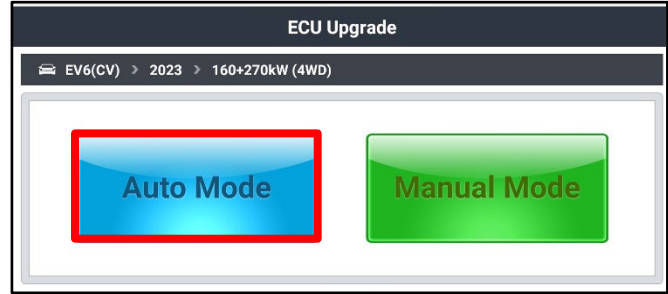
The required software must be installed by selecting the **'Auto Mode'** ECU Upgrade option.

**Note:** In some case, the 'Manual Mode' installation option may be required **ONLY** if the 'Auto Mode' function fails or is otherwise noted above.

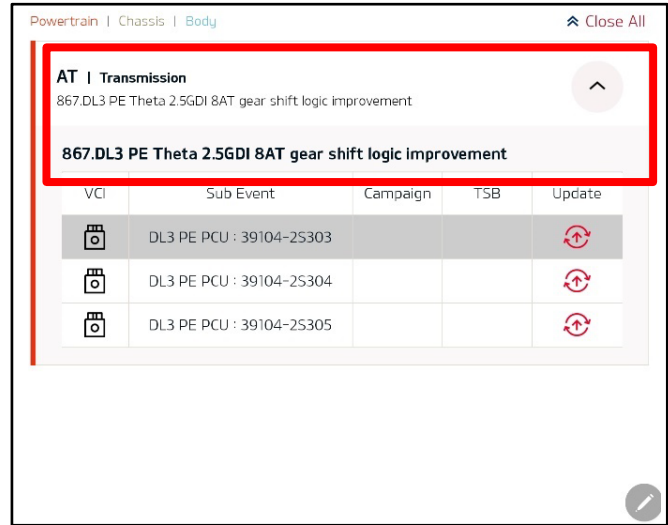
Select the applicable **'AT'** system module and the Event Group.

- **867.DL3 PE Theta 2.5GDI 8AT Gear Shift Logic Improvement**

Verify the affected vehicle Calibration Identification of the applicable ECU ROM ID and reference the Information Table on page 3 as necessary.
