**NUMBER:** 15-305-22R

## **SERVICE BULLETIN**

**APPLICABILITY:** 23-25MY Outback/Legacy Models

**SUBJECT:** Reprogramming File Availability for Optimization

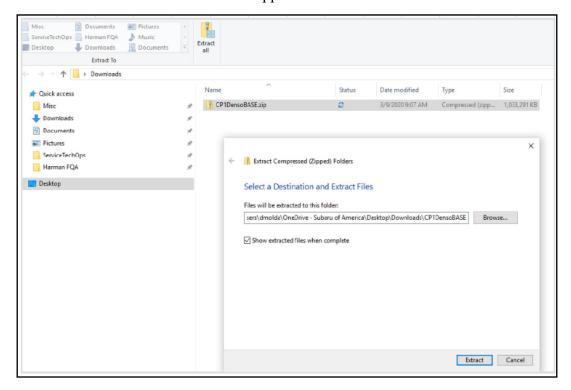
• The screen similar to the one below will appear to set a destination for the extracted file.

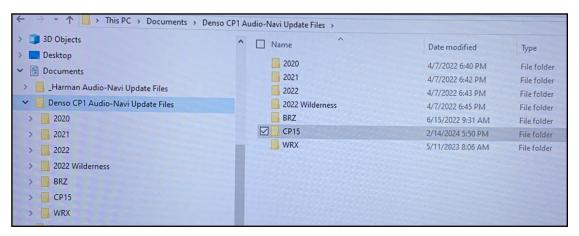
• Go to My Documents on the GUI screen click on the folder "Denso CP1 Audio-Navi Update Files" to display the list of available update files shown below.

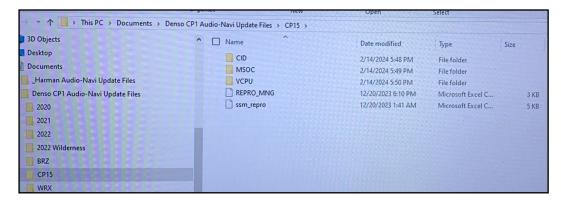
- CAUTION: After download is complete, NEVER change the file or folder names.
- Double-click on the required folder (for this example, select the file entitled "CP15") and the update file will display as shown.

Select all folders and files and either copy / paste or click / drag them to the USB flash drive.

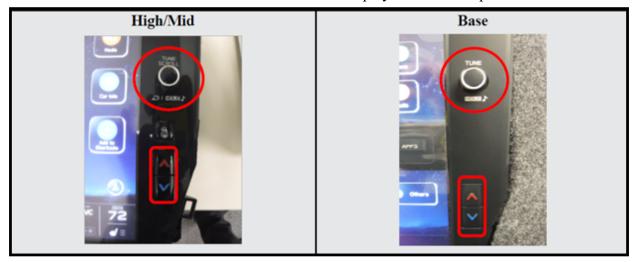
**4a)** PRESS and HOLD the RIGHT-side temperature control buttons (both up and down) and press the Tune / Scroll knob 6 times then release all to display the Dealership Mode Menu.

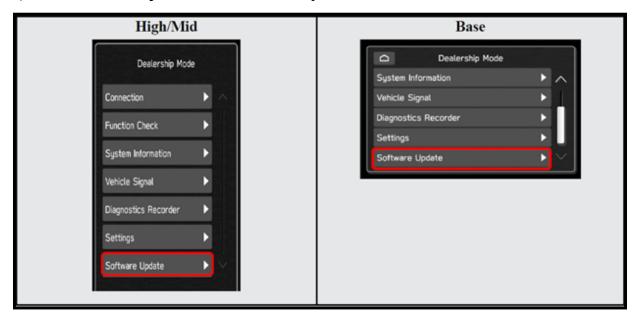
4b) Select Software Update from the Dealership Mode menu.

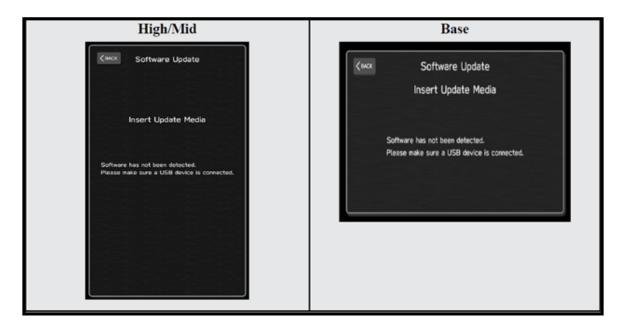
**4c)** The screen below will be displayed.

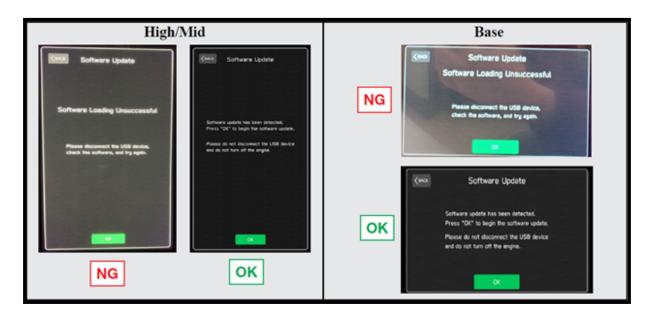
4d) Insert reprogramming USB into the USB port and press OK.

**NOTE:** If after plugging in the USB, the screen displays a **Software Loading Unsuccessful** message, confirm the USB device has been properly formatted and the software on the device matches the system being reprogrammed (example: Base software is being used to update a Base system) and retry.

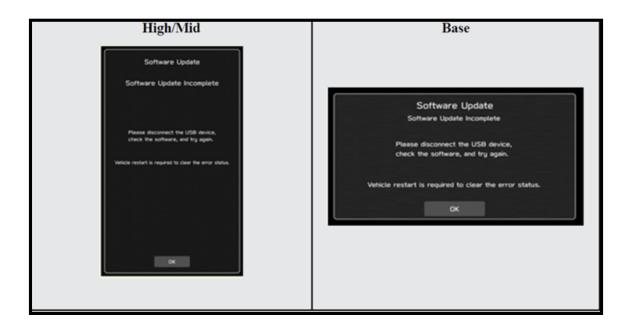
If you get the message **Software Update Incomplete** as shown below, please don't replace the hardware but retry updating the software according to the instructions in **Appendix 6 (page 30)**.

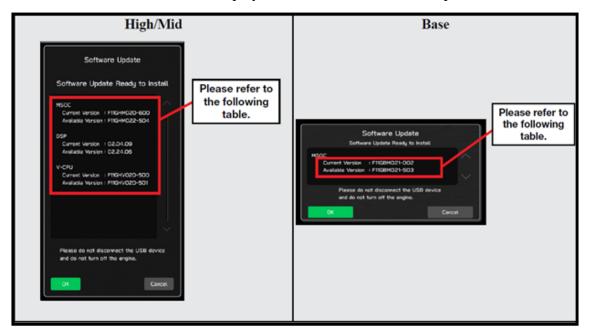
**4e)** The screen below will be displayed. Press **OK** to start the software update.

**NOTE:** The actual software version displayed will be different from the picture shown below.

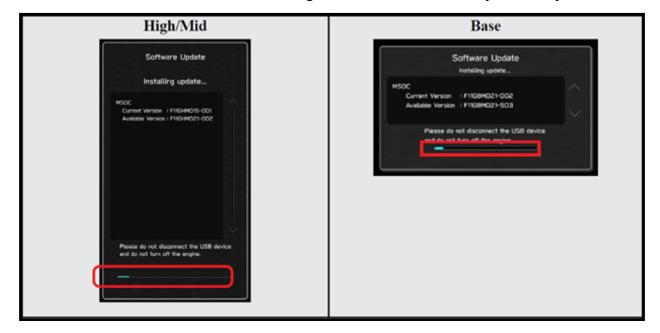
**4f)** Once the update begins, the screen below will be displayed with a progress bar. It takes about 15 to 20 minutes for the update to complete.

**VERY IMPORTANT:** NEVER turn off the ignition while the software update is in process.

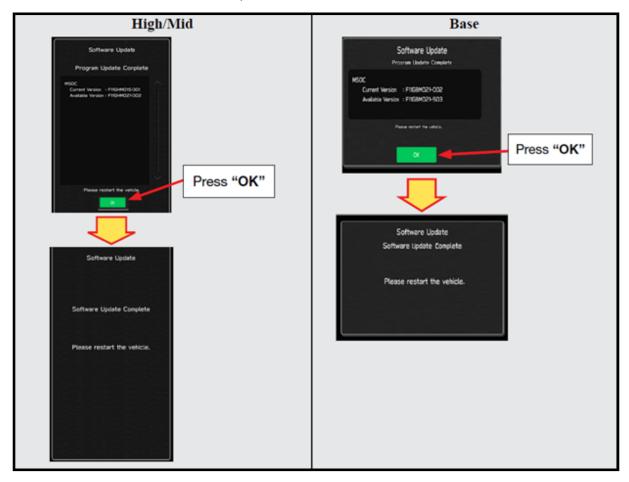
**4g**) When the software update is complete, the following screen will be displayed (the actual software version will be different).

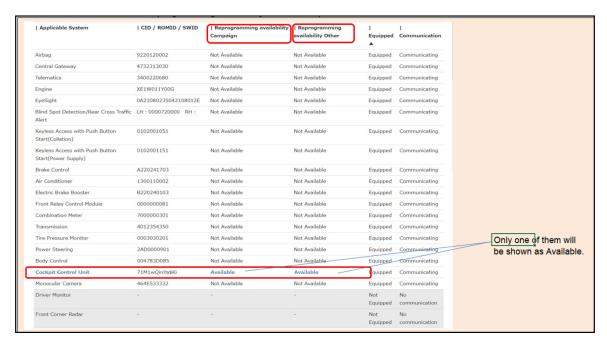
i. Follow TSB 14-28-21 "New Software Reprogramming Procedures / SSM5-R" STEP 1-STEP 11 to connect the vehicle and the laptop with SSM5 access. When vehicle information acquisition is completed, a list of on-board systems is displayed. Confirm that either one of the two reprogramming availability option on the Cockpit Control Unit is marked "Available" and click on it. See below.

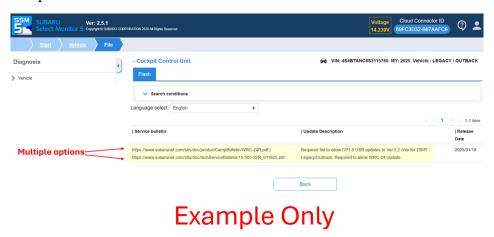
When you have multiple items listed, please select the one applicable to TSB 15-305-22 / Ver 6.0 as illustrated in the picture below."

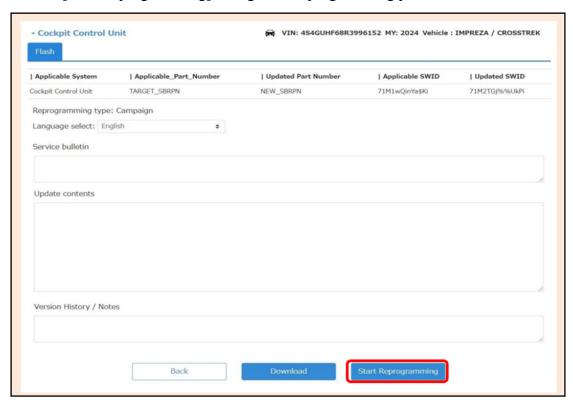
ii. Insert the USB flash drive containing the update data into the vehicle's USB port and click on [Start Reprogramming] to begin the reprogramming process.

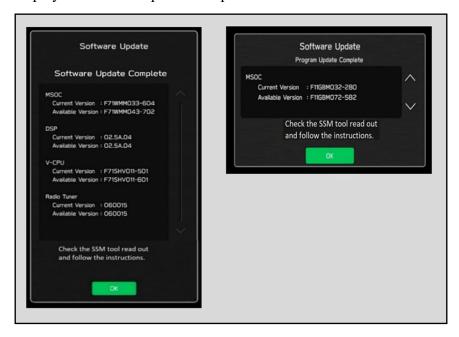
At that time CID display changes to show software installation details and progress bar. Wait until the CID screen displays "Software Update Complete". See below.

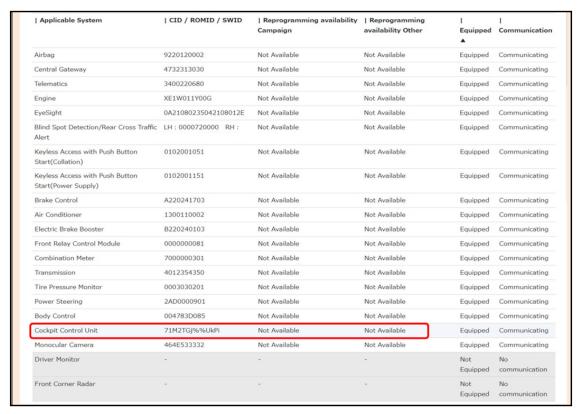
viii. Please verify that the Cockpit Control Unit's Reprogramming availability is set to 'Not Available.' The software update process is completed at this point.

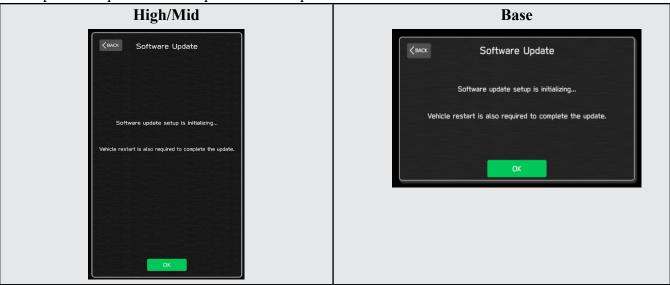
• If the screen shown below appears, **WAIT** for approximately 30 minutes or as long as necessary (waiting for longer than 60 minutes might indicate system malfunction). In that case please perform recovery according to the instructions in **Appendix 6 (page 30)** to allow the Software update setup initialization process to complete.

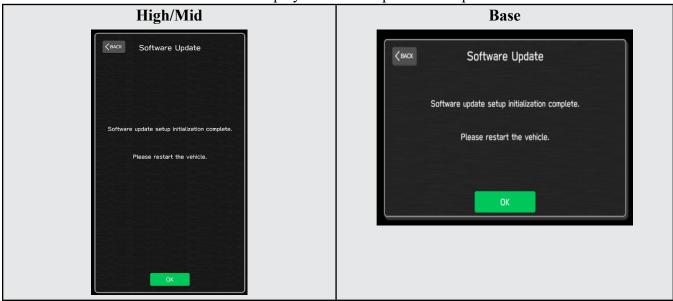
• The screens shown below will be displayed when the process completes.

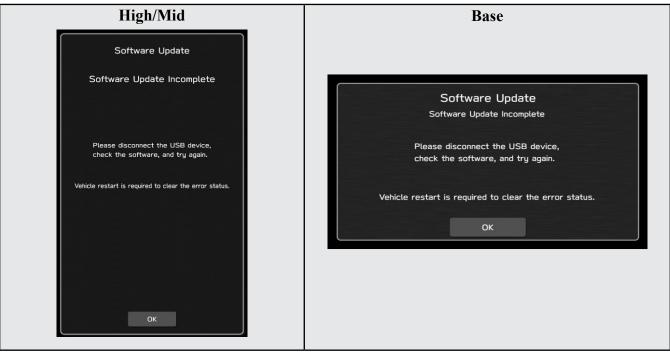
## 1-1. Select OK in the screen below

• If the first attempt of update fails with the message below, follow the steps described below 1-2 to 1-8 before retrying the software update.

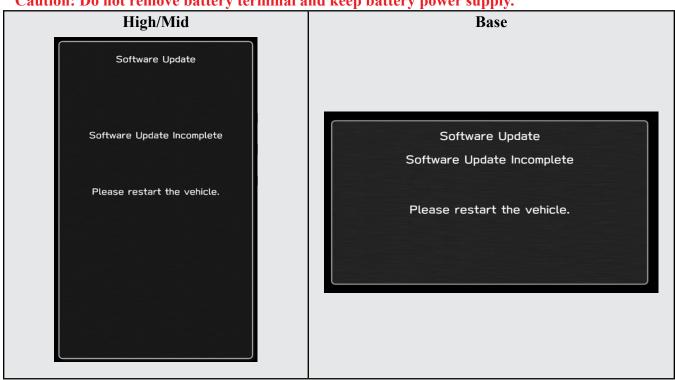
## 1-2. Turn the ignition switch or the engine OFF, and turn it ON again.

Caution: Do not remove battery terminal and keep battery power supply.

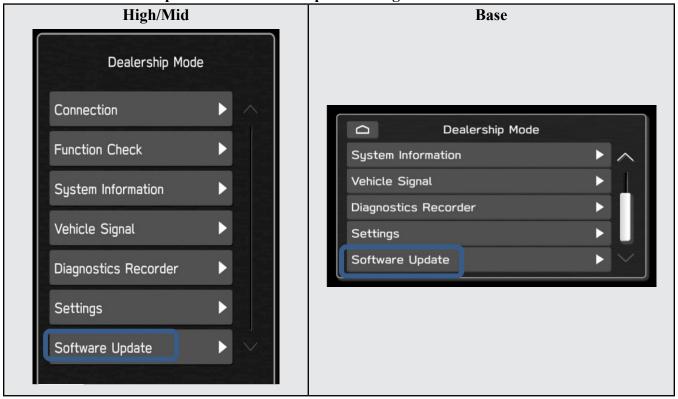
1-3. Select Software Update in the Dealership Mode diagnostics screen.

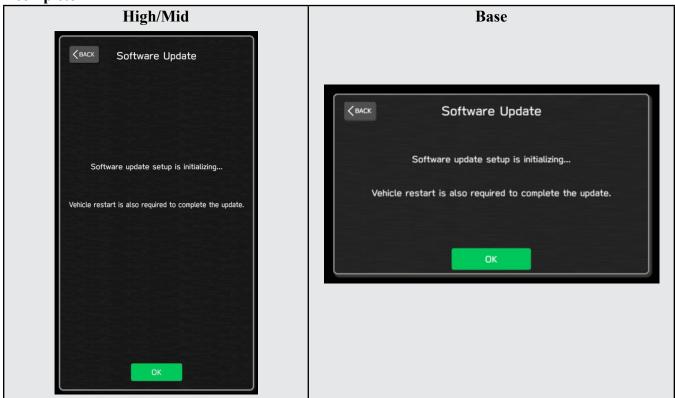
# 1-4. When you see the screen below, wait for approx. 15 minutes until the initialization is complete

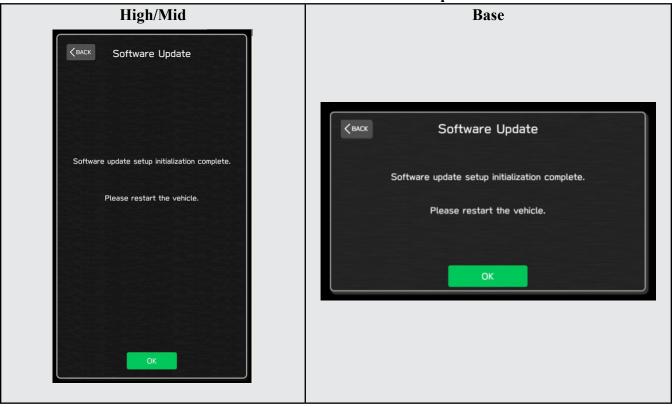
1-5. You will see the screen below when the initialization is complete.

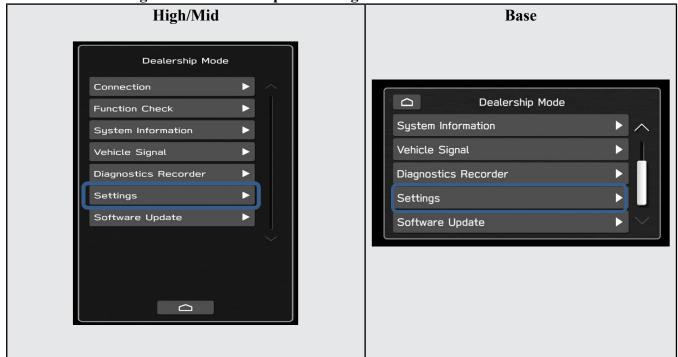
2-1. Select "Settings" in the Dealership Mode diagnostics screen.

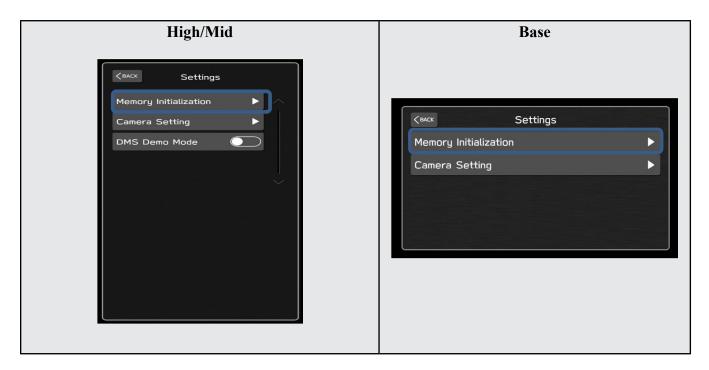
## 2-2. Select "Memory Initialization"

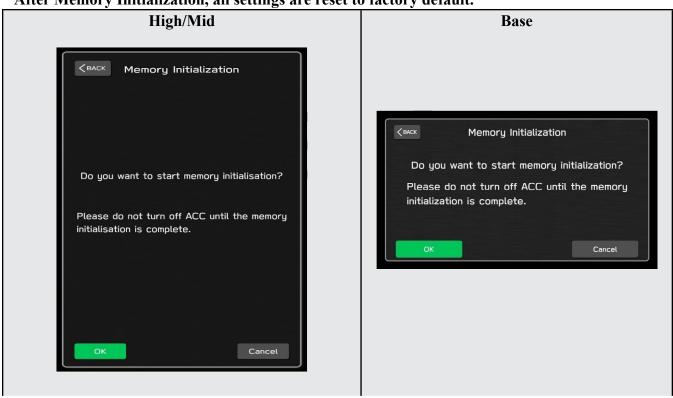
## 2-3. Select "OK"

After Memory Initialization, all settings are reset to factory default.

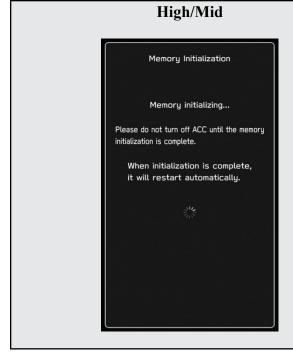
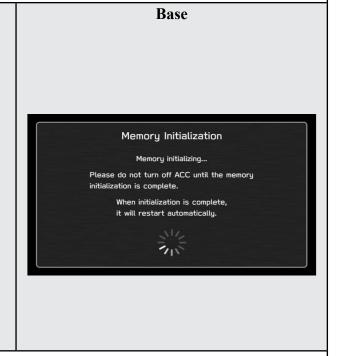
## 2-4. You will see the following screen

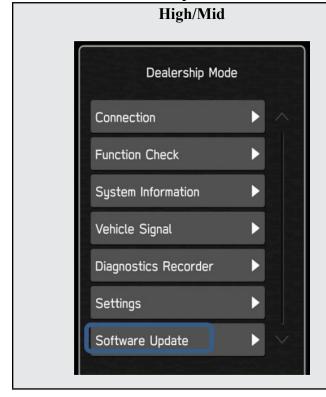
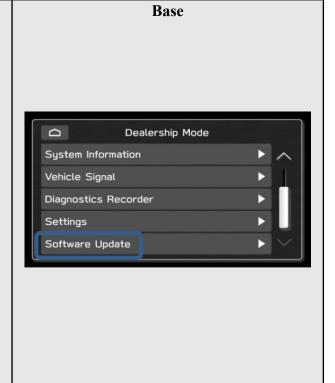
2-6. Select "Software Update" in the Dealership Mode diagnostics screen.

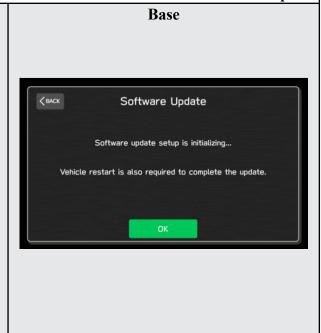
2-7. When you see the screen below, wait for about 15 minutes until the initialization is complete

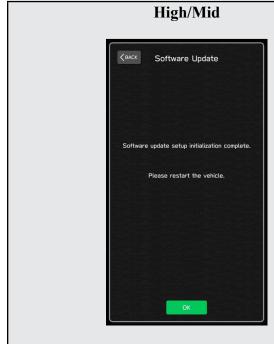
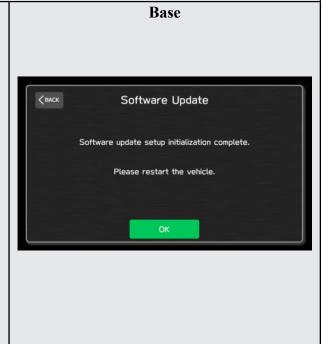
2-8. You will see the screen below when the initialization is complete.
