SERVICE BULLETIN

APPLICABILITY: 2025 WRX
2025 Forester Hybrid

NUMBER: 15-326-25R

SUBJECT: FOTA (Firmware Over-The-Air) Reprogramming for DENSO Gen 4.5 Audio Navigation Infotainment Systems via DCM

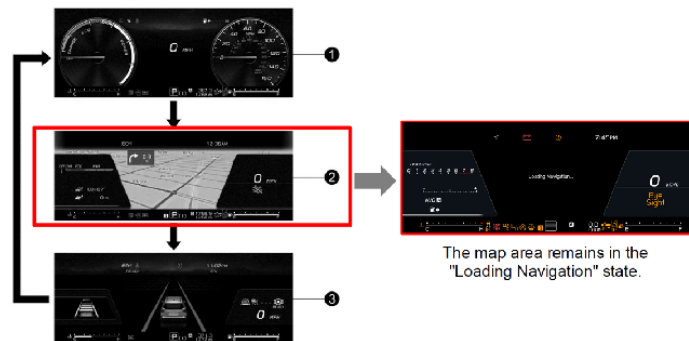
This update addresses an issue in “Map Mode” on the digital instrument cluster, where the map may fail to display and remain on “Loading Navigation” state.

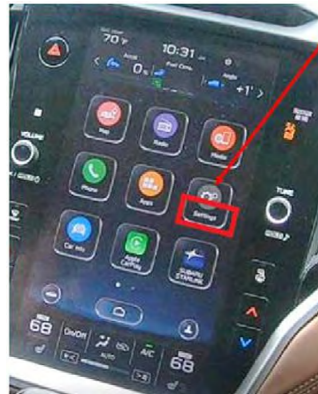
- 1) After starting the engine and system boot-up completes, from the HOME screen, touch then Settings button.

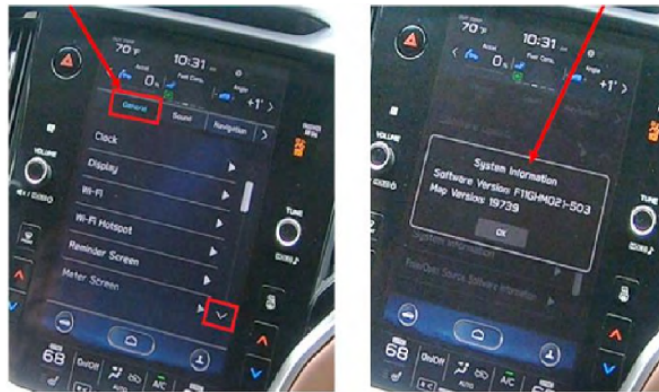
- 2) Press the **General** button. Use the down arrow to scroll to **System Information** then press to display the System Information / Version information.

The examples below identify the head unit model and the last 6 digits 9xxx-xxx) signify the software version number. Examples:

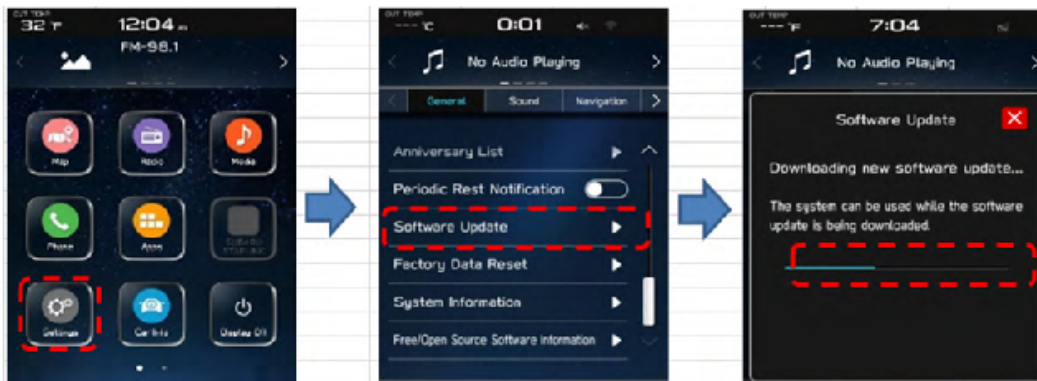
Downloading automatically starts and finishes. While the DCM is downloading the new software, all functions of Cockpit Control Unit remain available. The status of the downloading process can be checked using *Settings/General/Software update feature* as shown below.

Normally downloading takes 10-20 minutes depending on reception condition. Even if is pressed in the 3rd screen to return, downloading process continues.

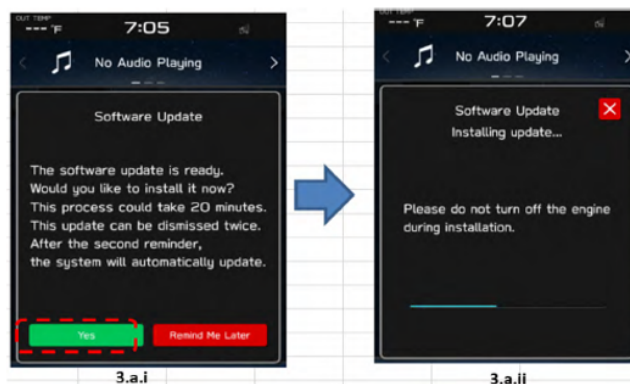
Notification screen is automatically displayed, after the background downloading has been successfully completed. This screen is displayed only while the vehicle is not in motion. Select “Yes” => Start installation. Once “Yes” is pressed, installation continues even if the “X” button is pressed.

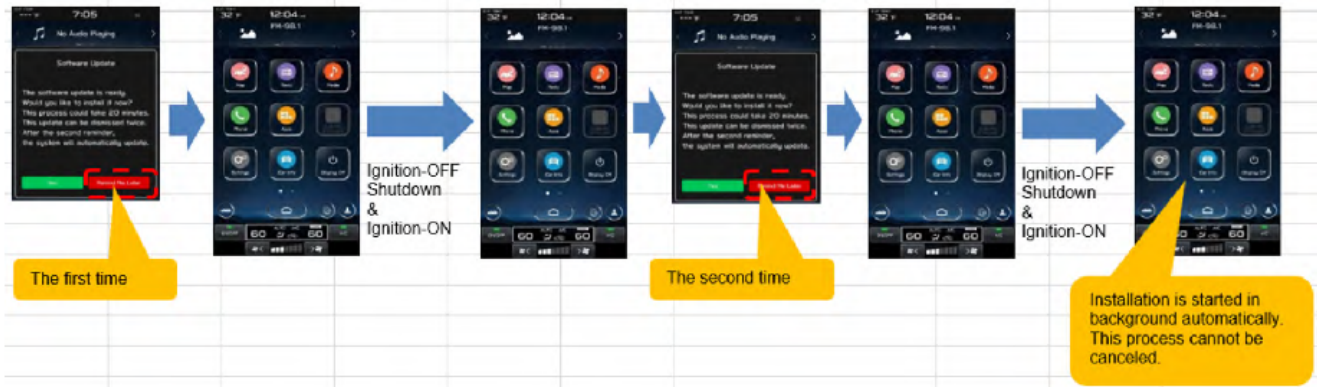
Customers can skip installation by selecting <Remind Me Later> up to two times. However, after skipping two times the installation starts automatically as soon as the Ignition Switch is turned ON without any notification. In that case the installation notification (3.a.i) is not displayed anymore. See below for more information.

- If ignition Switch is turned OFF while 3.a.i screen is being displayed, the installation process is terminated. In that case the screen 3.a.ii pops up automatically the next time the Ignition Switch is turned on.
- If ignition Switch is turned OFF during 3.a.ii screen is being displayed, the installation process is terminated. In that case installation process automatically resumes without showing 3.a.ii next time the Ignition Switch is turned on.
- Activation: Wait until the installation is completed (Time required for installation: 15 minutes or less). After the first installation process is coming to an end and the pop-up screen shown below comes up, then press “OK.”

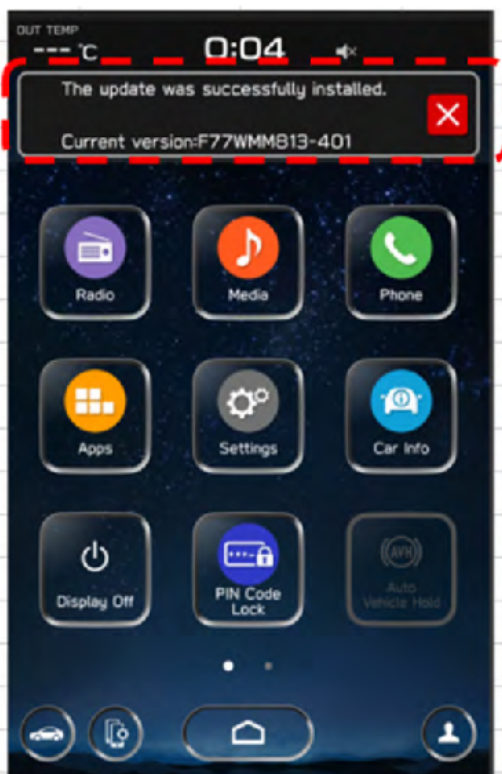
Pop-up screen shows up soon after the system completes to boot up. It confirms the software has been installed.

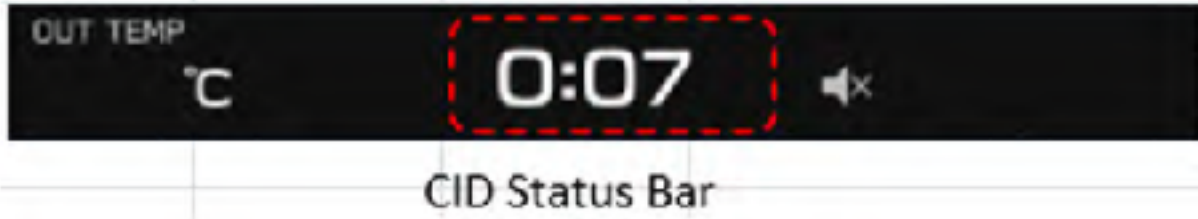
Software Update availability notification only works, if the clock has been set accurately. Check if the time shown on the status bar is correct or not.

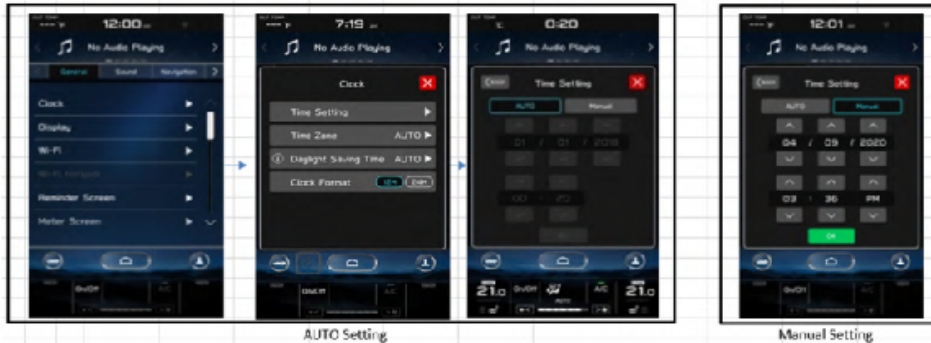
<Models with navigation system>

- Confirm GPS signal is received. Vehicle position on the map should match its location. If necessary, drive the vehicle to assure good reception.
- Check if Clock set to “Auto”: Setting → “Clock” → “Time Setting”.
- Once the Navi receives the GPS signal the clock is adjusted automatically.
- If the GPS signal is not available, set the clock to “Manual Setting”.

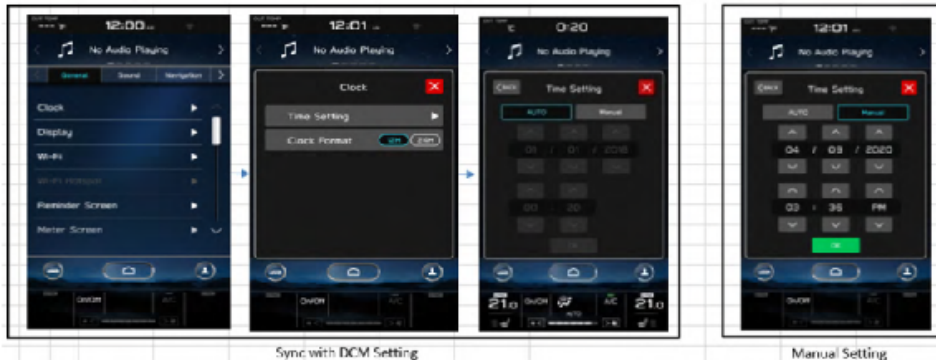
<Models without navigation system>

- Select “Setting” → “Clock” → “Time Setting” and check if the setting is “AUTO”. In case the clock is not adjusted correctly, set the clock in “Manual” setting.

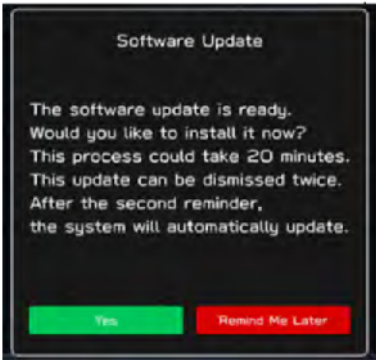
3-2		“The software installation failed. An error occurred during installation. Please contact your retailer.” popup is shown while installing.	An exception error due to hardware malfunction	Installation will resume automatically 24hours later. If same error message again, please perform diagnostic of CCU or update CCU software via USB.
3-3		Selected <Remind Me Later>, but next time IG ON 3.a.i screen is not displayed.

DCM has lost connection to SUBARU server. After downloading was com- pleted, DCM needs to con- nect with SUBARU server, before installing	Assure DCM has strong reception and reliable connection with the server, then turn ignition OFF and ON to repeat the test.
