REFERENCE:	TSB: 18-031-25 REV. B GROUP: 18 - Vehicle Performance	Date:	September 27, 2025	REVISION:	18-031-25 REV. A
VEHICLES AFFECTED:	2025 (DT) RAM 1500 Pickup This bulletin applies to vehicles built on or before May 08, 2025 (MDH 0508XX) equipped with 3.0L I6 Hurricane SO Twin Turbo ESS (Sales Code EFH).			MARKET APPLICABILITY: <input checked="" type="checkbox"/> NA <input checked="" type="checkbox"/> MEA <input checked="" type="checkbox"/> SA <input checked="" type="checkbox"/> IAP <input checked="" type="checkbox"/> EE <input checked="" type="checkbox"/> CH NOTE: This bulletin applies to the North and South America, Enlarged Europe, Middle East & Africa, India & Asia Pacific, China markets.	
CUSTOMER SYMPTOM:	<p>Customers must experience a Malfunction Indicator Lamp (MIL) illumination and the vehicle must exhibit/set one or more of the following Diagnostic Trouble Codes (DTCs):</p> <ul style="list-style-type: none"> ● **P00C6-00 - Fuel Rail Pressure Too Low - Engine Cranking - in ACTIVE or STORED status. ● P0325-00 - Knock/Combustion Vibration Sensor 1 Circuit - in ACTIVE or STORED status. ● P0330-00 - Knock/Combustion Vibration Sensor 2 Circuit - in ACTIVE or STORED status. ●

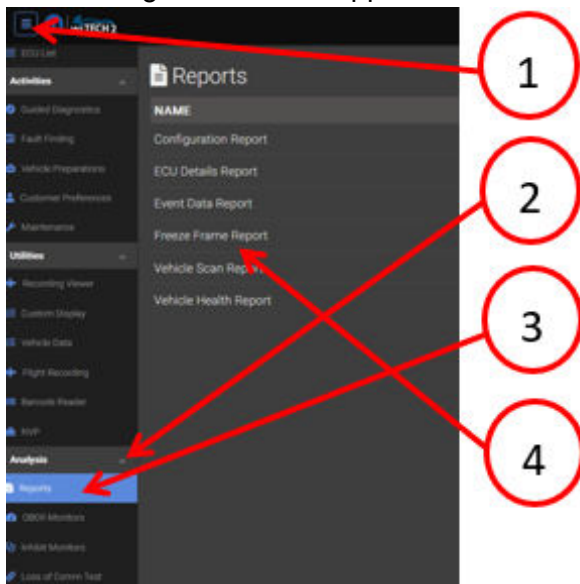
Fig. 1
Navigate To Freeze Frame Report

1. ****Is the vehicle on the RSU VIN list?**
 - YES >>> Proceed to [Step 10](#).
 - NO >>> Proceed to [Step 2](#).
2. Are DTCs P00C6-00, P0325-00, P0330-00, P032A-00, P018B-00, P2AF6-00 and/or U0104-00 and/or U0405-00 present in Active/Stored status?
 - YES >>> Proceed to [Step 10](#).
 - NO >>> Proceed to [Step 3](#).
3. Are DTCs P0300-00, P0301-00, P0302-00, P0303-00, P0304-00, P0305-00, and/or P0306-00 present in Active/Stored status?
 - YES >>> Proceed to [Step 4](#).
 - NO >>> This bulletin has been completed, use Inspect LOP (18-19-06-KF) to close the active RSU.
4. In the wiTECH tool, select the hamburger icon in the upper left corner [Fig. 1](#).

- 1 - Hamburger Icon
- 2 - Analysis
- 3 - Reports
- 4 - Freeze Frame Report

5. Navigate down to Analysis on the left column and select the drop down arrow [Fig. 1](#).
6. Select Reports [Fig. 1](#).
7. Select Freeze Frame Report [Fig. 1](#).
8. To confirm the cold start catalyst heating, use wiTech Freeze Frame data and confirm that DTCs P0300-00, P0301-00, P0302-00, P0303-00, P0304-00, P0305-00 and/or P0306-00 was set under following condition:
 - Engine Coolant Temperature °F less than 122°F (50°C)[Fig. 2](#).
 - Time Since Engine Start less than 30 seconds [Fig. 2](#).
