HYUNDAI Technical Service Bulletin	GROUP CAMPAIGN	NUMBER 25-01-068H
	DATE SEPTEMBER 2025	MODEL(S) SEE BELOW
SUBJECT: OIL PUMP UNIT (OPU) SOFTWARE UPDATE - DTC U100787 (SERVICE CAMPAIGN TEK)

Description: Certain Tucson Hybrid (NX4 HEV) and Tucson Plug-in Hybrid (NX4 PHEV) vehicles may exhibit a condition where the Oil Pump Unit (OPU) prevents the Ready Lamp from turning on. Some vehicles may also display DTC U100787 (malfunction on CAN communication). This bulletin provides instructions to update the Powertrain Control Unit (PCU) software.

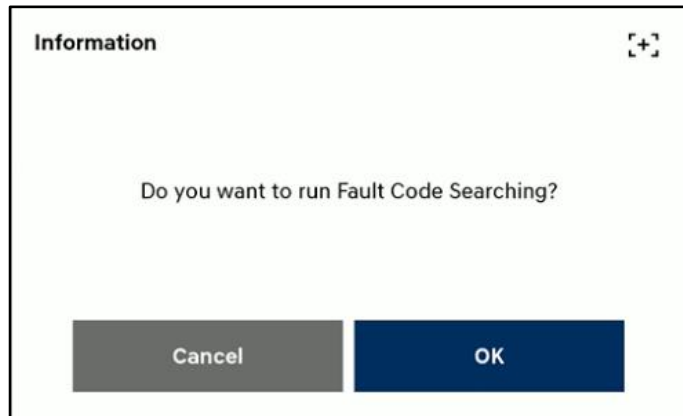
- 7. Perform an **All Systems Fault Code** search and erase DTC history that had incidentally occurred from the ECU update.
