Technical Service Bulletin

OUE7 - Over-the-Air (OTA) Software Update (SW Level 3.8.11) Dealer Recovery Process - OTA Software Update Not Successful

Applicable Vehicles

Country	Beginning Model Year	Ending Model Year	Vehicle
USA	2021	2025	ID.4
CAN	2021	2025	ID.4

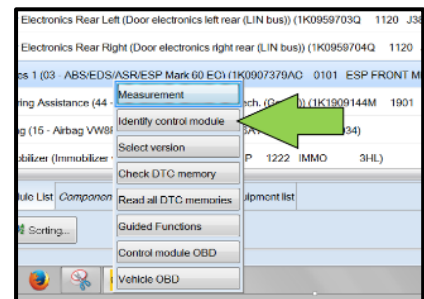
- The above module(s) are updated during the OTA update.
- Select the control module tab.
- Find the listed control module(s) in the control module list.
- Right click on the module(s) and select "Identify control module" for all modules listed above.
- Continue to Step 3.

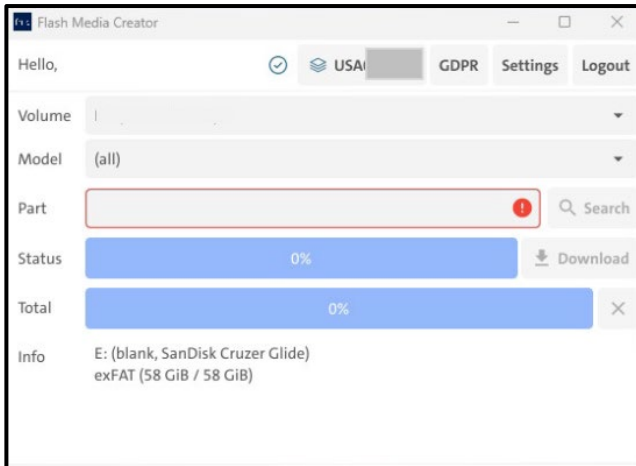
Step 4 – Update ICAS3 Software via USB

- The required software will have to be downloaded onto a USB (or USB-C) drive using the Flash Media Creator (Edgebox).
- **Reference the latest information in Elsa2Go Service References for additional information about the Flash Media Creator.**
- **Use ONLY a 32 GB USB stick.**

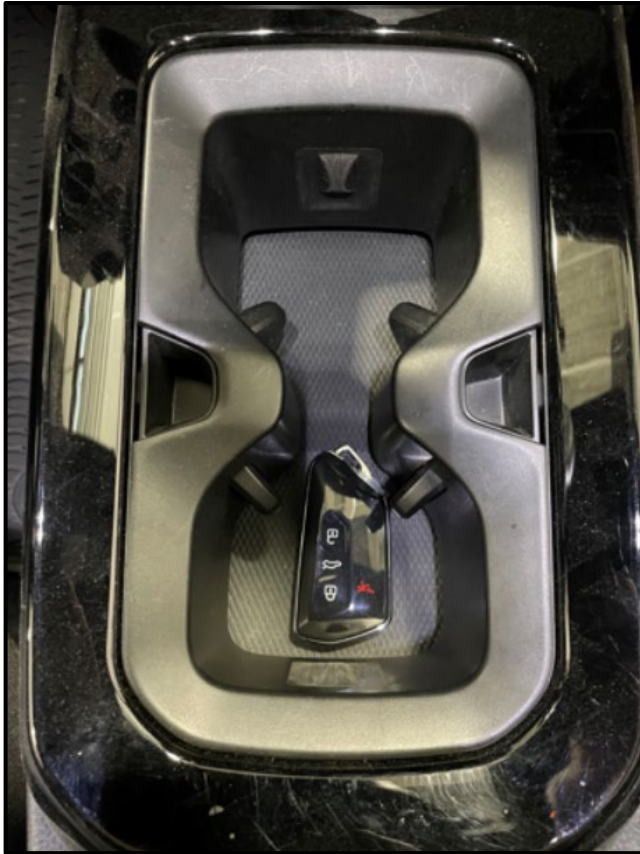
- Place the vehicle key over the reader coil in the center console cup holder.
- Any additional keys must be a minimum of 20 meters away from the vehicle.

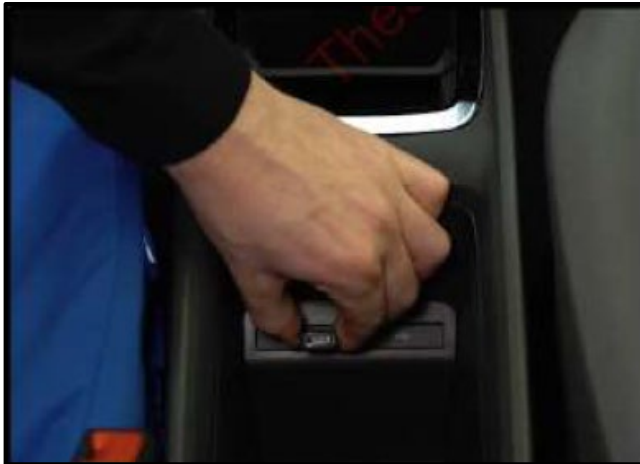
- Insert the USB drive into one of the USB ports.
- Turn the ignition ON.

The radio display may display “No playable content” when the ignition is turned on. This is normal. DO NOT remove the USB drive from the USB port.

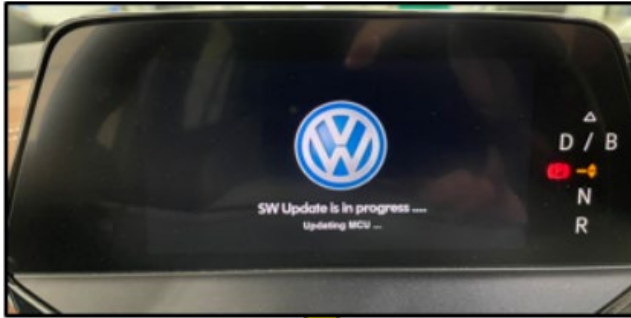
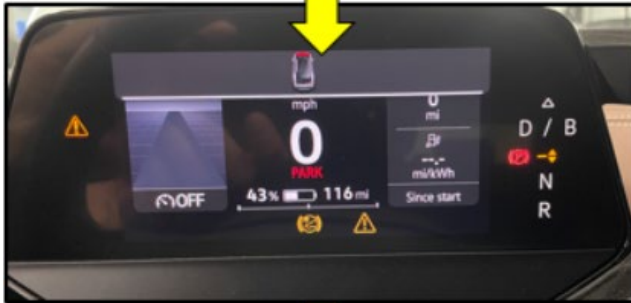
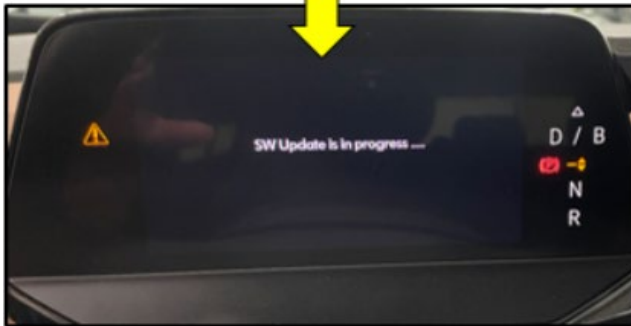
- The update will start on its own after about two minutes.
- During the update, the instrument cluster display will change multiple times.

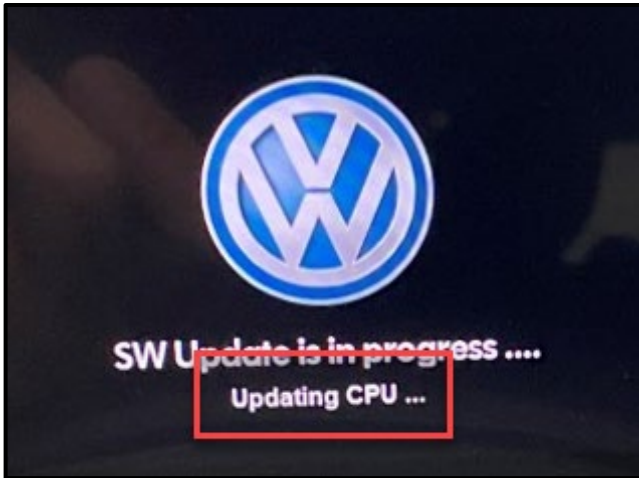
The instrument cluster may remain off, even though the update is complete. If the cluster is off after 40 minutes, cycle the ignition off and back on. The successful message should now appear.

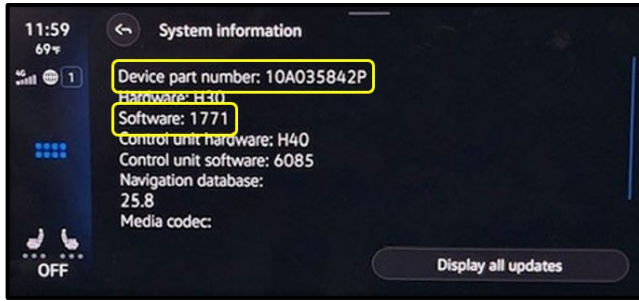
- Check SW version on infotainment display.
