KA-01889 McLaren Artura Ancillary High Voltage Component Diagnosis

Location: Hybrid/High Voltage

Topic: McLaren Artura Ancillary High Voltage Component Diagnosis

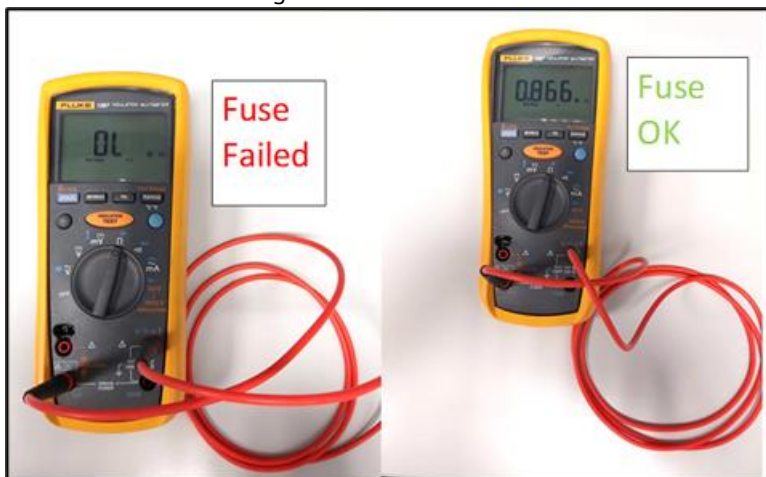
1. Set meter to resistance setting
2. Short the terminals shown below with a test lead (V Ω to mA)
3. "OL" indicates that the fuse has failed and must be replaced before proceeding with the insulation test. Any other resistance reading indicates that the fuse is OK and the insulation test can proceed

The multimeter must be checked to ensure that it is operating correctly before and after the HV resistance measurements to ensure that the internal fuse is not blown causing incorrect readings. The below instructions are provided for the McLaren approved Fluke 1587 Insulation Multimeter. For other multimeter models please refer to the user manual.

The following steps must be carried out before and after completing the HV resistance measurements:

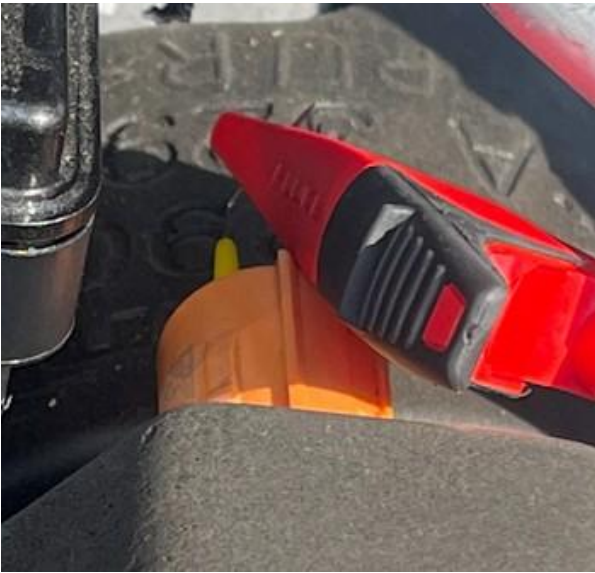
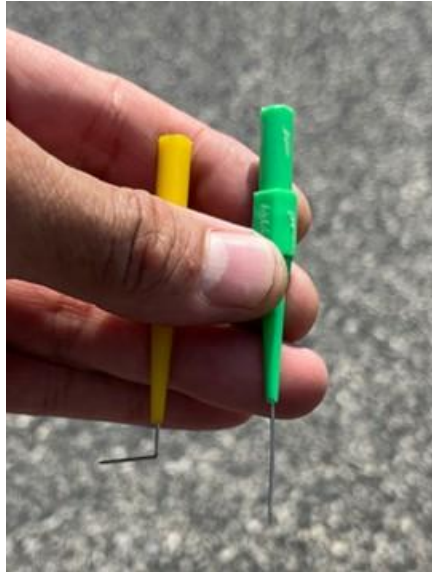
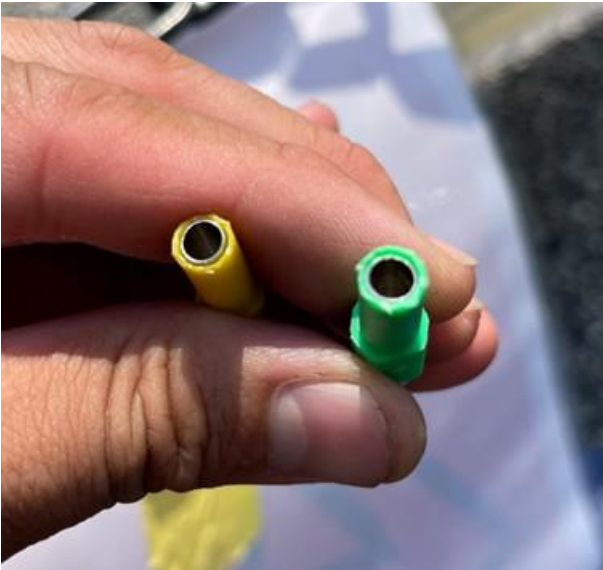
HVAC eCompressor

Please measure into the eCompressor using suitable pins. Back probe pins have been used and found to provide good results. See images below:

Once a good connection has been established, please measure the resistance between pin 1 to chassis ground, pin 2 to chassis ground and finally between pin 1 and pin 2. Results will be reviewed once submitted.
