**WSLO - Re-coding Front and Rear Door Control Units (Workshop Campaigns)**

Model Year: **2025**

Model Line: **Macan Electric (XAB)**

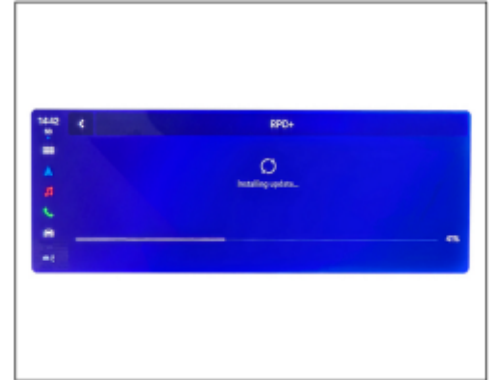
*Update progress on central display*

During the update process, all displays in the vehicle (instrument cluster, central display and passenger display) are occasionally switched off. However if coding is ongoing, **the ignition must not be switched on/off**, as this can result in the destruction of the control units.

If Wi-Fi coverage is insufficient, the connection between the Porsche Tester and VCI can be interrupted (battery charge indicator at the top right inactive on the Tester display). The vehicle will, however, continue coding **independently**. Whilst this is ongoing it is not possible to make any entries on the Porsche Tester or restart the process. In this case, the update progress can still be checked in the vehicle on the diagnostic tester or in the front display and control panel (R238) by going to the **"Messages" (RPC+)** tile.

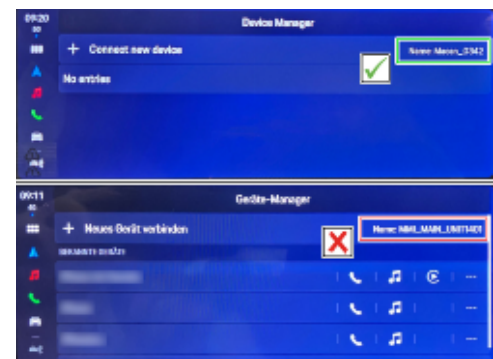
PCM device manager - Bluetooth identifier
