WSK9 - Re-Programming DME Control Unit (Workshop Campaign)

Model Line: **Cayenne (9YA / 9YB)**

Concerns: **DME control unit**

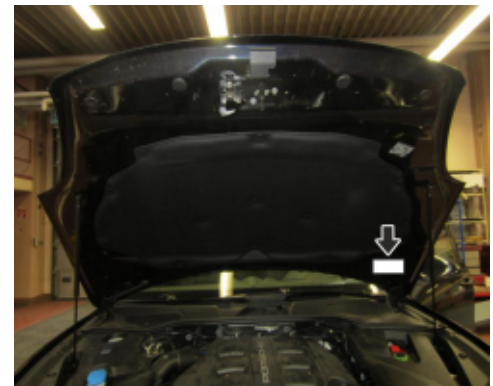
Proof of Completion Label: specified position (Exemplary illustration)

- 5.1 Fill out the Recall Proof of Completion label
⇒ *Recall Proof of Completion Label* fully and correctly. This includes the recall code “**WSK9**”, your Porsche Center code and the repair date.
- 5.2 Clean the surface in the lower area on the front lid at the left-hand side in direction of travel at which the Recall Proof of Completion label must be attached ⇒ *Proof of Completion Label: specified position (Exemplary illustration) -arrow-* using a suitable cleaning agent and a clean, grease-free and lint-free cloth.
- 5.3 Affix Recall Proof of Completion label in the lower area of the front lid at the lefthand side in direction of travel ⇒ *Proof of Completion Label: specified position (Exemplary illustration) -arrow-*.
- 5.4 Close front lid.
- 6 Enter the Campaign in the Warranty and Maintenance Logbook.
