# Technical Service Bulletin

<b>Topic</b>	MIB3 Telecom Infotainment MMI becoming stuck on the 'initialisation/loading' screen   Bentayga Series   21-23MY
<b>Market area</b>	Australia E04 Bentley rest Asia and Australia (6E04), Germany E02 Bentley rest Europe (6E02), India 938 Indien; SKODA AUTO Volkswagen India (6938), United Arab Emirates E06 Bentley Middle East and Africa (6E06), United Kingdom E01 Bentley UK (6E01), United States E05 Bentley USA and rest America (6E05)
<b>Brand</b>	Bentley
<b>Transaction No.</b>	2079175/1
<b>Level</b>	EH
<b>Status</b>	Released for publishing
<b>Release date</b>	Oct 20, 2025

The customer complains of an issue with MMI becoming stuck on the 'initialisation/loading' screen.

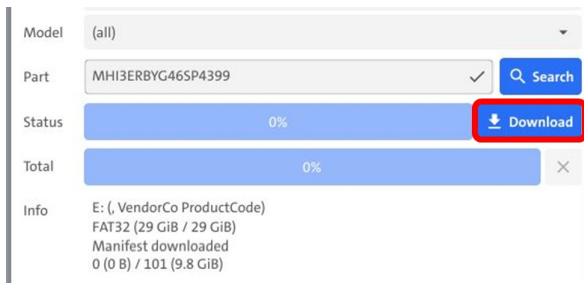
6) Press “Search”. You should receive a prompt stating “Flash files downloaded”.

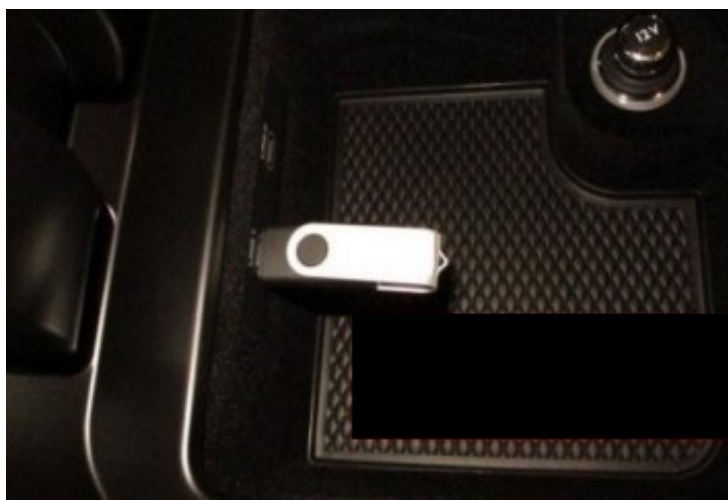
Figure 1

13. Insert the USB update stick with the instrument cluster software from **table 2** into the USB 1 socket (Figure 1).

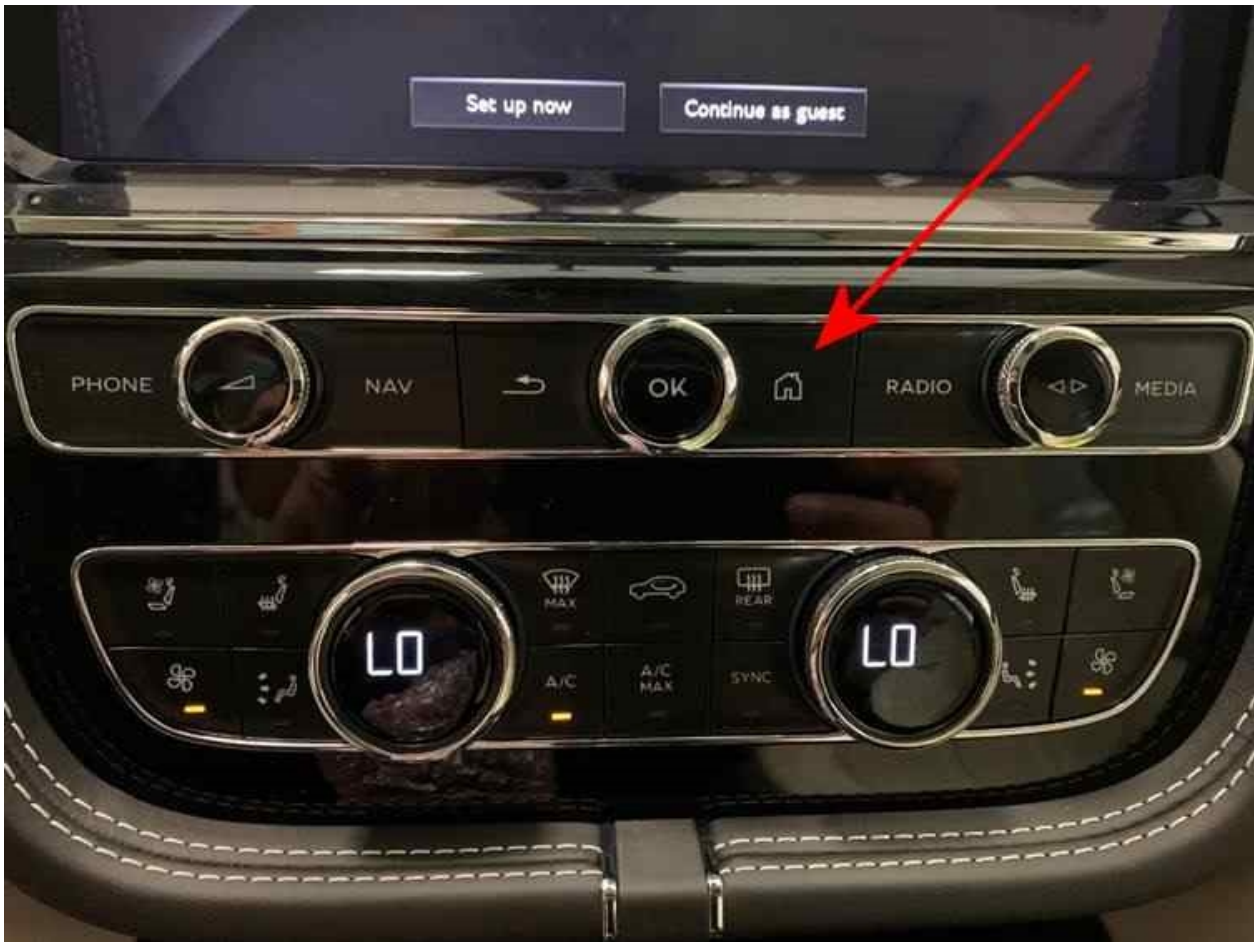
Figure 2

- Press the home screen button (Figure 2)

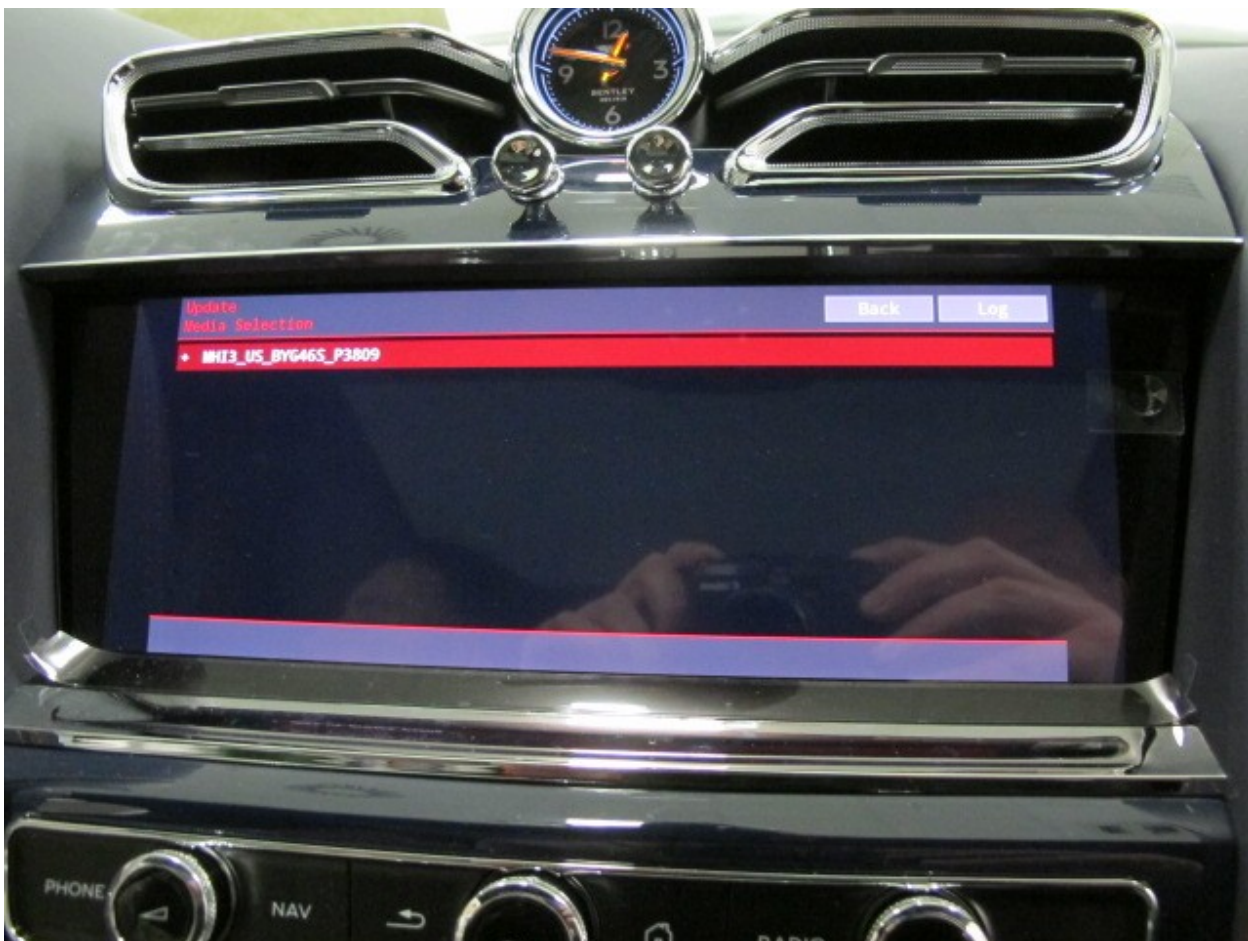
Figure 5

14. Select the suggested update. (Figure 5)

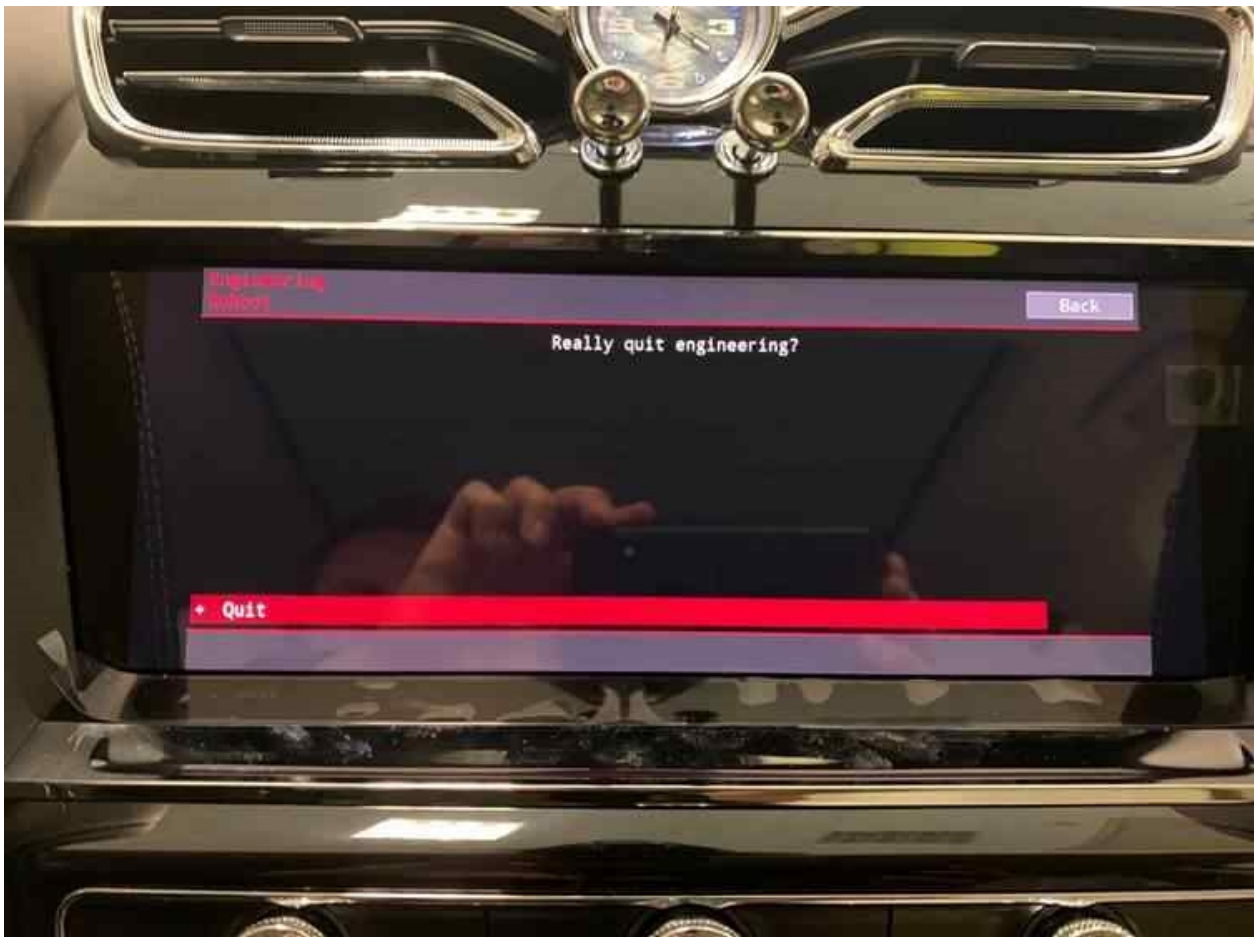
Figure 12

19. On the next screen select 'Quit' (Figure 12), the system will then reboot. Once the home screen is displayed, remove the USB update stick and carry out an ignition cycle.

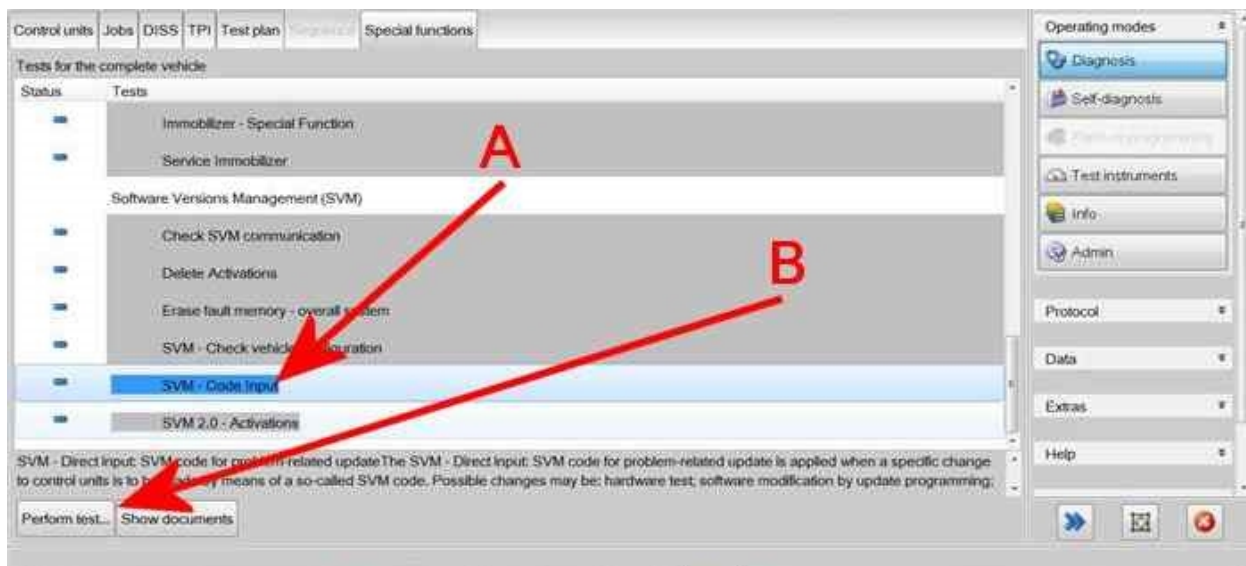
- Referring to Figure 13 - Within the Special functions tab select SVM – Code Input (A) then select Perform test (B)

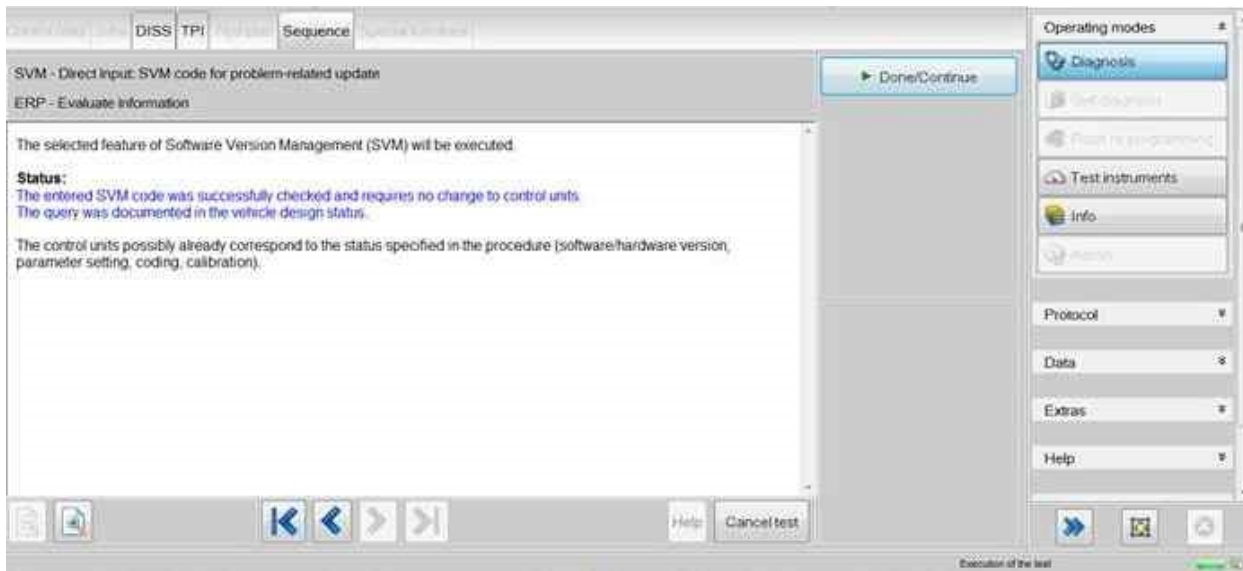
Figure 16

24. Once complete a summary screen will appear (Figure 16), this confirms successful completion - Follow any on screen prompts until program end
