# Service Bulletin

Bulletin No.: 24-NA-170

**Subject: Check Engine Lamp Illuminated with HVAC Related DTC**

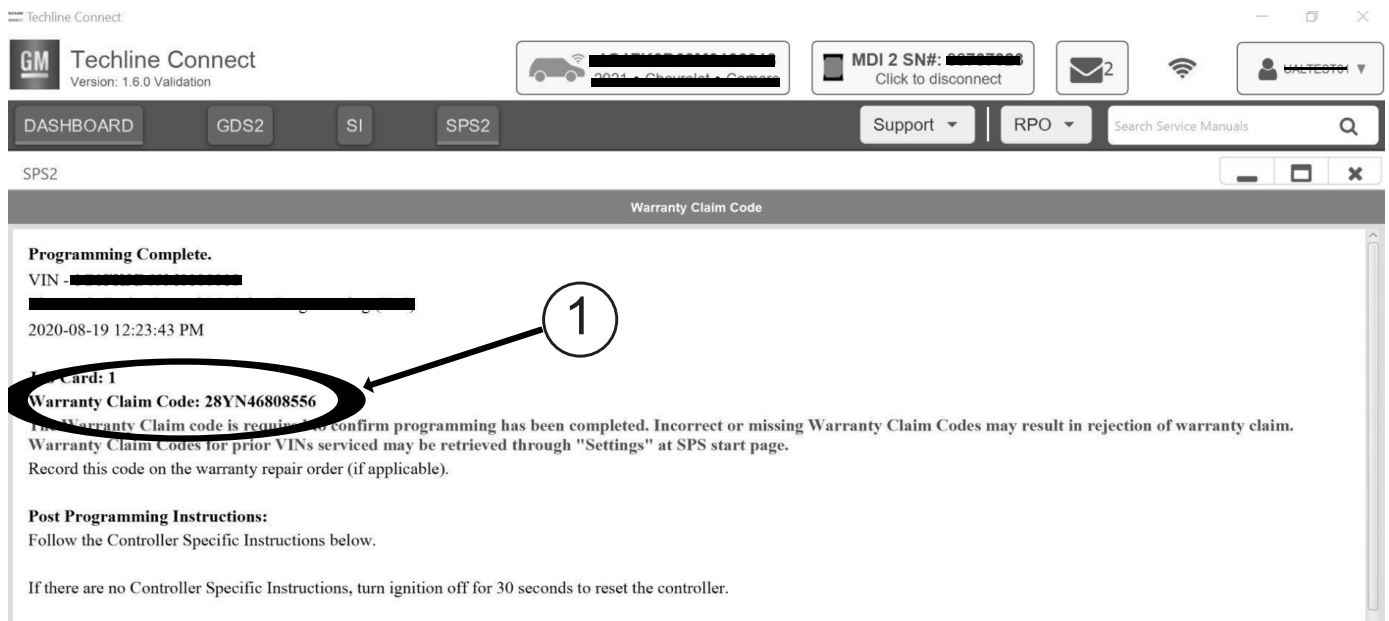
5644478

**Note:** The screenshot above is an example of module programming and may not be indicative of the specific module that is being programmed. Module selection and VIN information have been blacked out.

**Important:** To avoid warranty transaction rejections, you MUST record the warranty claim code provided on the Warranty Claim Code (WCC) screen shown above on the job card. Refer to callout 1 above for the location of the WCC on the screen.

2. Record the SPS Warranty Claim Code on the job card for warranty transaction submission.
