# HYUNDAI Technical Service Bulletin

GROUP <b>CAMPAIGN</b>	NUMBER <b>25-01-075H</b>
DATE <b>OCTOBER 2025</b>	MODEL(S) <b>SONATA (DN8)</b>

**SUBJECT:** AC NOT SHUTTING OFF – ATCU SOFTWARE UPDATE  
(SERVICE CAMPAIGN TEB)

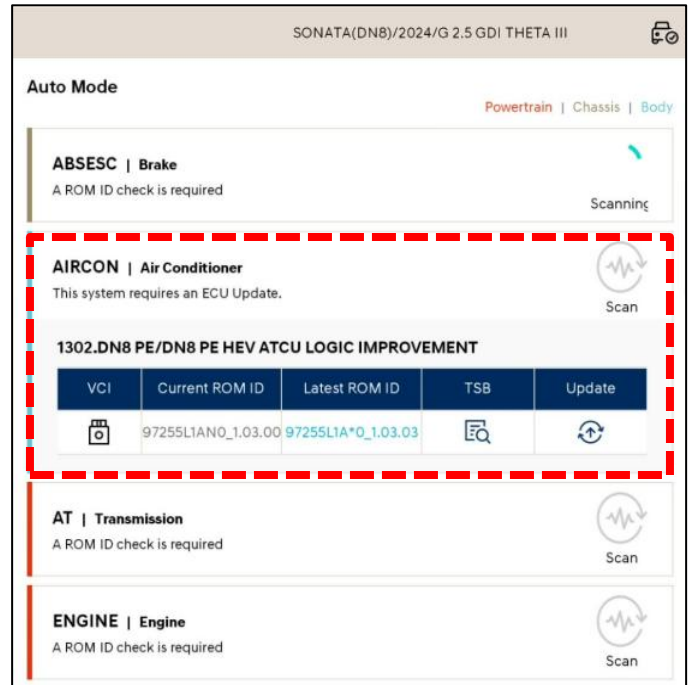
If the update fails, remove the power connector from the in-cabin fuse box for at least **5 seconds**. Reassemble and retry the update.

3. After the ECU update process shows 100% complete, follow the prompts on the screen to cycle the ignition **OFF** for at least **10 seconds** to reset the control unit (certain models may take up to **30 seconds**).

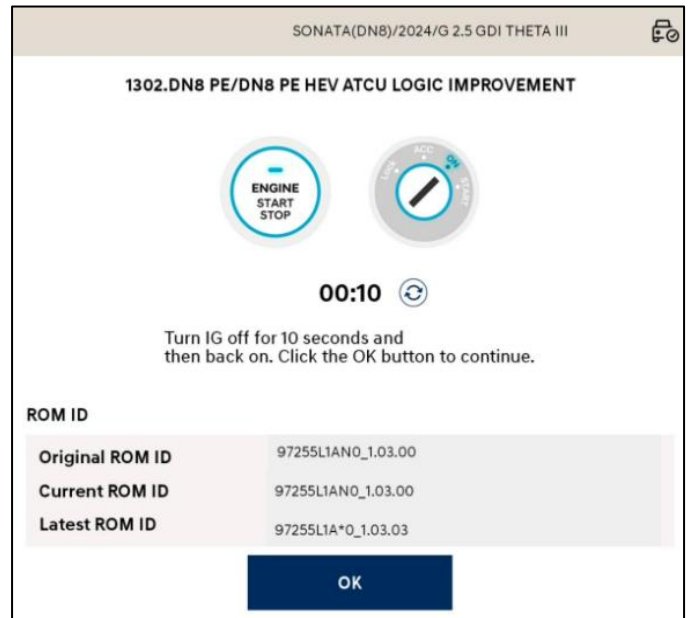
Use the **Refresh** button to reset the timer.

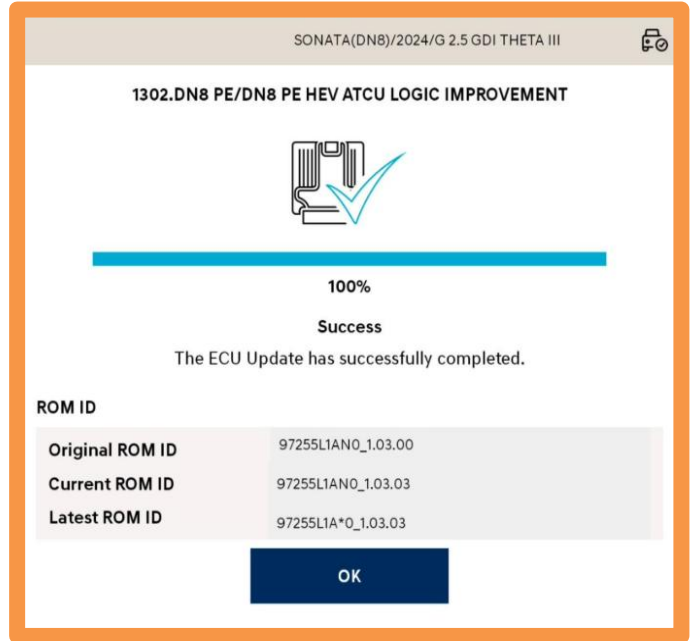
Take a screenshot of the ECU update “Success” screen using your tablet and upload to STUI.

**NOTE 3:** This TSB includes repair validation photos. Op times include VIN, mileage, and photo capture of the ECU Update “Success” screen as outlined in the Digital Documentation Policy.

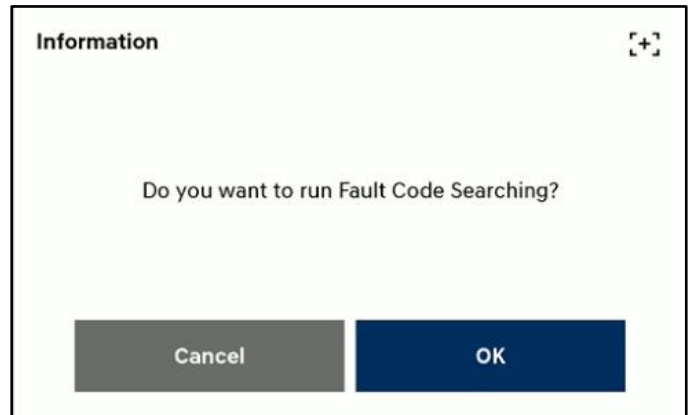
6. Perform an **All Systems Fault Code** search and erase DTC history that had incidentally occurred from the ECU update.
