# HYUNDAI

## Technical Service Bulletin

GROUP <b>CAMPAIGN</b>	NUMBER <b>25-01-072H-1</b>
DATE <b>OCTOBER 2025</b>	MODEL(S) <b>SANTA FE (MX5A)</b>

**SUBJECT:** TCU SOFTWARE UPDATE FOR 8DCT HIGH PRESSURE ELECTRIC OIL PUMP (SERVICE CAMPAIGN TEJ)

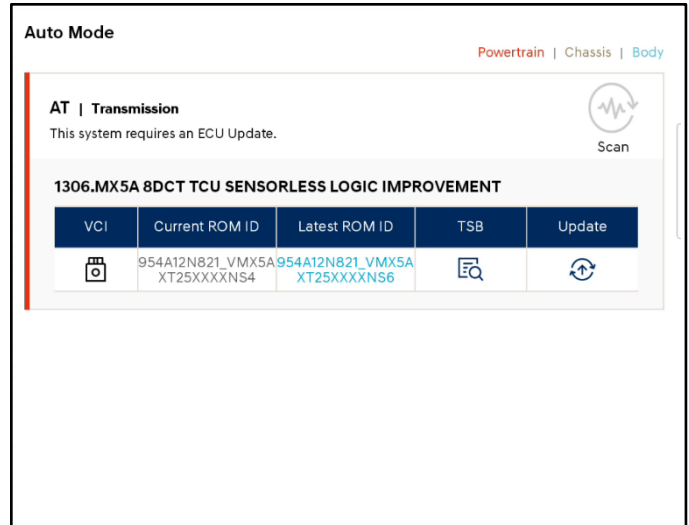
Check the current ROM ID version and compare it to the **ROM ID Information** table before attempting to perform the software update.

If the update fails, remove the power connector from the in-cabin fuse box for at least **5 seconds**. Alternatively, disconnect the negative (–) **12V** battery terminal and wait at least **5 seconds**. Reassemble and retry the update.

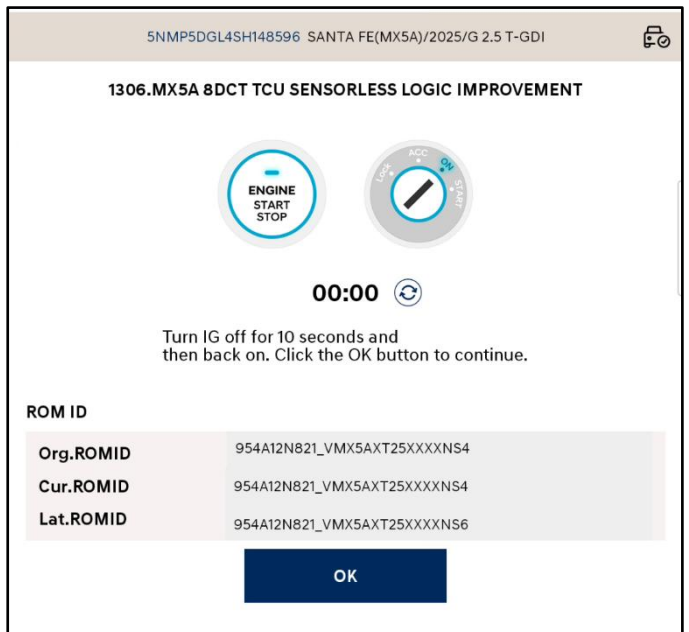
3. After the ECU update process shows 100% complete, follow the prompts on the screen to cycle the ignition **OFF** for at least **10 seconds** to reset the control unit (certain models may take up to **30 seconds**).

Use the **Refresh** button to reset the timer.

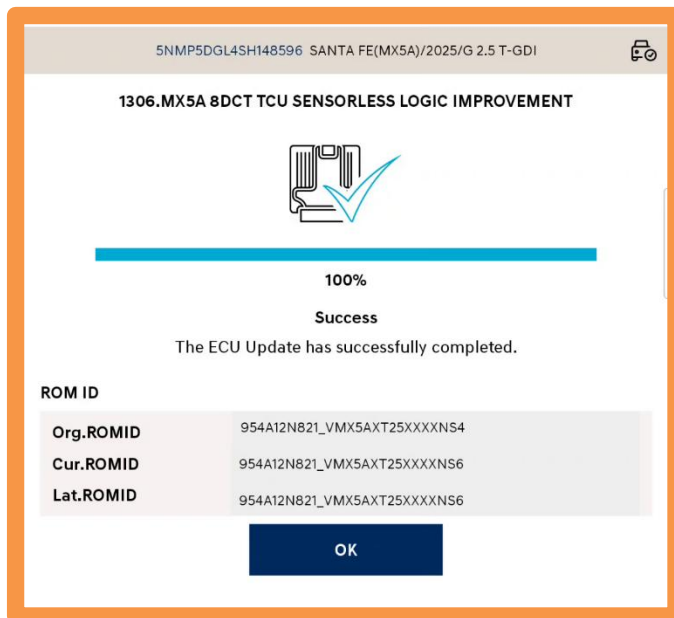
Using the tablet or GDS screen capture function, take a screenshot of the ECU Update "Success" result screen.

Upload the photo to STUI.

**NOTE:** The VIN/Date/Time/Mileage photo imprint is **NOT** required for GDS screenshots.

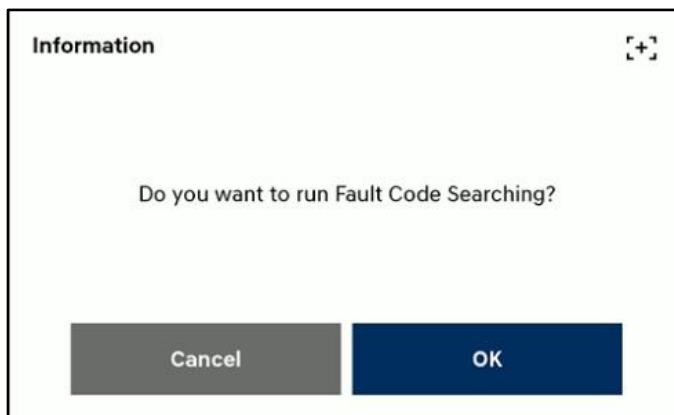
5. Perform an **All Systems Fault Code** search and erase DTC history that had incidentally occurred from the ECU update.

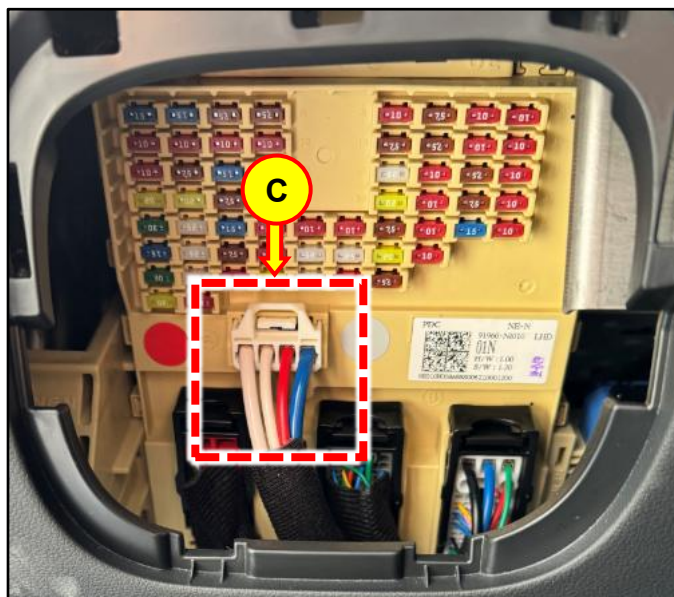
6. Remove the power connector (C) from the in-cabin fuse box for at least **5 seconds**, then reconnect it.

Alternatively, disconnect the negative (-) **12V** battery terminal, wait at least **5 seconds**, then reconnect it.
