# HYUNDAI

## Technical Service Bulletin

GROUP <b>CAMPAIGN</b>	NUMBER <b>25-01-076H</b>
DATE <b>OCTOBER 2025</b>	MODEL(S) <b>SONATA HYBRID (DN8 HEV)</b>

**SUBJECT:** AC NOT SHUTTING OFF – ATCU SOFTWARE UPDATE (SERVICE CAMPAIGN TEBA)

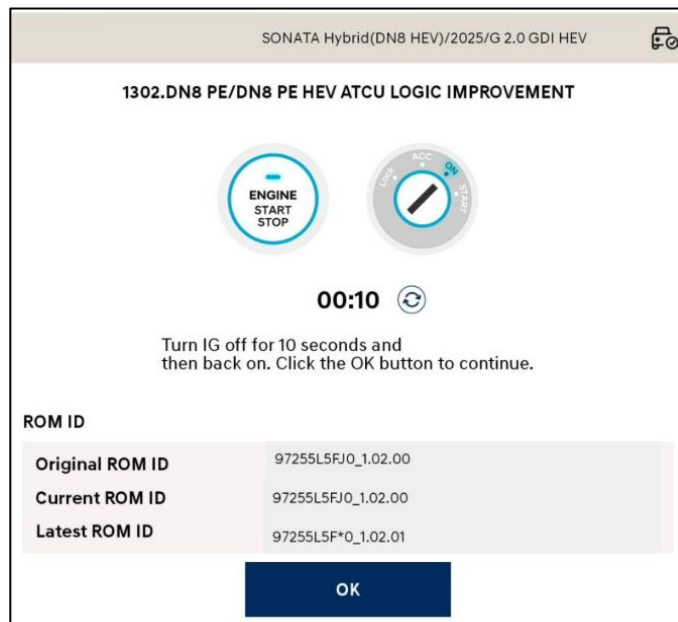
- After the ECU update process shows 100% complete, follow the prompts on the screen to cycle the ignition **OFF** for at least **10 seconds** to reset the control unit (certain models may take up to **30 seconds**).

Use the **Refresh** button to reset the timer.

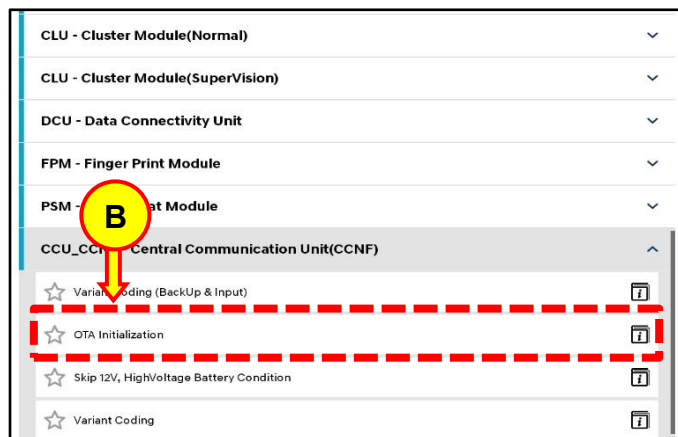
5.

- OTA initialization (A) should perform automatically:
  - If OTA initialization performs automatically, then proceed with the service procedure.
  - If the OTA initialization process fails, complete it manually under: **S/W Management > CCU\_CCNF - Central Communication Unit (CCNF) > OTA Initialization (B)**.

Follow the instructions on the screen.

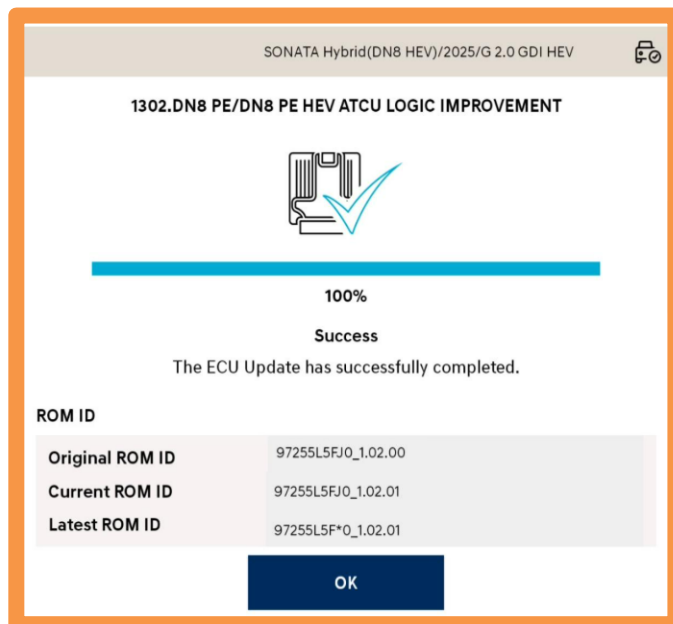
Take a screenshot of the ECU update “Success” screen using your tablet and upload to STUI.

**NOTE 3:** This TSB includes repair validation photos. Op times include VIN, mileage, and photo capture of the ECU Update “Success” screen as outlined in the Digital Documentation Policy.

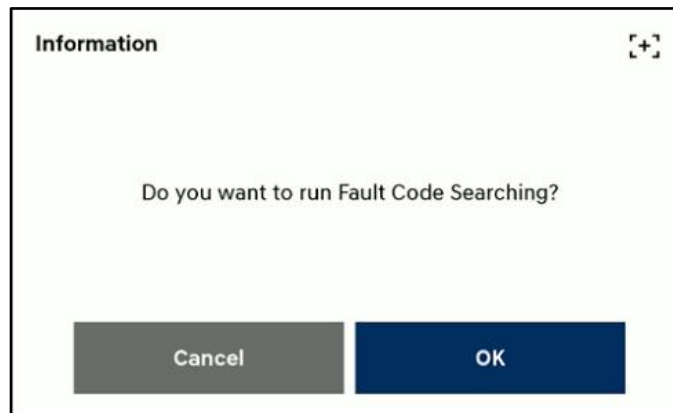
6. Perform an **All Systems Fault Code** search and erase DTC history that had incidentally occurred from the ECU update.
