Technical Service Bulletin

GROUP CAMPAIGN	NUMBER 25-01-079H
DATE OCTOBER 2025	MODEL(S) SANTA CRUZ (NXT)

SUBJECT: DCU SOFTWARE UPDATE
(LIMITED COVERAGE CAMPAIGN LA2)

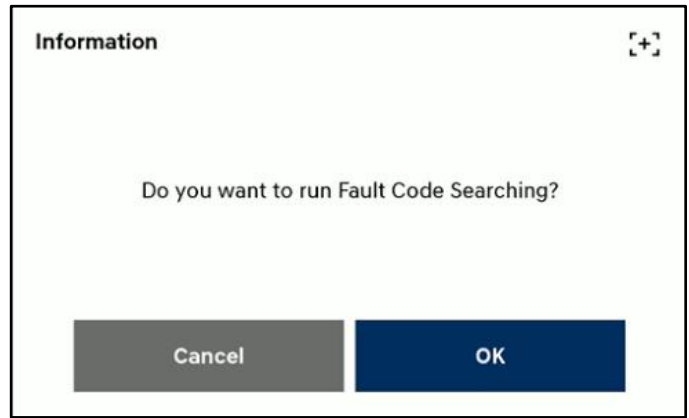
7. Perform an **All Systems Fault Code** search and erase DTC history that had incidentally occurred from the ECU update.
