SERVICE BULLETIN

NUMBER: 15-311-23R

SUBJECT: FOTA (Firmware Over-The-Air) Reprogramming for DENSO Gen 4.5 Audio Navigation Infotainment Systems via DCM

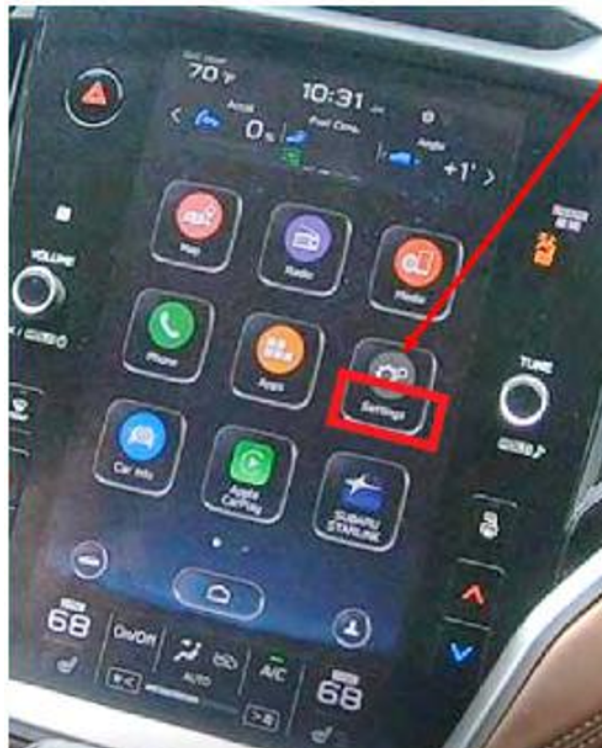
- 1) After starting the engine and system boot-up completes, from the HOME screen, touch the Settings button.

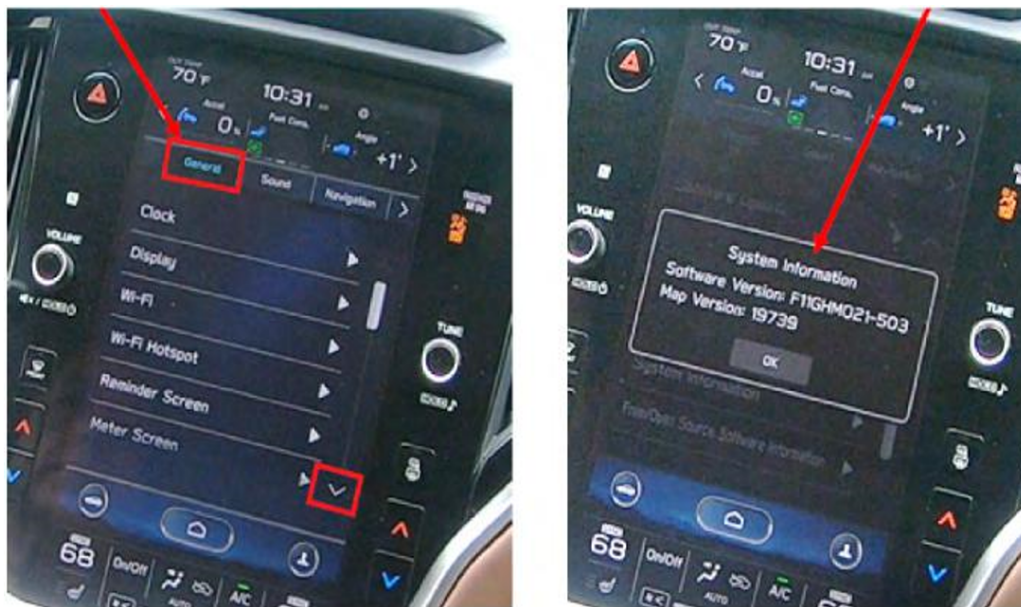
- 2) Press the **General** button. Use the down arrow to scroll to **System Information** then press to display the System Information / Version information.

Please note the last six digits of the software version (XXX-XXX) would determine an eligibility for the software update. If the the last six digits of the software version are not listed in the table below proceed to section “**FOTA REPROGRAMMING OVERVIEW**” below. Otherwise the unit already has the latest software version installed. No update is required at this time.

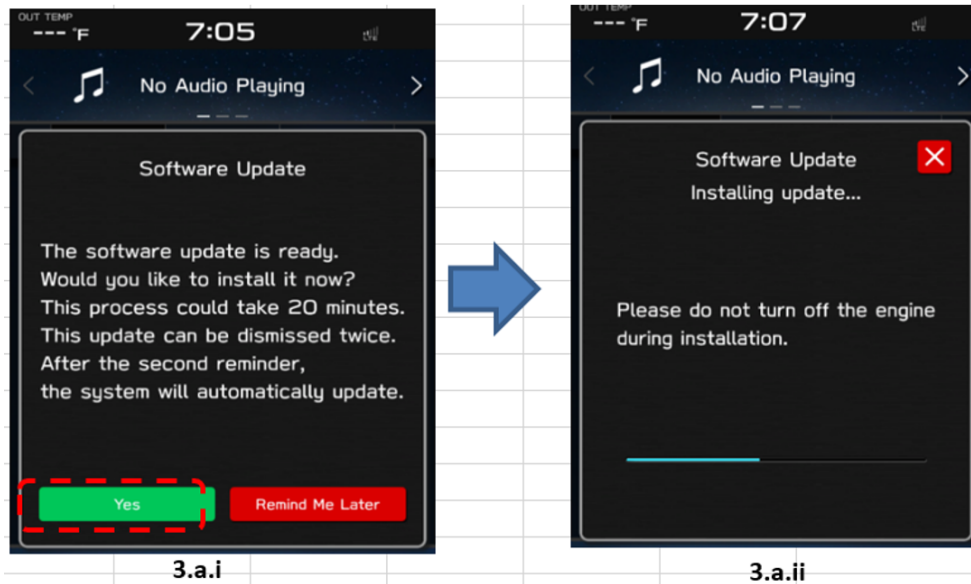
Notification screen is automatically displayed, after the background downloading has been successfully completed. This screen is displayed only while the vehicle is not in motion. Select “Yes” => Start installation. Once “Yes” is pressed, installation continues even if the

Customers can skip installation by selecting <Remind Me Later> up to two times. However, after skipping two times the installation starts automatically as soon as the Ignition Switch is turned ON without any notification. In that case the installation notification (3.a.i) is not displayed anymore. See below for more information.

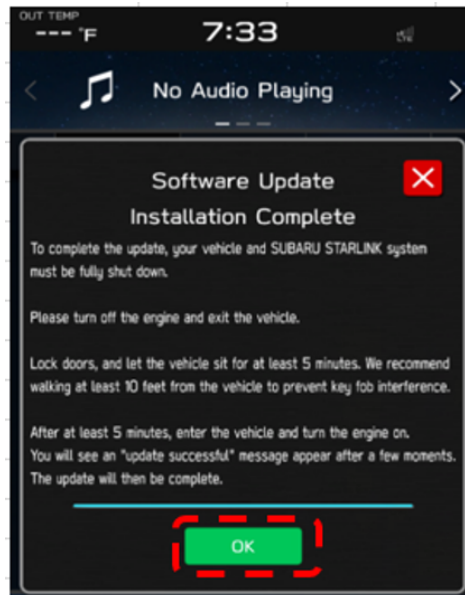
- If ignition Switch is turned OFF while 3.a.i screen is being displayed, the installation process is terminated. In that case the screen 3.a.ii pops up automatically the next time the Ignition Switch is turned on.
- If ignition Switch is turned OFF during 3.a.ii screen is being displayed, the installation process is terminated. In that case installation process automatically resumes without showing 3.a.ii next time the Ignition Switch is turned on.
- Activation: Wait until the installation is completed (Time required for installation: 15 minutes or less). After the first installation process is coming to an end and the pop-up screen shown below comes up, then press “OK.”

Switch the vehicle OFF, exit the vehicle, lock all doors including the rear gate (if equipped) and **move the key fob away from the vehicle at least 10 feet (3m) to enable affected systems to go to sleep. WAIT AT LEAST 5 MINUTES** prior to switching the vehicle ON to assure proper software activation.

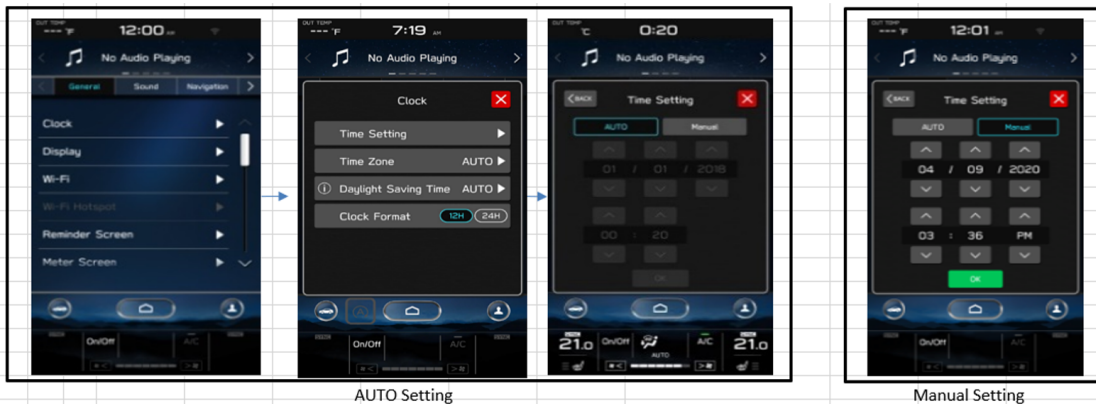
<Models with navigation system>

- Confirm GPS signal is received. Vehicle position on the map should match its location. If necessary, drive the vehicle to assure good reception.
- Check if Clock set to “Auto”: Setting→”Clock”→”Time Setting”.
- Once the Navi receives the GPS signal the clock is adjusted automatically.
- If the GPS signal is not available, set the clock to “Manual Setting”.

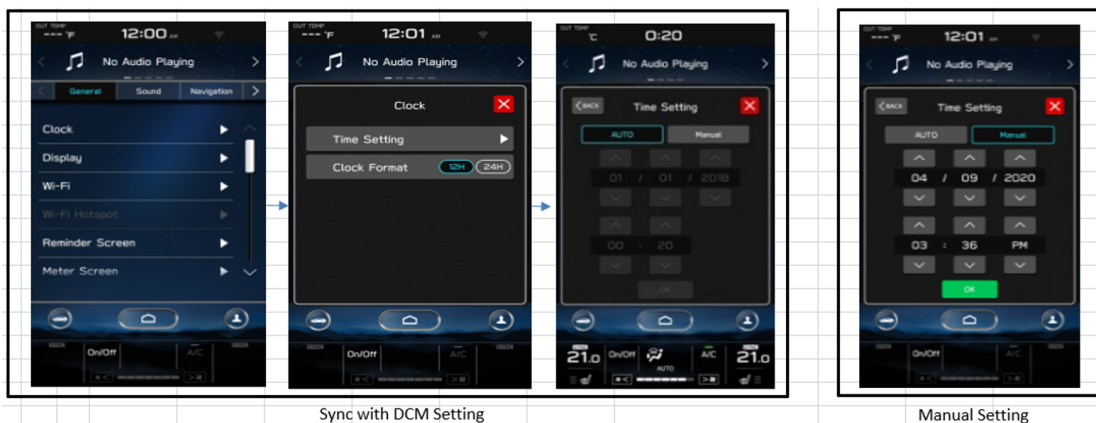
<Models without navigation system>

- Select “Setting”→”Clock”→”Time Setting” and check if the setting is “AUTO”. In case the clock is not adjusted correctly, set the clock in “Manual” setting.

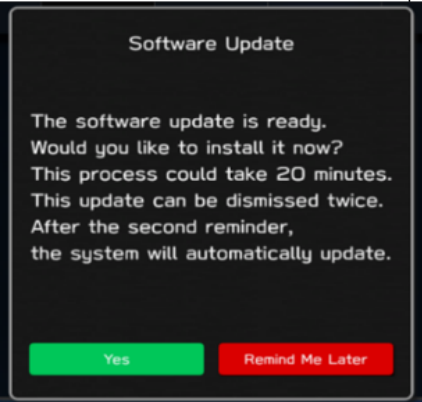
3-2		"The software installation failed. An error occurred during installation. Please contact your retailer." popup is shown while installing.	An exception error due to hardware malfunction	Installation will resume automatically 24hours later. If same error message again, please perform diagnostic of CCU or update CCU software via USB.
3-3		Selected <Remind Me Later>, but next time IG ON 3.a.i screen is not displayed.

DCM has lost connection to SUBARU server. After downloading was completed, DCM needs to connect with SUBARU server, before installing	Assure DCM has strong reception and reliable connection with the server, then turn ignition OFF and ON to repeat the test.
