SERVICE INFORMATION BULLETIN

NUMBER: 15-308-23R

SUBJECT: Diagnostic Information - Testing Telematics Systems for Dark/Standby Current

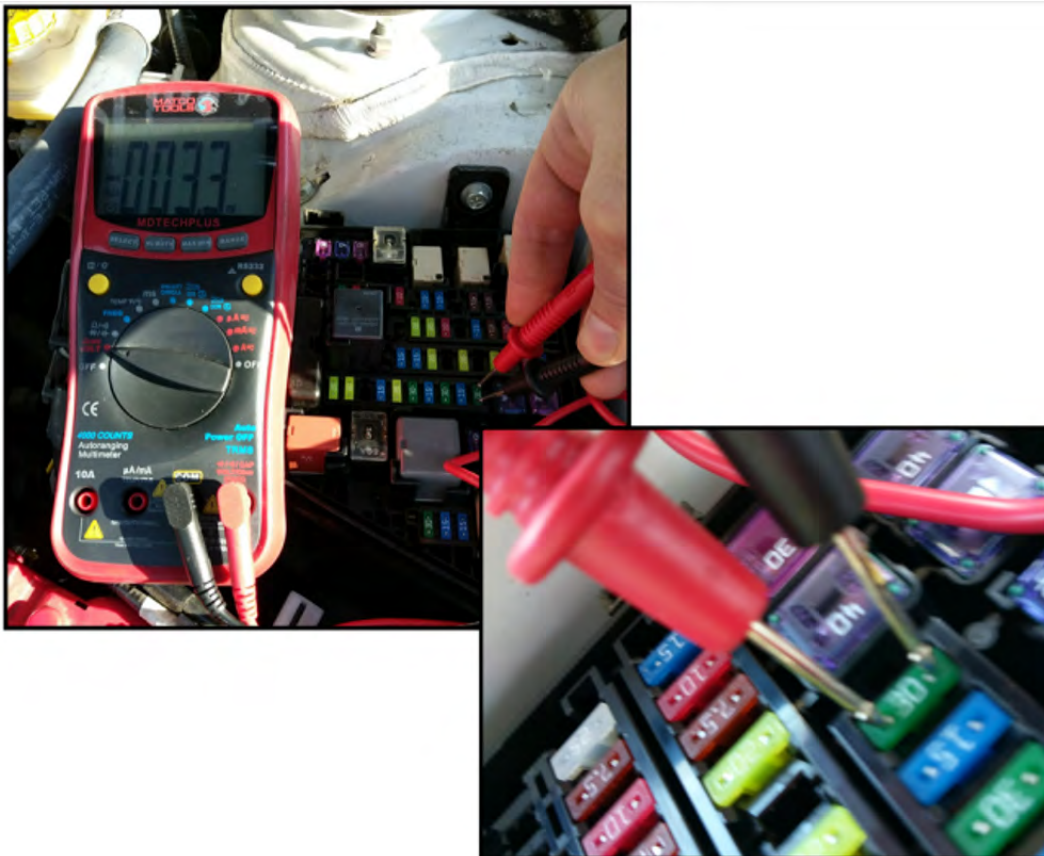
An alternative diagnostic method of dark/standby current draw testing can be performed by measuring the voltage drop across the fuses. This can be done by using the test points on the fuses without breaking the battery connection, pulling fuses, disturbing the circuit, or awakening any modules. What you are looking for is a voltage drop in the millivolts range. This is caused by an increase in resistance brought about by heating the fuse through the movement of current.

Different sized fuses will show different voltage drops. For example, a 10A fuse with 175 mA flowing through it will show a voltage drop of 1.5mV. When measuring the same fuse with no current flow, it would be more like 0.1mV or 0.2mV.

While using this dark/standby draw isolation method, excessive mV readings indicate the need for further root cause isolation. Disconnecting components fed by the fuse until mV readings come within expected tolerances.

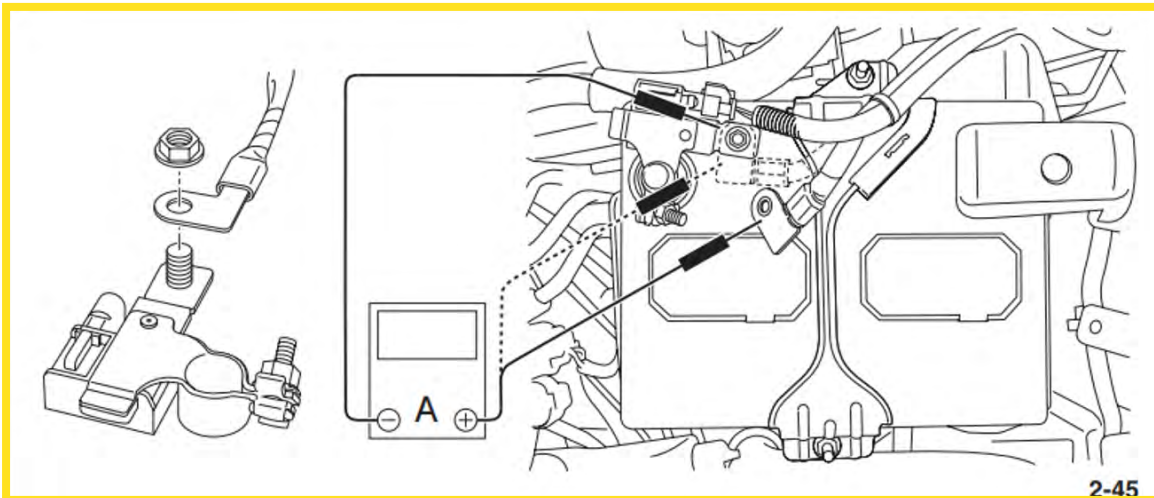
1. Prepare the DVOM with capability to measure down to 1mA.
 - To ensure circuit integrity, connect the digital voltmeter (DVOM) in series with the negative battery cable prior to disconnecting the cable from the battery negative terminal.
