HYUNDAI Technical Service Bulletin	GROUP CAMPAIGN	NUMBER 25-01-070H
	DATE NOVEMBER 2025	MODEL(S) PALISADE (LX2)
SUBJECT: UNINTENDED ABS ACTIVATION SOFTWARE UPDATE (SERVICE CAMPAIGN 9C8)

Description: Certain Palisade (LX2) vehicles may exhibit vibration in the brake pedal and/or steering wheel and noises from the Anti-lock Brake System (ABS) when braking over uneven road surfaces or bumps. The brake system remains functional under these conditions. This bulletin provides instructions to update the ABS software to address vibration and noise that can occur under certain operating conditions and road surfaces, such as driving at lower speeds over uneven surfaces.

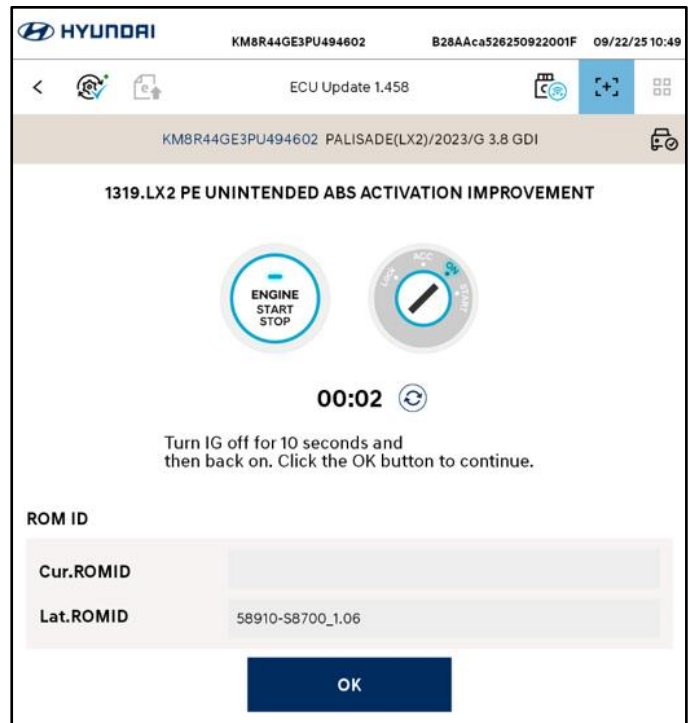
3. After the ECU update process shows 100% complete, follow the prompts on the screen to cycle the ignition **OFF** for at least **10 seconds** to reset the control unit (certain models may take up to **30 seconds**).

Use the **Refresh** button to reset the timer.

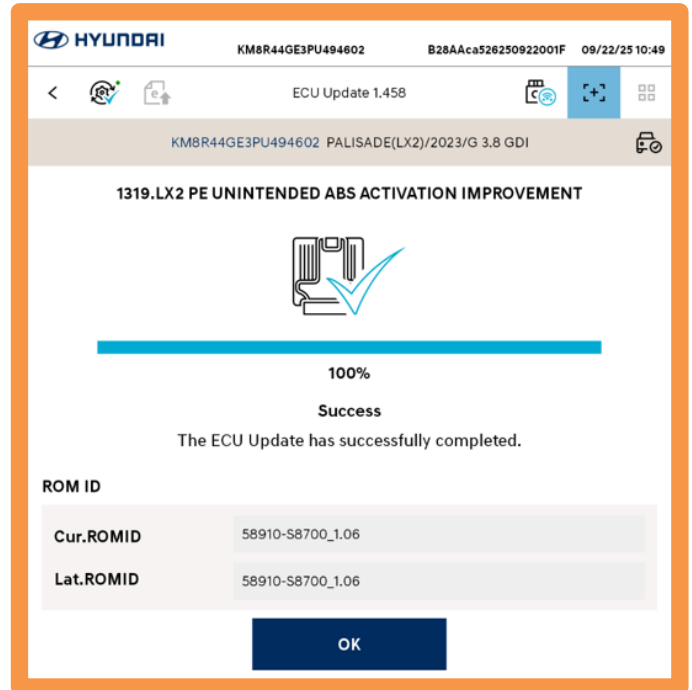
Using the tablet or GDS screen capture function, take a screenshot of the ECU Update “Success” result screen.

Upload the photo to STUI.

NOTE: The VIN/Date/Time/Mileage photo imprint is **NOT** required for GDS screenshots.

NOTE 3: This TSB includes repair validation photos. Op times include VIN, mileage, and photo capture of the ECU Update “Success” screen as outlined in the Digital Documentation Policy.

This TSB includes repair validation photos. Refer to the latest Warranty Digital Documentation Policy for requirements.

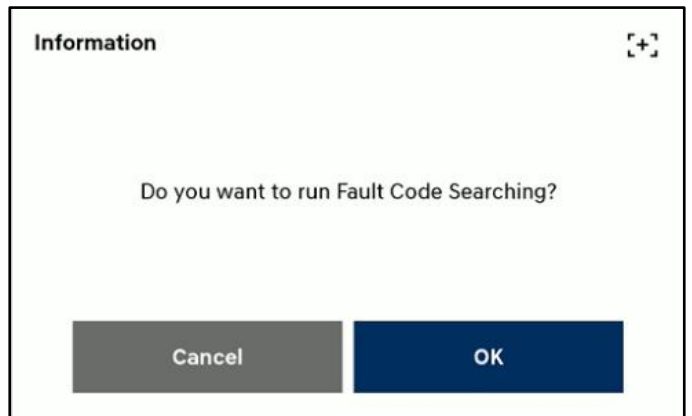
5. Perform an **All Systems Fault Code** search and erase DTC history that had incidentally occurred from the ECU update.
