# Technical Service Bulletin

<b>GROUP</b>	<b>NUMBER</b>
<b>CAMPAIGN</b>	<b>25-01-080G</b>
<b>DATE</b>	<b>MODEL(S)</b>
<b>NOVEMBER 2025</b>	<b>GV70 (JK1)</b>

**SUBJECT:** DCU SOFTWARE UPDATE  
(LIMITED COVERAGE CAMPAIGN L02G)

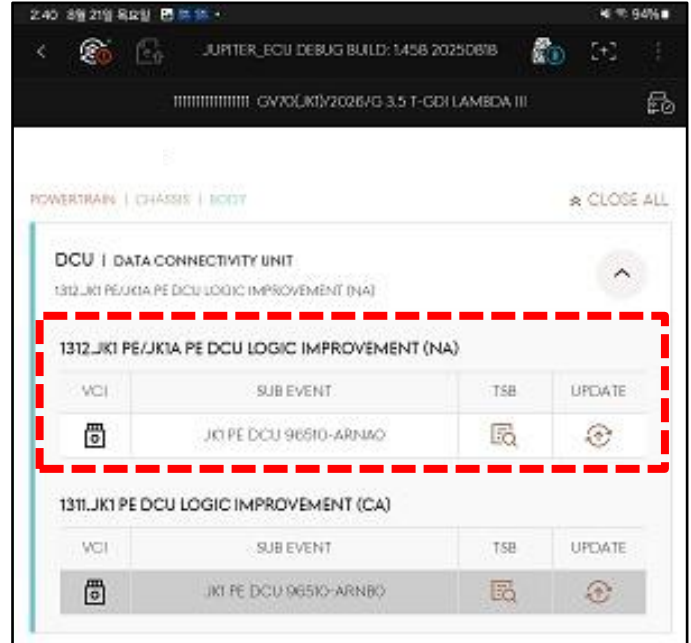
If the update fails, remove the power connector from the in-cabin fuse box for at least **5 seconds**. Reassemble and retry the update.

The screenshots within this service procedure refers to a GV70 Internal Engine Combustion (ICE) vehicle from Hyundai Motor Manufacturing Alabama factory, but is also applicable to the GV70 ICE vehicle from Hyundai Motor Company.

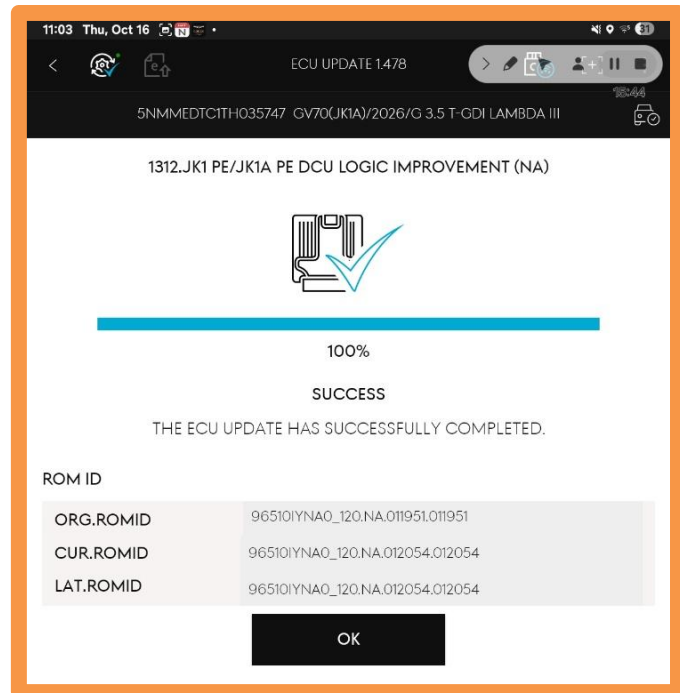
6. **DIGITAL DOCUMENTATION**

Upload the photo to STUI.

**NOTE:** The VIN/Date/Time/Mileage photo imprint is **NOT** required for GDS screenshots.

**NOTE 4:** This TSB includes repair validation photos. Op times include VIN, mileage, and photo capture of the ECU Update “Success” result screen as outlined in the Digital Documentation Policy.
