# Technical Service Bulletin

GROUP <b>CAMPAIGN</b>	NUMBER <b>25-01-079H-1</b>
DATE <b>NOVEMBER 2025</b>	MODEL(S) <b>SANTA CRUZ (NXT)</b>

**SUBJECT:** DCU SOFTWARE UPDATE  
(LIMITED COVERAGE CAMPAIGN LA2)

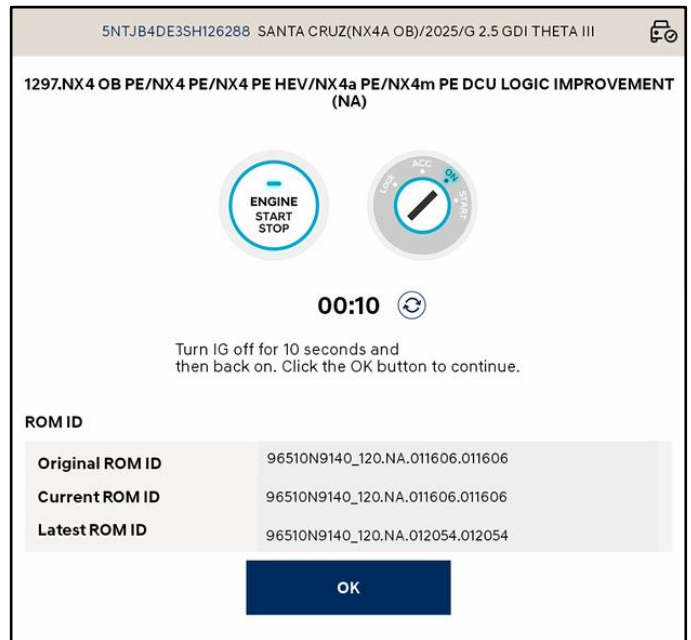
Use the **Refresh** button to reset the timer.

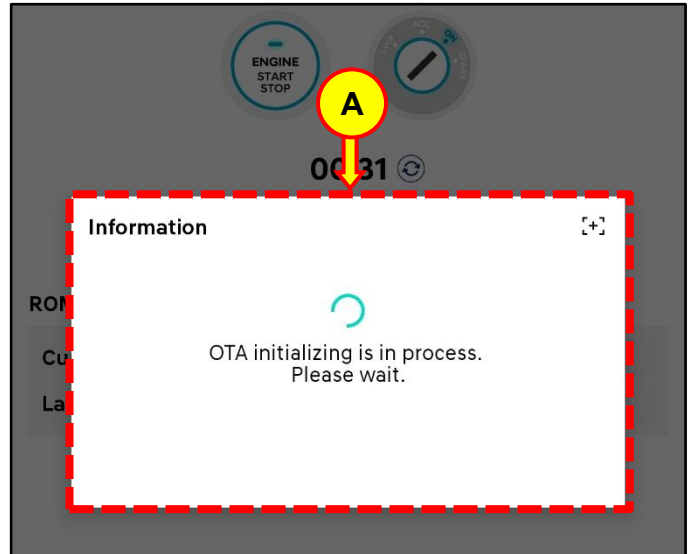
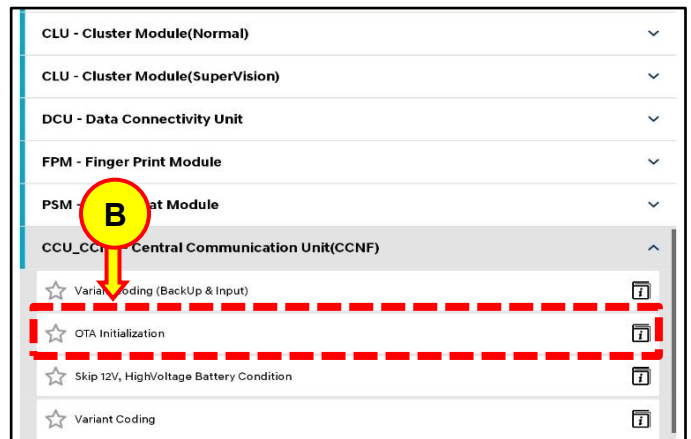
5. OTA initialization (A) should perform automatically:
  - If OTA initialization performs automatically, then proceed with the service procedure.
  - If the OTA initialization process fails, complete it manually under: **S/W Management > CCU\_CCNF - Central Communication Unit (CCNF) > OTA Initialization (B).**

Follow the instructions on the screen.

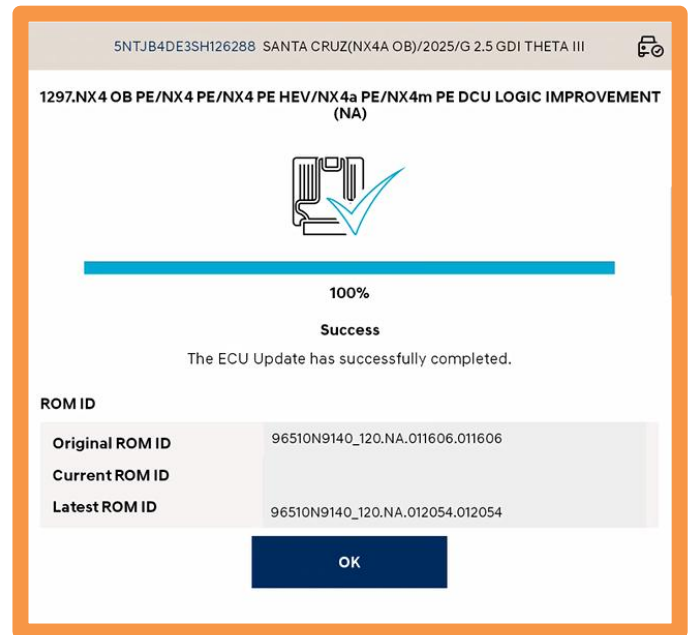
Using the tablet or GDS screen capture function, take a screenshot of the ECU Update "Success" result screen.

Upload the photo to STUI.

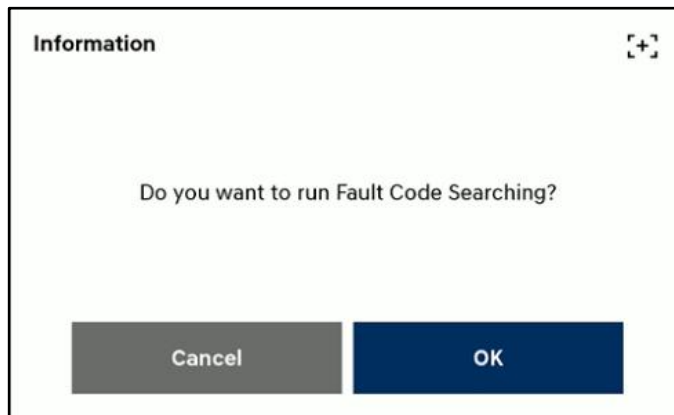
7. Perform an **All Systems Fault Code** search and erase DTC history that had incidentally occurred from the ECU update.
