Technical Service Bulletin

GROUP CAMPAIGN	NUMBER 25-01-025H-1
DATE NOVEMBER 2025	MODEL(S) SANTA FE (MX5A)

SUBJECT: SEAT HEATER UNIT (SHU) SOFTWARE UPDATE
(LIMITED COVERAGE CAMPAIGN LA1)

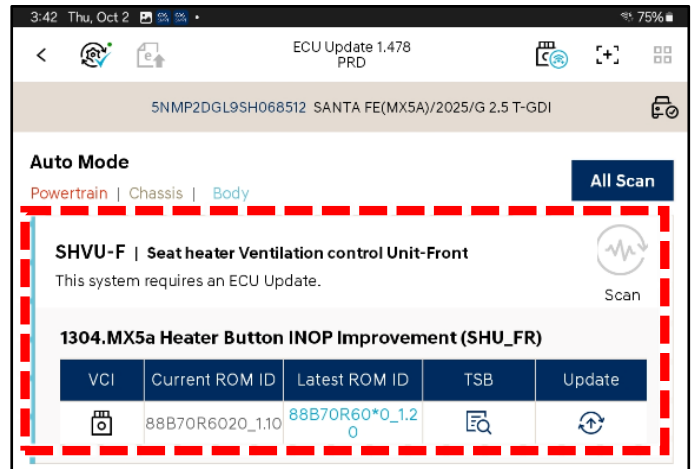
Check the current ROM ID version and compare it to the ROM ID Information table before attempting to perform the software update.

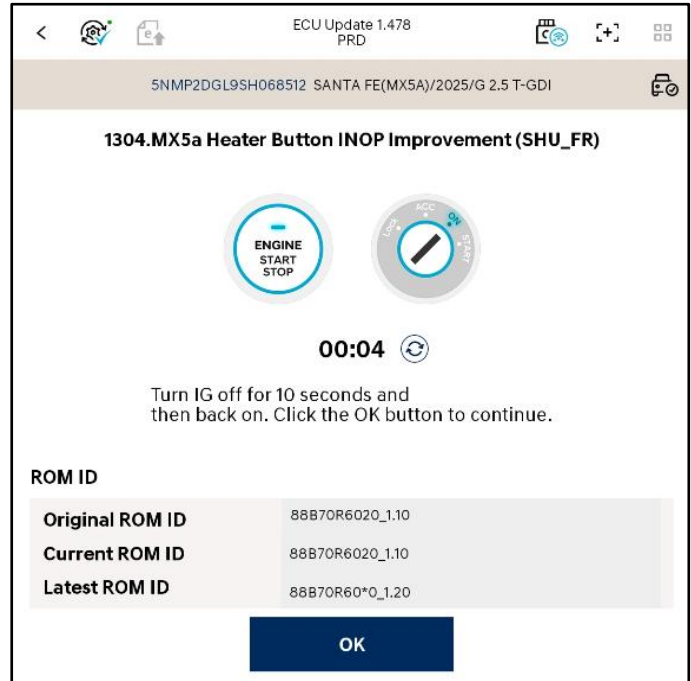
3. After the ECU update process shows 100% complete, follow the prompts on the screen to cycle the ignition **OFF** for at least **10 seconds** to reset the control unit (certain models may take up to **30 seconds**).

Use the **Refresh** button to reset the timer.

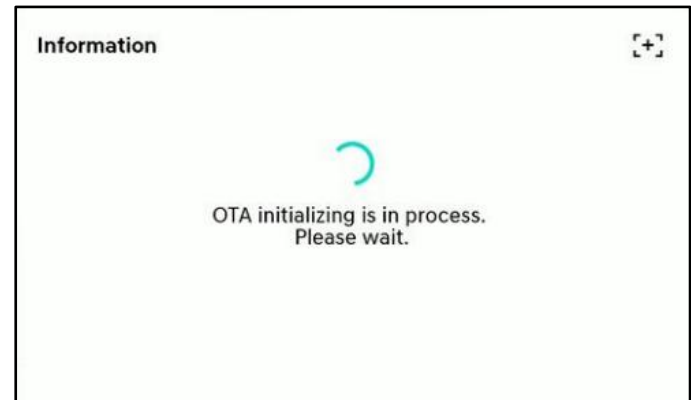
4. After clicking **OK**, the OTA Initialization process will begin.
- If OTA initialization performs automatically, then proceed with the service procedure.
 - If the OTA initialization fails, **connect GDS-Smart > S/W Management > Central Communication Unit (CCNF) > OTA Initialization**

Follow the instructions on the screen.

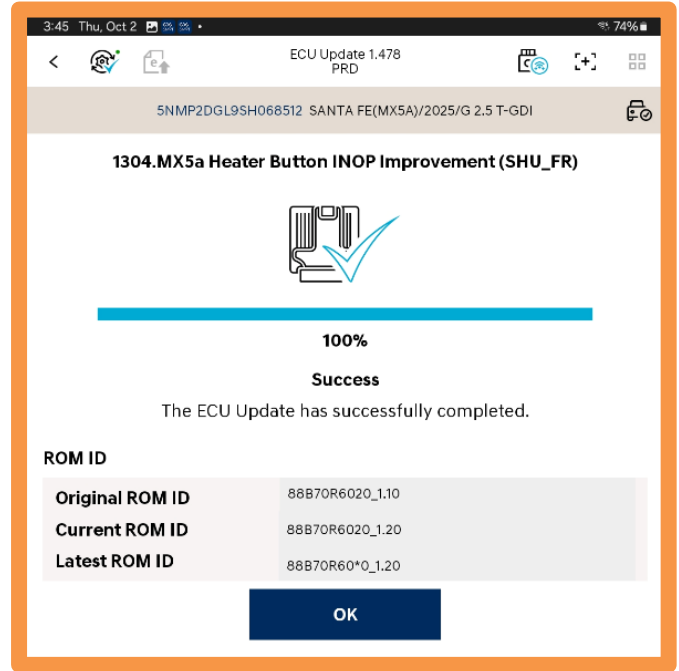
Using the tablet or GDS screen capture function, take a screenshot of the ECU Update “Success” result screen.

Upload the photo to STUI.

NOTE 4: This TSB includes repair validation photos. Op times include VIN, mileage, and photo capture of the ECU Update "Success" screen as outlined in the Digital Documentation Policy.

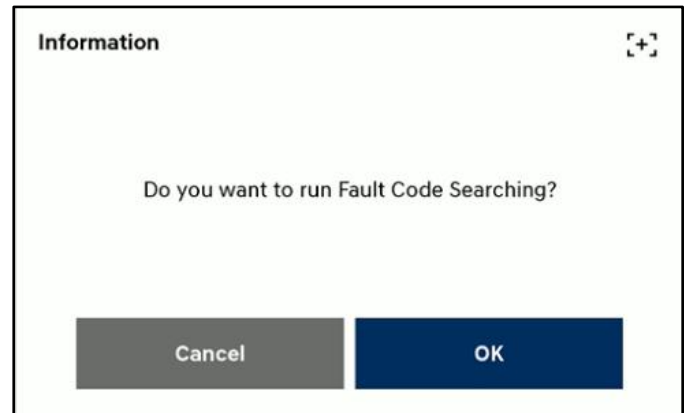
6. Perform an **All Systems Fault Code** search and erase DTC history that had incidentally occurred from the ECU update.

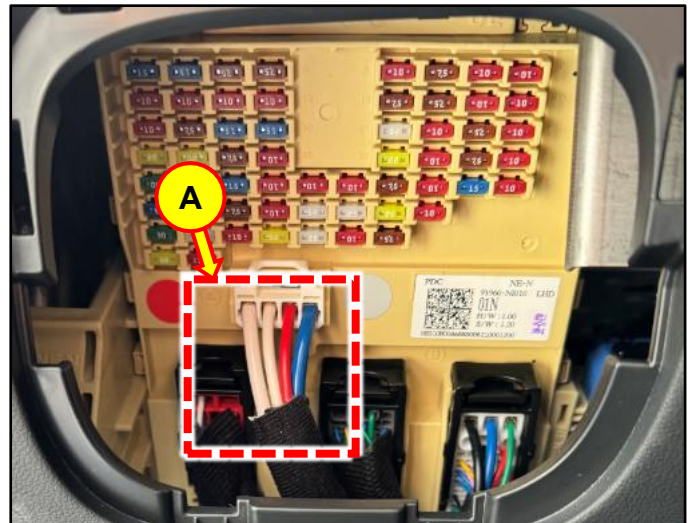
7. Disconnect the power connector (A) of the indoor fuse box, wait at least **5 seconds**, then reconnect it.

Alternatively, disconnect the negative (-) **12V** battery terminal, wait **5 seconds**, then reconnect it.
