HYUNDAI

Technical Service Bulletin

GROUP CAMPAIGN	NUMBER 25-01-057H-1
DATE NOVEMBER 2025	MODEL(S) SEE BELOW

SUBJECT: DCU SOFTWARE UPDATE
(SERVICE CAMPAIGN TDF)

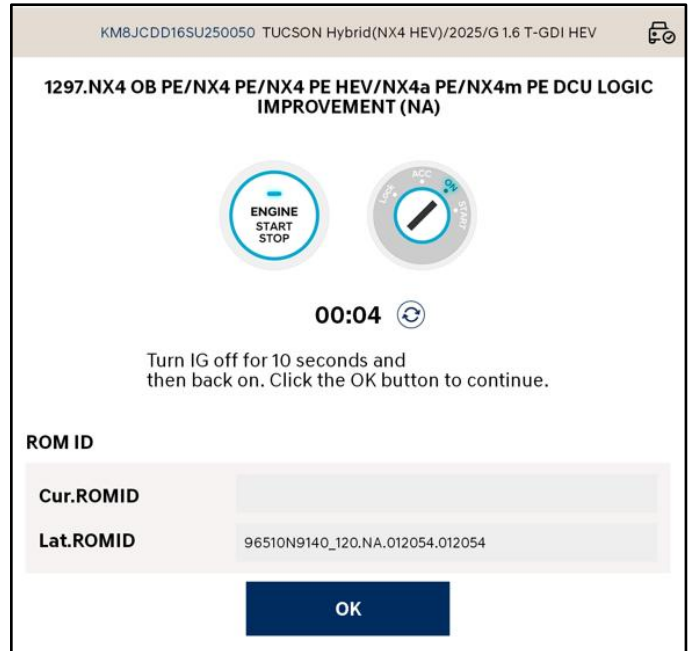
- After the ECU update process shows 100% complete, follow the prompts on the screen to cycle the ignition **OFF** for at least **10 seconds** to reset the control unit (certain models may take up to **30 seconds**).

Information

Use the **Refresh** button to reset the timer.

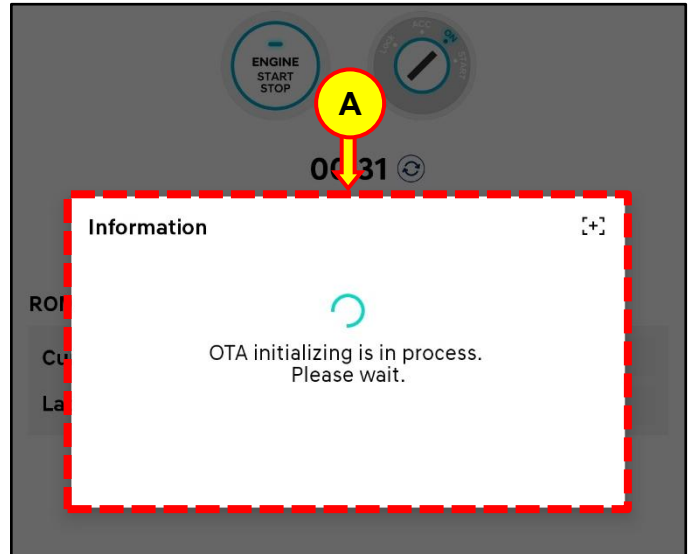
5. OTA initialization (A) should perform automatically:
 - If OTA initialization performs automatically, then proceed with the service procedure.
 - If the OTA initialization process fails, complete it manually under: **S/W Management > CCU_CCNF - Central Communication Unit (CCNF) > OTA Initialization (B).**

Follow the instructions on the screen.

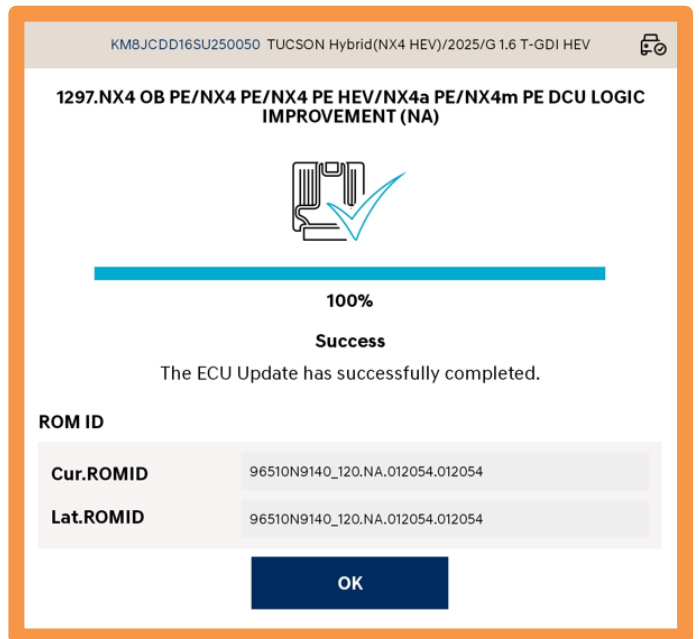
DIGITAL DOCUMENTATION

Using the tablet or GDS screen capture function, take a screenshot of the ECU Update "Success" result screen.

Upload the photo to STUI.

NOTE: The VIN/Date/Time/Mileage photo imprint is **NOT** required for GDS screenshots.

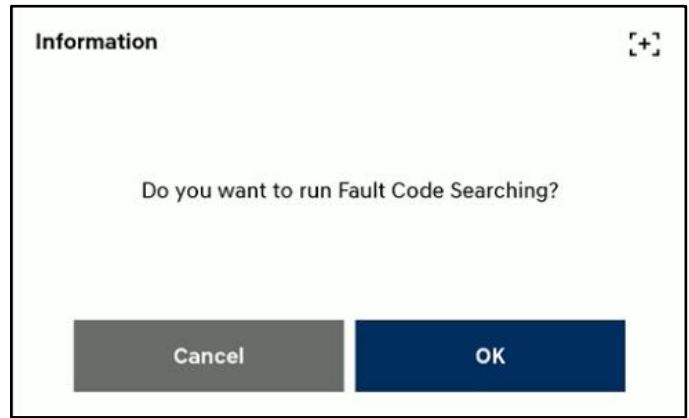
7. Perform an **All Systems Fault Code** search and erase DTC history that had incidentally occurred from the ECU update.
