Technical Service Bulletin

GROUP CAMPAIGN	NUMBER 25-01-060H-1
DATE NOVEMBER 2025	MODEL(S) TUCSON (NX4M)

SUBJECT: DCU SOFTWARE UPDATE
(SERVICE CAMPAIGN TDFB)

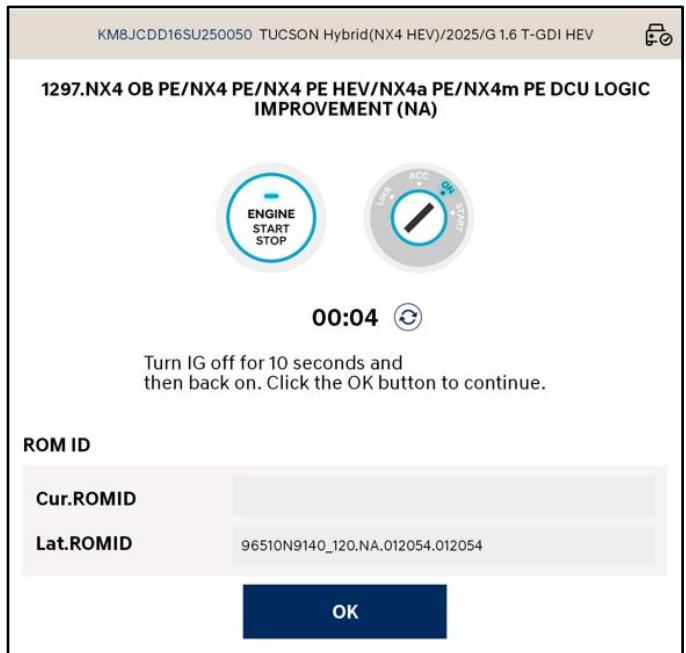
- After the ECU update process shows 100% complete, follow the prompts on the screen to cycle the ignition **OFF** for at least **10 seconds** to reset the control unit (certain models may take up to **30 seconds**).

Use the **Refresh** button to reset the timer.

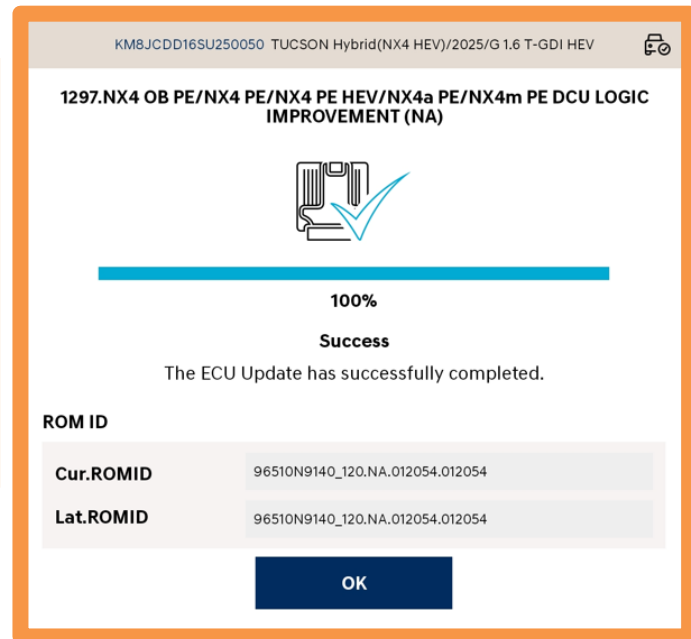
DIGITAL DOCUMENTATION

Using the tablet or GDS screen capture function, take a screenshot of the ECU Update "Success" result screen.

Upload the photo to STUI.

NOTE: The VIN/Date/Time/Mileage photo imprint is **NOT** required for GDS screenshots.

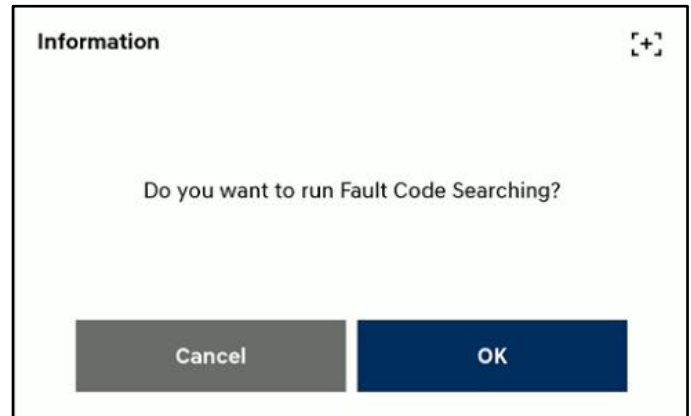
7. Perform an **All Systems Fault Code** search and erase DTC history that had incidentally occurred from the ECU update.
