Technical Service Bulletin

GROUP CAMPAIGN	NUMBER 25-01-083H
DATE NOVEMBER 2025	MODEL(S) SEE BELOW

SUBJECT: ECU SOFTWARE UPDATE - DTC P04DB00
(LIMITED COVERAGE CAMPAIGN LA11)

Description: Certain Tucson Hybrid (NX4 HEV) and Tucson Plug-in Hybrid (NX4 PHEV) vehicles equipped with the 1.6T-GDI Gamma II engine may set DTC P04DB00 (Crankcase Ventilation System Disconnected). This bulletin provides instructions to perform a software update on the Engine Control Module (ECM) to resolve this condition.

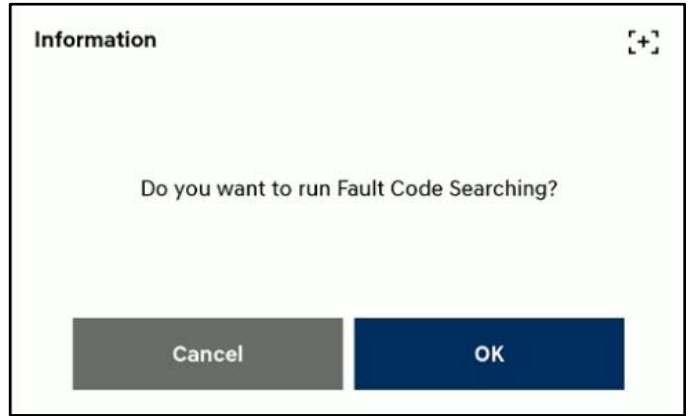
7. Place the vehicle in **Ready** mode to confirm proper operation of the vehicle.
8. The service procedure is now complete.
