GROUP	MODEL
ELE	2024-2026MY EV9 (MV1, MV1a)
NUMBER	DATE
407	November 2025

TECHNICAL SERVICE BULLETIN

SERVICE ACTION: FPM OPERATION LOGIC IMPROVEMENT (SA637)

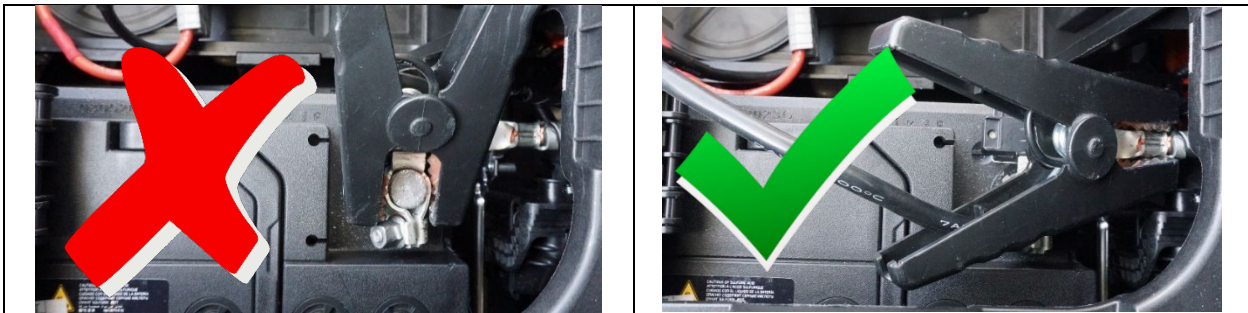
[Connect the negative \(-\) terminal to the battery as shown below.](#)

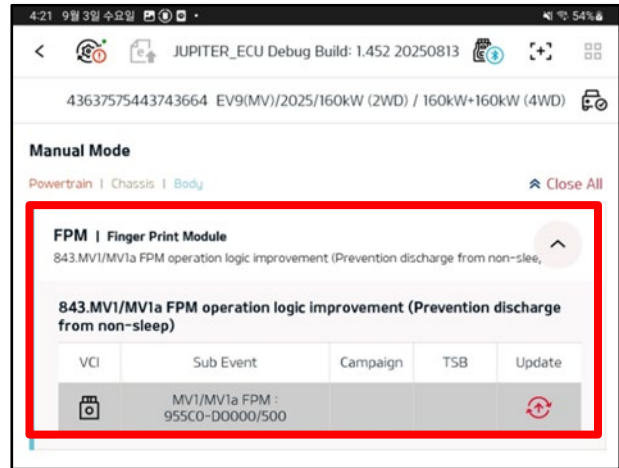
Select the applicable **'FPM' system** module and the Event Group.

- **"843. MV1/MV1a FPM operation logic improvement (Prevention discharge from non-sleep)"**

Verify the affected vehicle Calibration Identification of the applicable ECU ROM ID and reference the Information Table on page 3 as necessary.
