**PRODUCT CAMPAIGN BULLETIN**

**APPLICABILITY:** 2023-25MY Solterra **NUMBER:** WRE-25

**SUBJECT:** Safety Recall: Solterra Parking Assist **DATE:** 11/12/25

ECU Reprogramming **NHTSA ID:** 25V744

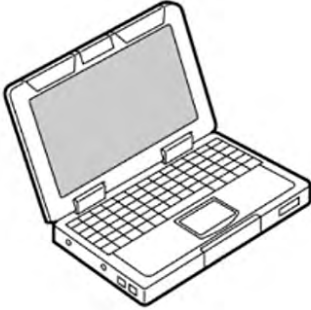
Tool Description	Image	Details
GTS+ ( Global Tech Stream)

For performing the Health Check and installing the .cuw file.
DST-i or DST-010

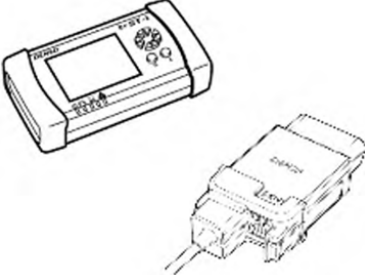
Both will work as a passthrough device for reprogramming.
DCA-8000 SUB Battery Diagnostic Charger
