GROUP	MODEL
Product Improvement	2024-2026MY EV9 (MV1, MV1a)
NUMBER	DATE
PI2502	November 2025

TECHNICAL SERVICE BULLETIN

SUBJECT: **WINDSHIELD WIPER LOGIC IMPROVEMENT (PI2502)**

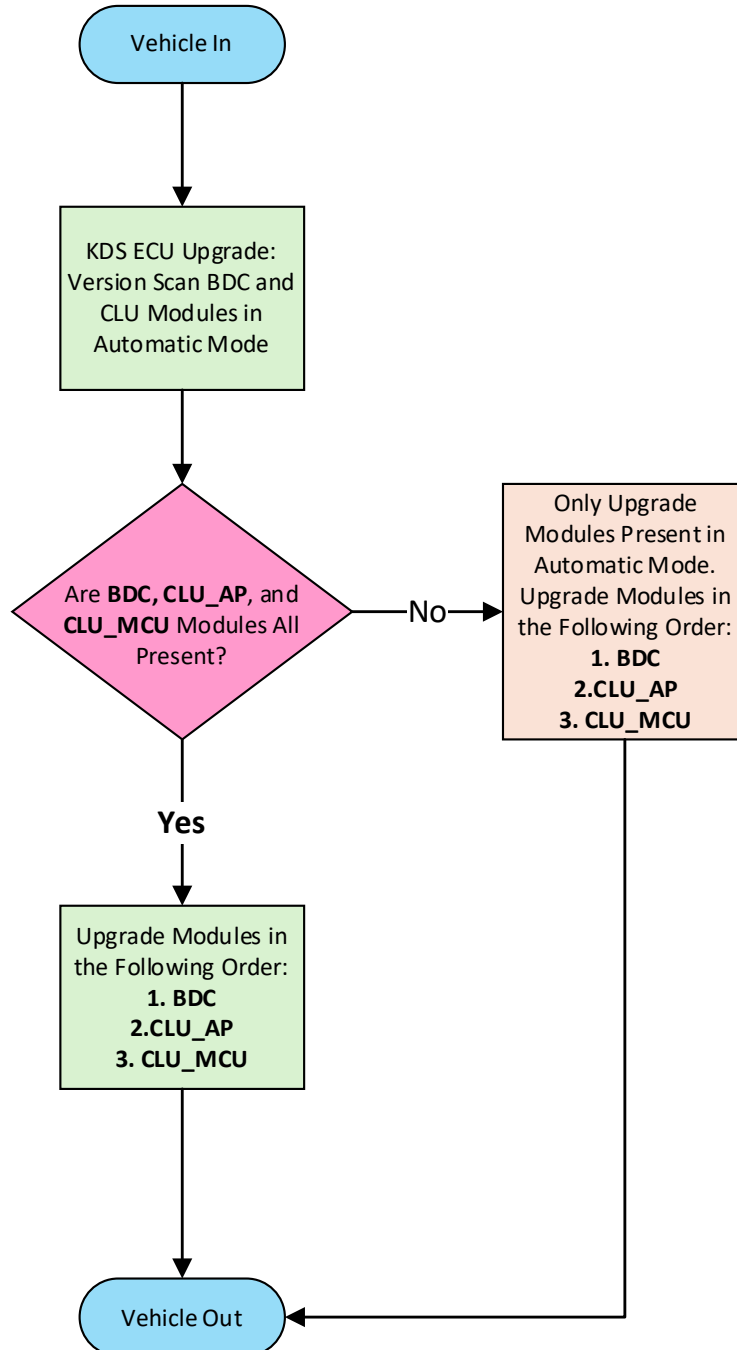
On certain vehicles, not all modules will require all three (3) software updates. Perform updates only on the modules that appear when running Auto Mode AND, in the following order.

On certain vehicles, not all modules will require all three (3) software updates. Perform updates only on the modules that appear when running Auto Mode AND, in the order shown on the flowchart, on page 2.

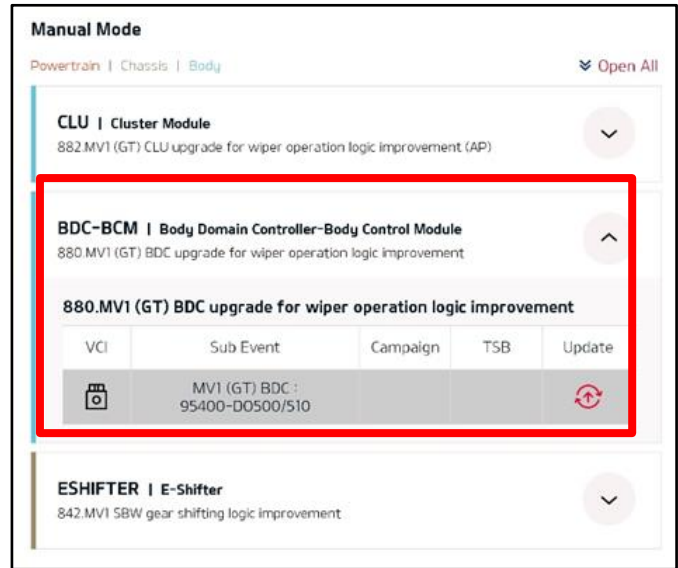
Verify the affected vehicle Calibration Identification of the applicable ECU ROM ID and reference the Information Table on page 4 as necessary.
