Service Action

Code: 91VH

Subject Vehicle Software (SW Level 5.4.3)

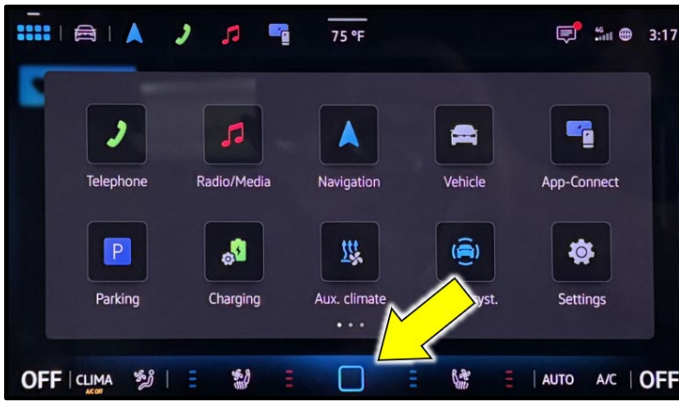
- Press and hold the home key.
- During the update, the instrument cluster display will change multiple times.

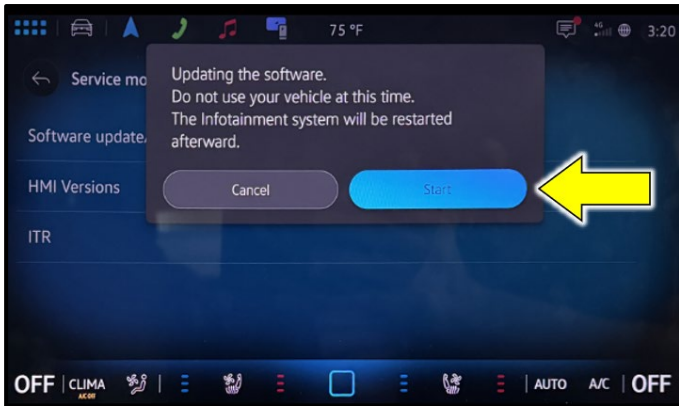
- Select "Start" when prompted.

After selecting the "Start" option, the infotainment screen will go blank and the red engineering menu (REM) will populate after a few moments.

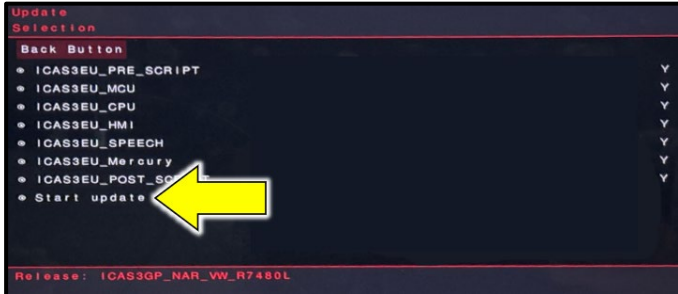
- Select "Start update".

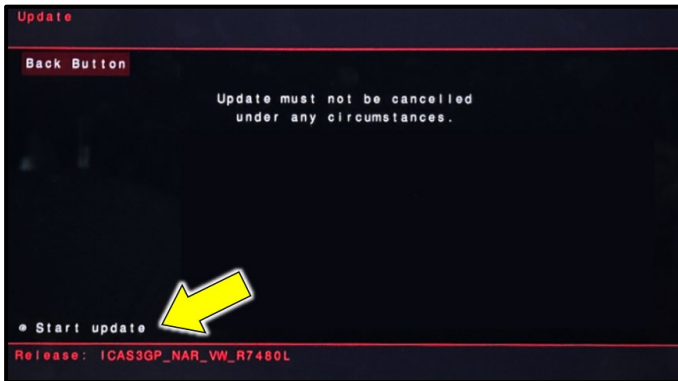
- Select "Start update".

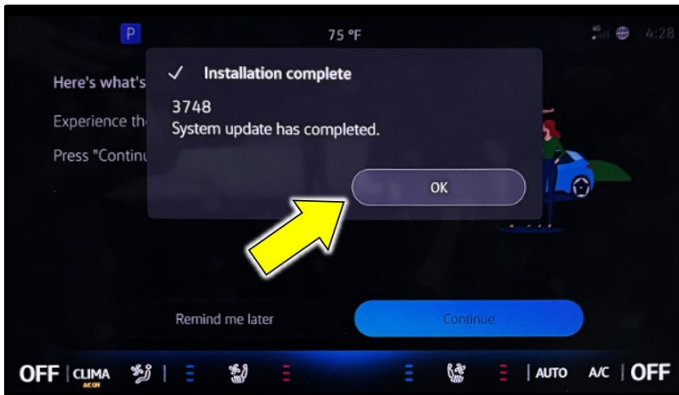
After the update has been completed and the system is back on the home screen, after a few moments a message confirming the installation was completed will populate.

- Select the option for “OK”.
- Remove the USB drive.

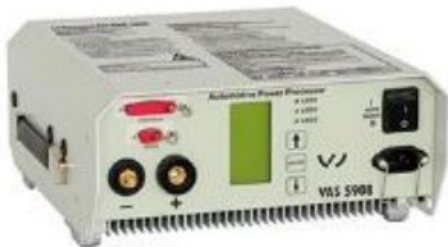
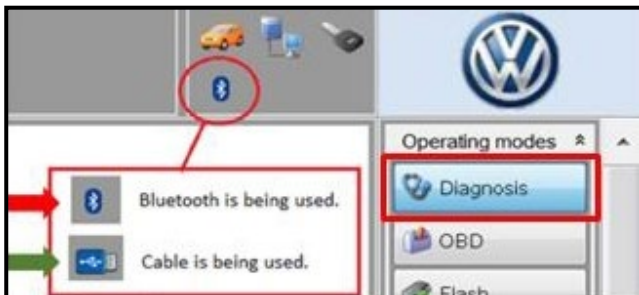
- Turn battery charger OFF, then back ON.
- Connect battery charger.
- **Cycle the ignition OFF, then back ON.**
- Confirm that scan tool is communicating with the diagnostic head by USB <Green Arrow>.
 - If the Bluetooth symbol is shown <Red Arrow> then disconnect the diagnostic head from the vehicle and reconnect the USB cable to the diagnostic head and then reattach to the vehicle.

- Upon ODIS startup, verify the “Diagnosis” operating mode is selected <as shown>.

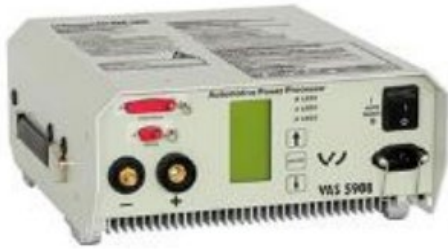
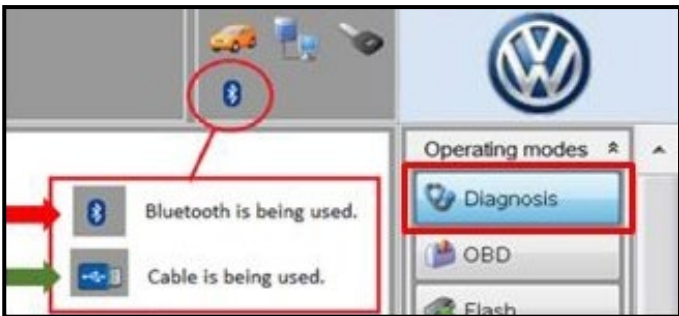
- Turn battery charger OFF, then back ON.
- Connect battery charger.
- Cycle the ignition off and on.
- Confirm that scan tool is communicating with the diagnostic head by USB <Green Arrow>.
 - If the Bluetooth symbol is shown <Red Arrow> then disconnect the diagnostic head from the vehicle and reconnect the USB cable to the diagnostic head and then reattach to the vehicle.
- Upon ODIS startup, verify the “Diagnosis” operating mode is selected <as shown>.
- Once the GFF scan is complete, select “Test plan” <arrow A>, then “Software version management” <arrow B>, then “Adapting software” <arrow C>, then select “Attach to the test plan” <arrow D>.

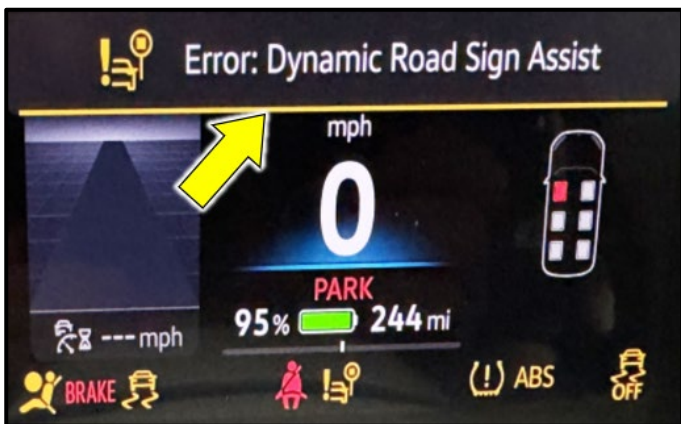
SVM code
F543

- Select “Accept” <arrow> and follow the on-screen prompts.
- Pay attention to the status report of the control module updates.
- Any module stating NOT OK will have to be updated again.
- Selecting “Complete/Next” will begin another attempt to update the control module.
- Do not end the diagnostic session.

After completion of the update, an error for the dynamic road sign assist <arrow> may occur in the infotainment display. This error will be eliminated during the three-phase drive motor calibration road test.

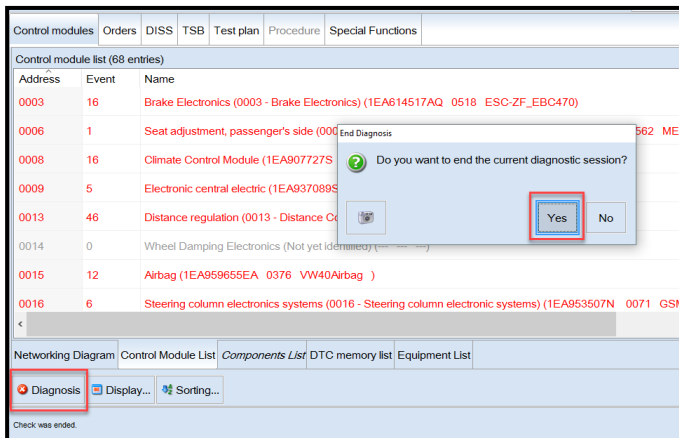
- Exit Diagnosis and select “Yes” to end the diagnostic session.
