Technical Service Bulletin

Topic	MIB3 Telecom Infotainment MMI becoming stuck on the 'initialisation/loading' screen Bentayga Series 23MY
Market area	Australia E04 Bentley rest Asia and Australia (6E04), Germany E02 Bentley rest Europe (6E02), India 938 Indien; SKODA AUTO Volkswagen India (6938), United Arab Emirates E06 Bentley Middle East and Africa (6E06), United Kingdom E01 Bentley UK (6E01), United States E05 Bentley USA and rest America (6E05)
Brand	Bentley
Transaction No.	2079175/3
Level	EH
Status	Released for publishing
Release date	Nov 14, 2025

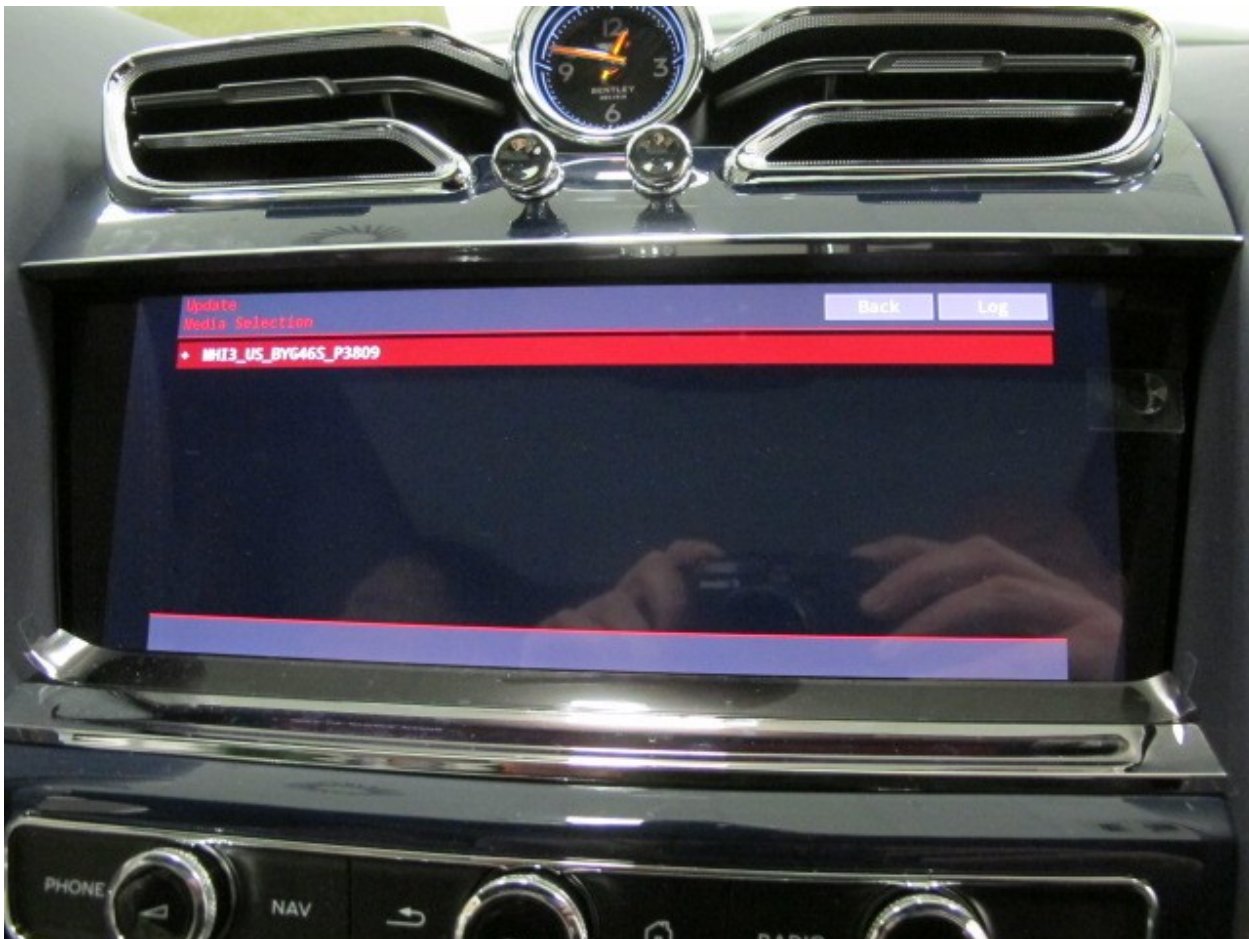
Figure 5

14. Select the suggested update. (Figure 5)
