Volvo Car USA LLC
Technical Journal

Technical Journal Title Rattle Noise from A-Pillar Panel		Ref. No. TJ 37539.1.0	
Issuer (Dept.) Technical Service		Issue Date 11/6/25	Status Date 11/18/25
Car Market United States and Canada	Partner 3 US 7510 Volvo Car USA	Function Group 8510	
Function Description upholstery for wall/door, side, rear she		Page Page 1 of 3

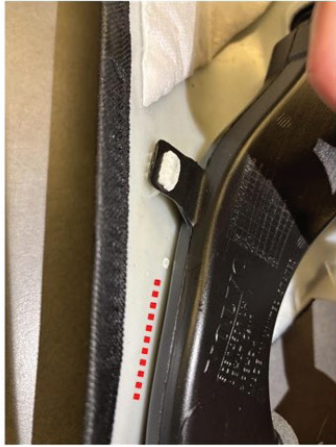
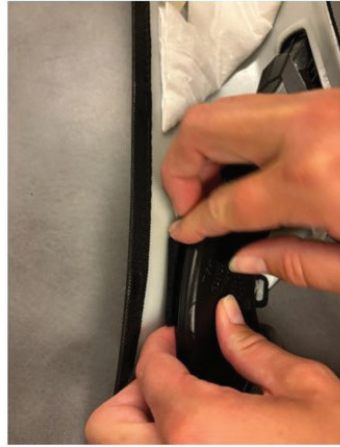
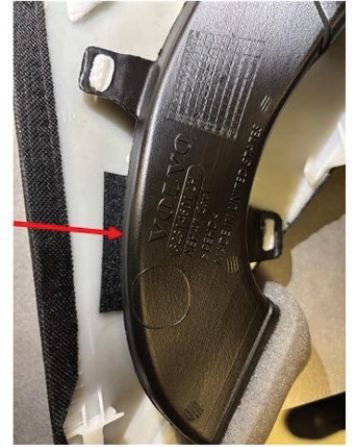
1. Disassemble the A-pillar panel
2. Position felt-tape between the air duct and the A-pillar panel surface according to the picture (TJ_37539_1.jpg)
3. Position felt tape on the A-surface of the lower tip of the A-pillar panel and fold it over the edge according to the picture (TJ_37539_2.jpg)
4. Position felt tape on the air duct and air outlet according to the picture (TJ_37539_3.jpg)
5. Reassemble the A-Pillar panel
