GROUP	MODEL
ELE	2025MY EV6 (CV1a) 2026MY Sportage (NQ5a)
NUMBER	DATE
406	December 2025

TECHNICAL SERVICE BULLETIN

SERVICE ACTION: DCU OPERATION SOFTWARE LOGIC IMPROVEMENT (SA635)

This bulletin provides information to improve the Data Connectivity Unit (DCU) performance on certain 2026MYSportage and 2025MY EV6 vehicles equipped with Kia Connect Services.

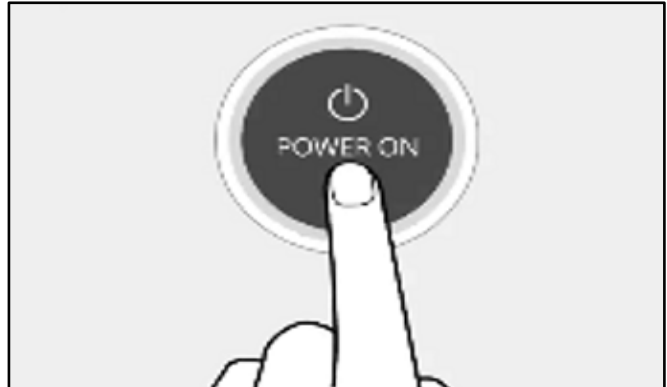
2. Press the ignition 'Power ON' button once (without depressing the brake pedal).

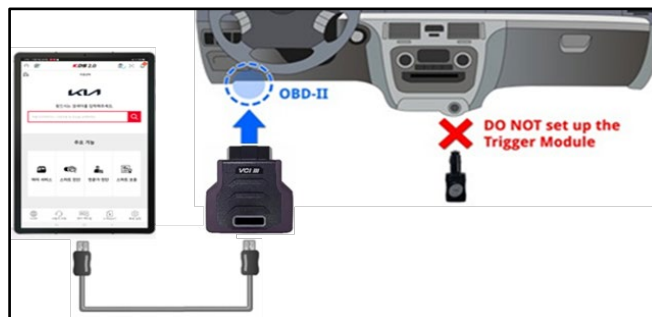
**Using KDS + VCI-III Connection**

1. Connect the VCI III USB-C connector to the KDS tablet.
2. Connect the VCI III to the OBD-II connector of the vehicle.

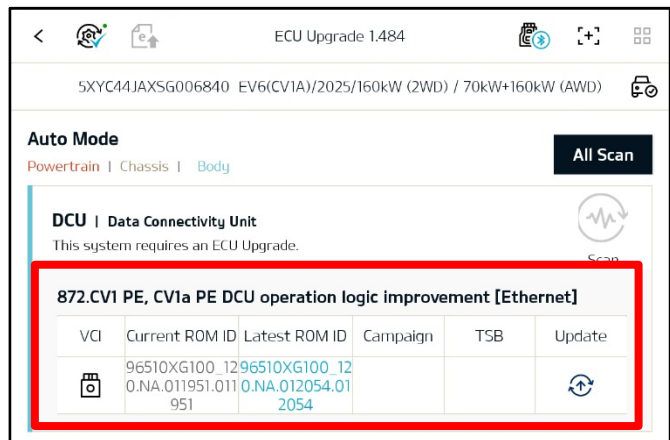
UPGRADE EVENT: EV6 (CV1a)

Select the applicable **'DCU'** system module and the Event Group.

- **872.CV1 PE, CV1a PE DCU operation logic improvement [Ethernet]**

Verify the affected vehicle Calibration Identification of the applicable ECU ROM ID and reference the Information Table on page 4 as necessary.
