Service Engineering Operations  
Customer Service Division

**SUBJECT: NEW VEHICLE DELIVERY HOLD - Emissions Recall 25E08**  
Certain 2017 - 2020 Model Year Lincoln Continental Vehicles with 3.7L Engines  
Powertrain Control Module (PCM) Reprogramming

**SERVICE ACTION**

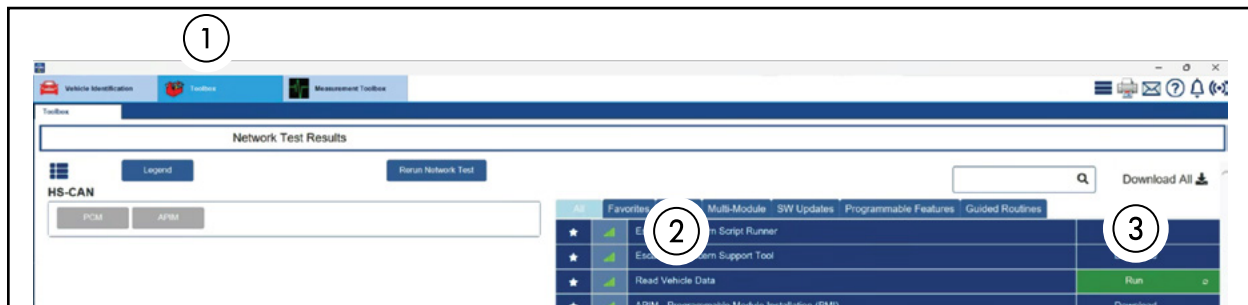
FIGURE 1

7. Select **All**. See Figure 1.

8. Select **Read Vehicle Data** (2) and then **Run** (3).

**NOTE:** Steps 4-7 (Read VIN from Vehicle) and Step 8 (Read Vehicle Data) MUST be completed prior to performing Steps 9-13. Failure to complete Steps 5-9 will result in a "Not Complete" or "An Error Occurred" from the Software Update Status Screen.

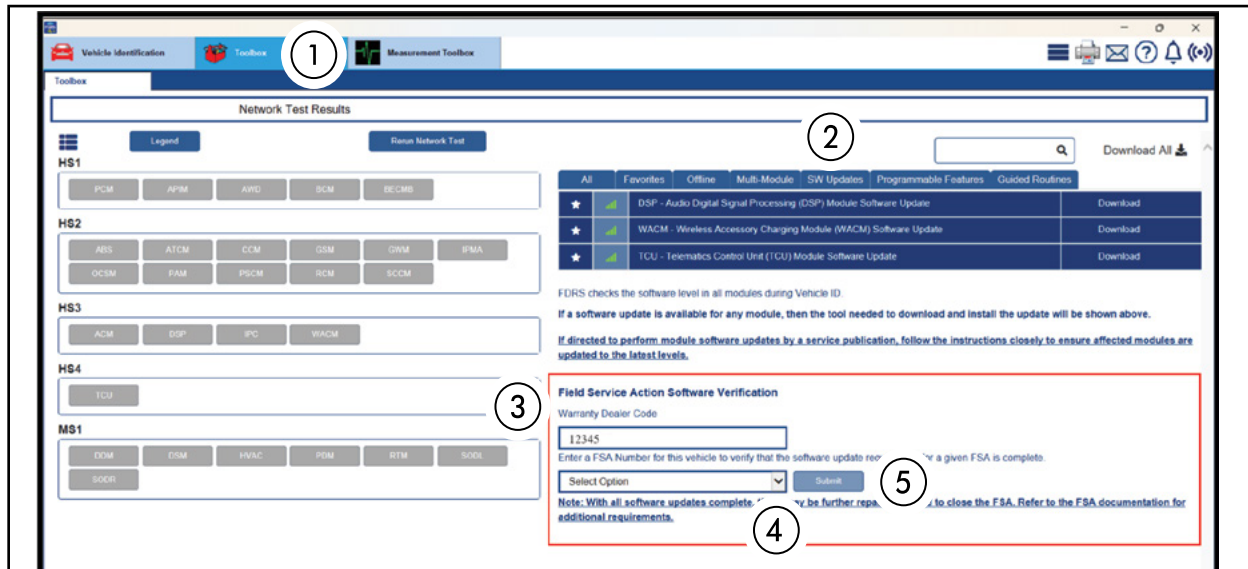
FIGURE 2

9. Select the **Toolbox** (1) tab. See Figure 2.

10. Select the **SW Updates** (2) tab. See Figure 2.

11. **Warranty Dealer Code** (3) - Change the displayed PA code as necessary. See Figure 2.

12. Select the **FSA** (4) from the drop-down menu. See Figure 2.

13. Select **Submit** (5). See Figure 2.

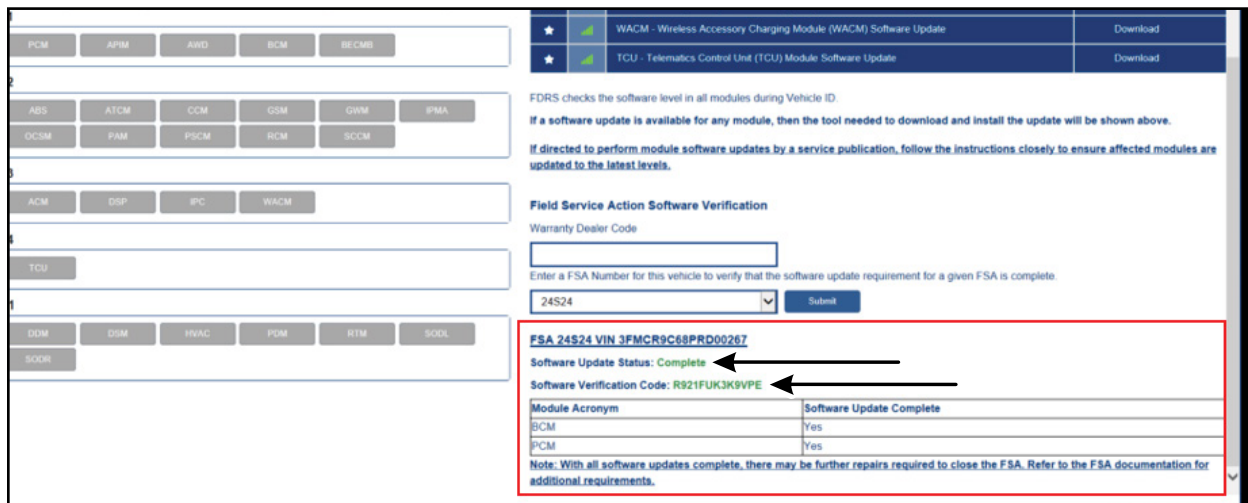
FIGURE 3

14. Does the FDRS Field Service Action Software Verification Status display a **Complete** status?  
See Figure 3.

**NOTE:** The vehicle may be returned to the customer when the Software Verification Form provides a Complete status for ALL modules listed.

**No** - Proceed to Step 17.
