Technical Service Bulletin

GROUP	NUMBER
CAMPAIGN	25-01-080G-1
DATE	MODEL(S)
DECEMBER 2025	GV70 (JK1)

SUBJECT: DCU SOFTWARE UPDATE
(LIMITED COVERAGE CAMPAIGN L02G)

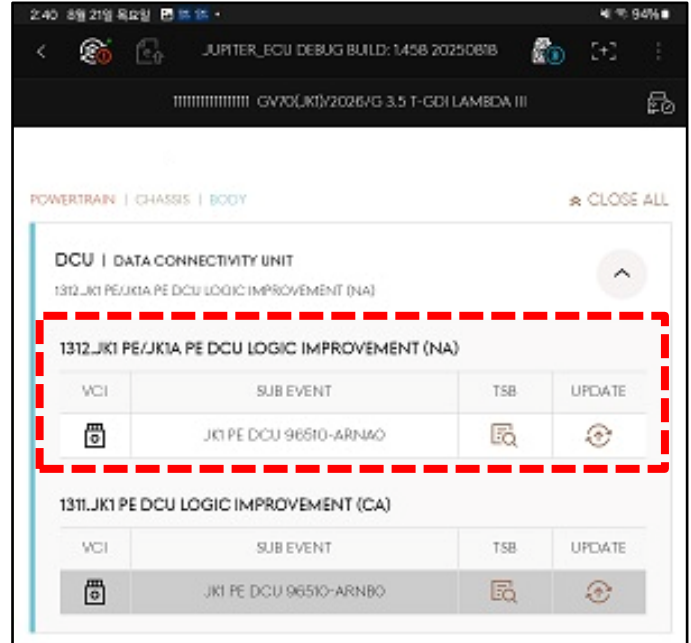
- Verify the ROM ID by selecting the **DCU** system to scan the vehicle's current ROM ID.

Check the current ROM ID version and compare it to the ROM ID Information table before attempting to perform the software update.

The screenshots within this service procedure refers to a GV70 Internal Engine Combustion (ICE) vehicle from Hyundai Motor Manufacturing Alabama factory, but is also applicable to the GV70 ICE vehicle from Hyundai Motor Company.

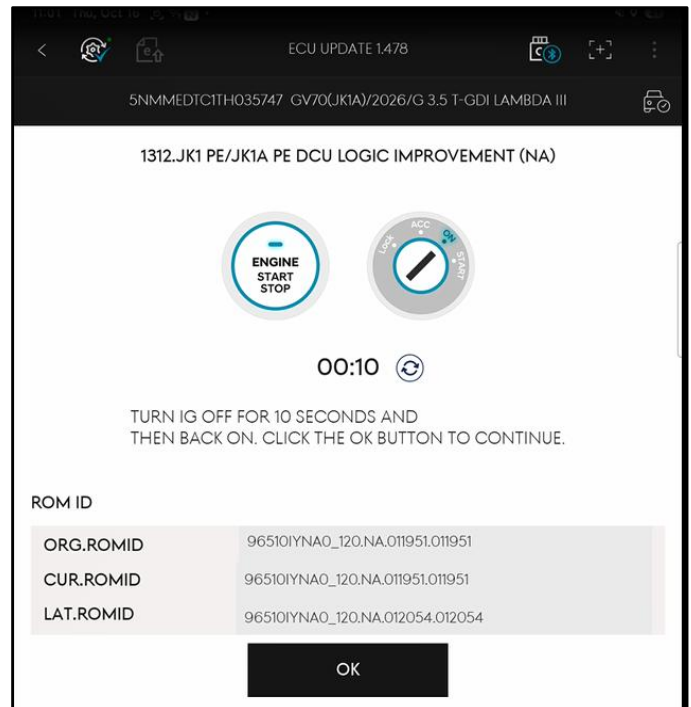
- Once the ECU update is 100% complete, follow the prompts on the screen to cycle the ignition **OFF** for at least **10 seconds** to reset the control unit (certain models may take up to **30 seconds**).

Use the **Refresh** button to reset the timer.
