## SERVICE INFORMATION BULLETIN

**APPLICABILITY:** 2026MY Outback

**NUMBER:** 15-331-25R

**SUBJECT:** Infotainment Concern Data Collection and Sharing Guidelines for Denso Gen5 CP25 System

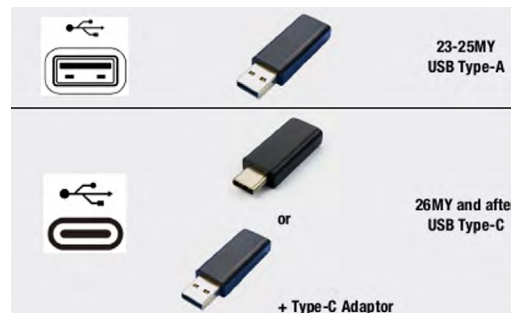
**Note: For 26MY and later vehicles use either a USB Type-C memory stick or a USB Type-A with a conversion adapter to Type-C**

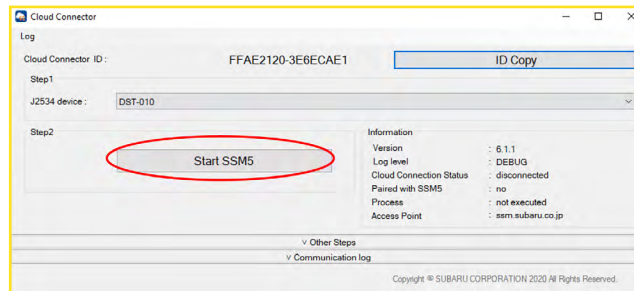
- Connect the DST-010 to both the OBD connector and the PC.
- Launch “Cloud Connector”, then open SSM5.
- Click “Start SSM5” from the Cloud Connector screen.

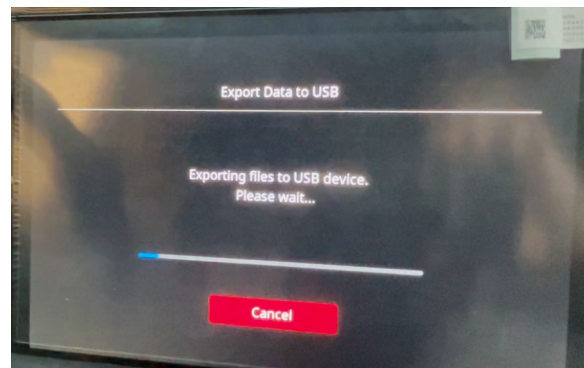
9. Confirm that the display changes to “Export Data to USB.” Wait until the process is completed.

Note: In a rare case the progress bar might not appear on the CID. Don't be alert the data log extraction is in progress. Once the data log export is completed, there will be a notification on the CID. If the progress bar is not displayed, please wait until "Complete" is shown on the SSM5 screen. This issue is scheduled to be resolved in a future software update (RC#1).
