Technical Service Bulletin

Topic	Electronic Parking Brake (EPB) control unit cannot be coded
Market area	Bentley: worldwide (2WBE),China 723 Volkswagen (Anhui) Automotive CO (6723),China 796 VW Import Comp. Ltd (Vico), Beijing (6796)
Brand	Bentley
Transaction No.	2071089/4
Level	EH
Status	Released for publishing
Release date	Dec 16, 2025

Continental GT/C and Flying Spur

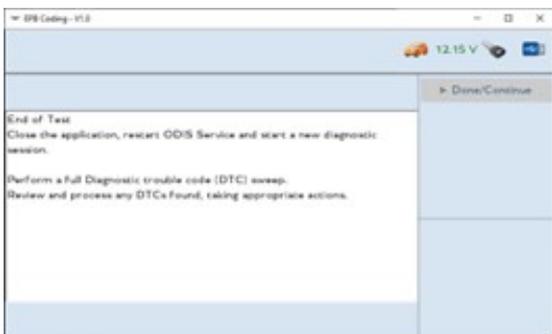
8. The application will now interrogate the control module for DTCs.
 - a. If no DTCs are found the application will report the end of the test.
Click the Exit button to close the application.
 - b. If DTCs are found an option will be given to clear them.
Select Yes to clear the DTCs.
Select to end the test without clearing the DTCs.

Figure 8. End of test

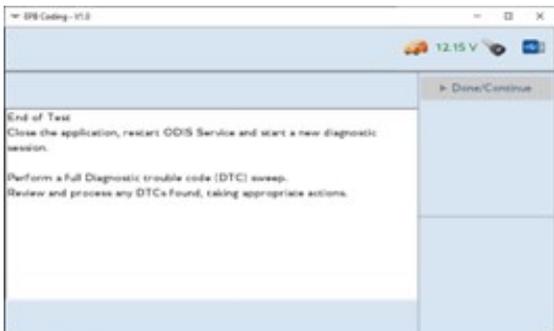
Figure 11. End of test
