Technical Service Bulletin

GROUP	NUMBER
CAMPAIGN	26-01-007G
DATE	MODEL(S)
JANUARY 2026	G70 (IK)

SUBJECT: ECM SOFTWARE UPDATE - DTC P019100
(LIMITED COVERAGE CAMPAIGN L07G)

Description: Certain G70 (IK) vehicles equipped with the 2.0T-GDI engine may illuminate the Check Engine Light as a result of DTC P019100 (Fuel Rail Pressure Sensor Circuit Range/Performance). This bulletin provides instructions for updating the Engine Control Module (ECM).

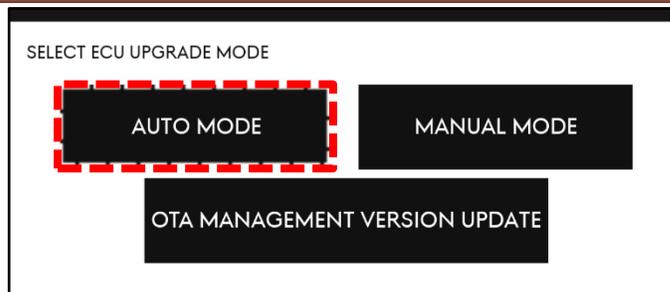
2. Verify the ROM ID by selecting the **Engine** system to scan the vehicle’s current ROM ID.

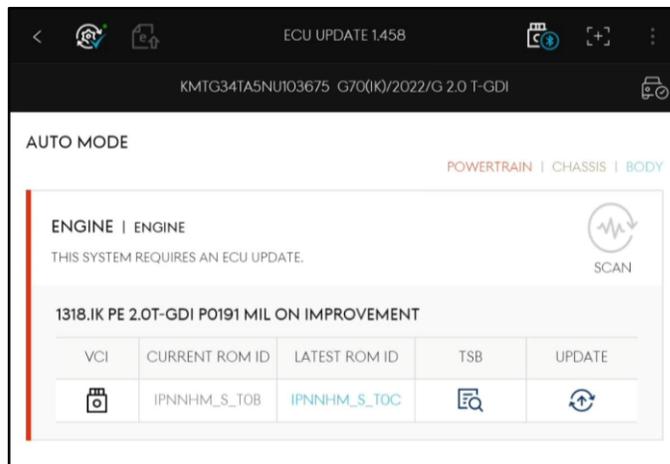
NOTICE

Check the current ROM ID version and compare it to the ROM ID Information table before attempting to perform the software update.

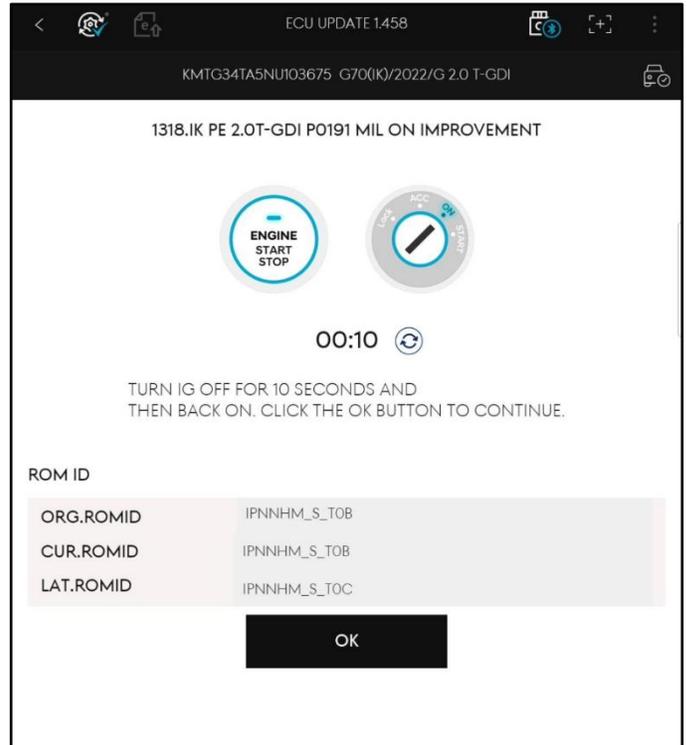
- Once the ECU update is 100% complete, follow the prompts on the screen to cycle the ignition **OFF** for at least **10 seconds** to reset the control unit (certain models may take up to **30 seconds**).

Use the **Refresh** button to reset the timer.

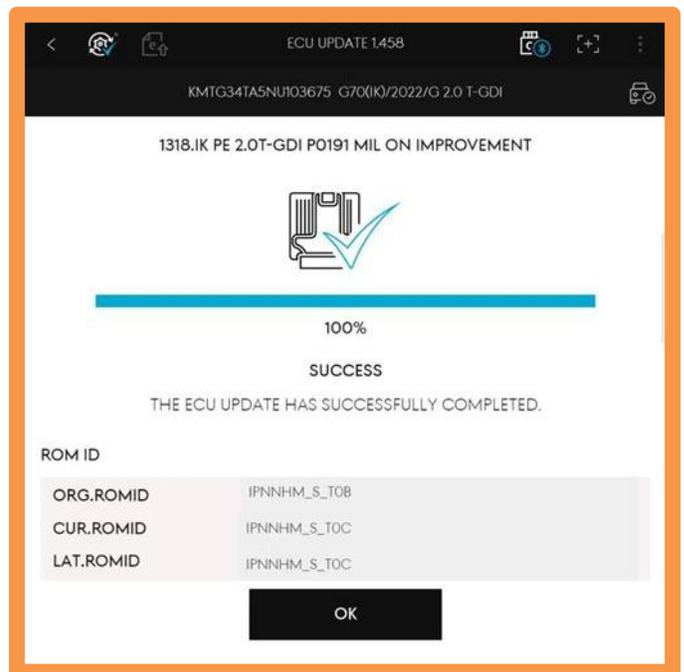
Using the tablet or GDS screen capture function, take a screenshot of the ECU update "Success" results screen.

Upload the photo to STUI.

NOTE: The VIN/Date/Time/Mileage photo imprint is **NOT** required for GDS screenshots.

NOTE 4: This TSB includes repair validation photos. Op times include VIN, mileage, and photo capture of the ECU Update “Success” screen as outlined in the Digital Documentation Policy.

This TSB includes repair validation photos. Refer to the latest Warranty Digital Documentation Policy for requirements.

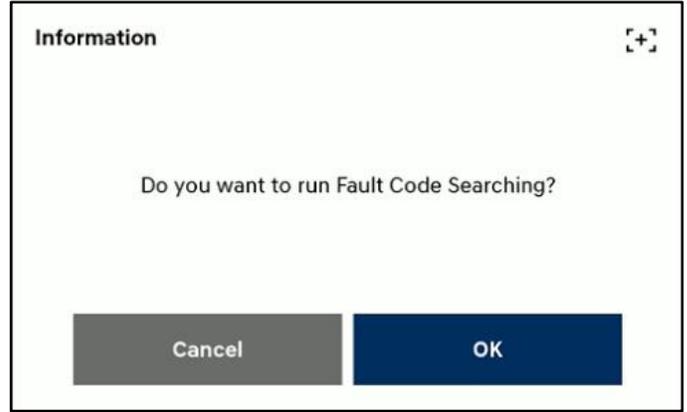
5. Perform an **All Systems Fault Code** search and erase DTC history that had incidentally occurred from the ECU update.
