GROUP	MODEL
	ELE	2023-2024MY Sportage HEV (NQ5 HEV)
	NUMBER	DATE
	399 (Rev 1, 01/23/2026)	September 2025
<h2>TECHNICAL SERVICE BULLETIN</h2>		
<p>SUBJECT: BMS DISCHARGE LOGIC IMPROVEMENT</p>

This bulletin provides information to upgrade the 'BMS' system software on certain 2023-2024MY Sportage HEV (NQ5 HEV) vehicles produced from February 15, 2022, through December 15, 2023, which may experience excessive discharging of the 12V lithium battery while parked, potentially resulting in a no-start condition. Follow the procedure outlined in this publication to improve the discharge prevention logic for the 12V lithium battery. Refer to [SST081](#) for software upgrade instructions using Kia Diagnostic System (KDS) tablet and VCI-II and confirm the Upgrade Event Number/Name, ROM ID Information, and Manual Mode passwords (if applicable) on the applicable vehicle.

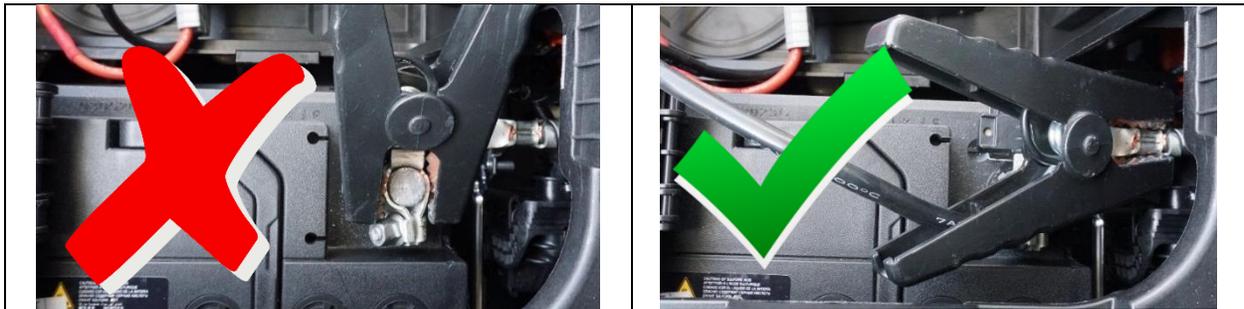
[Connect the negative \(-\) terminal to the battery as shown below.](#)

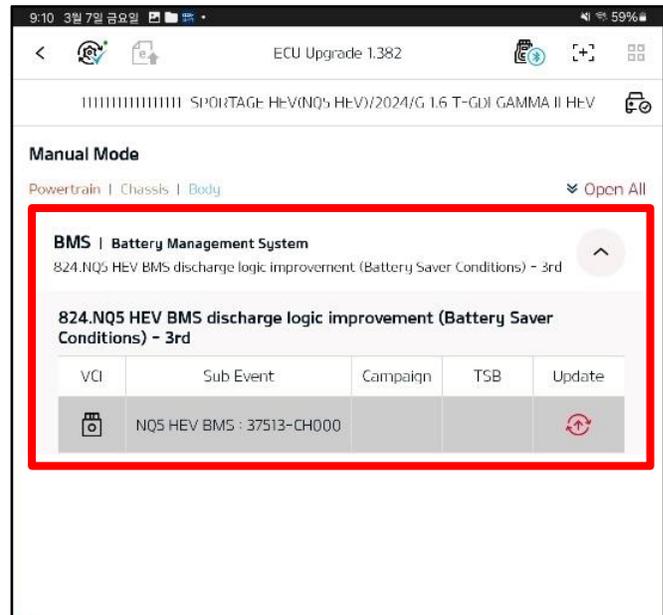
Select the applicable **'824'** system module and the Event Group.

- **824.NQ5 HEV BMS discharge logic improvement (Battery Saver Conditions) - 3rd**

Verify the affected vehicle Calibration Identification of the applicable ECU ROM ID and reference the Information Table on page 3 as necessary.
