ESC Warning Lamp and ECU Replacement

TSB-54-379-FTL

Vehicles equipped with mBSP braking and ESC that show repeated DTC 1810/02 and a yellow ESC warning lamp (ESC disabled) have a longitudinal acceleration fault.

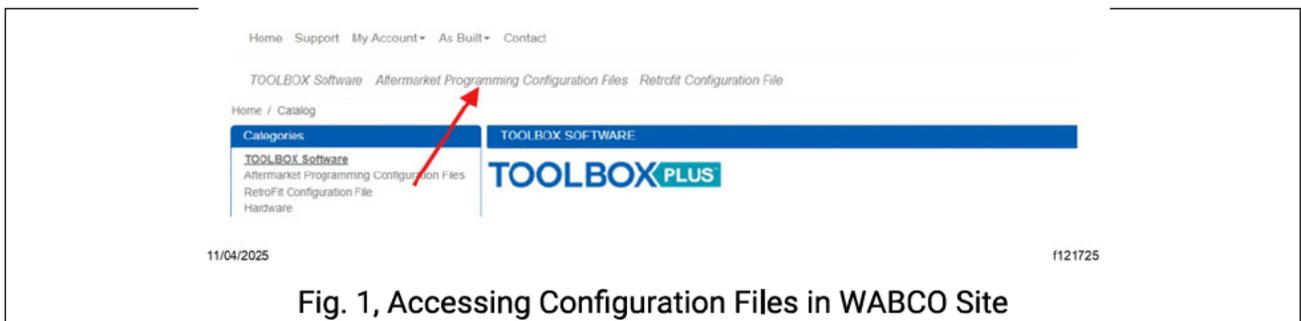
Fig. 1, Accessing Configuration Files in WABCO Site

3. Select 'Aftermarket Programming Configuration File.' See Fig. 1 and Fig. 2.

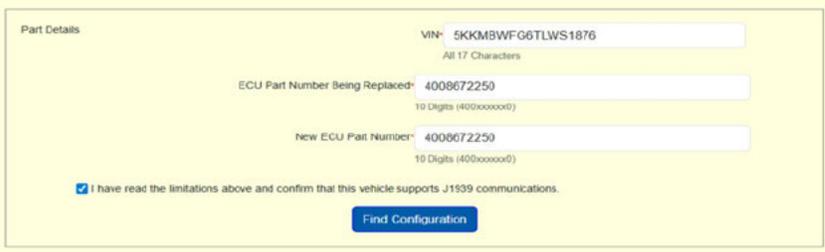
Fig. 3, Finding the Configuration File

4. Enter the full VIN and old part number in both places and select 'Find Configuration.' See Fig. 3.

The screenshot shows a form titled "Part Details" with the following fields and content:

- VIN: 5KKBWFG6TLWS1876 (All 17 Characters)
- ECU Part Number Being Replaced: 4008672250 (10 Digits (400xxxxxx0))
- New ECU Part Number: 4008672250 (10 Digits (400xxxxxx0))
- A checkbox: I have read the limitations above and confirm that this vehicle supports J1509 communications.
- A blue button: Find Configuration

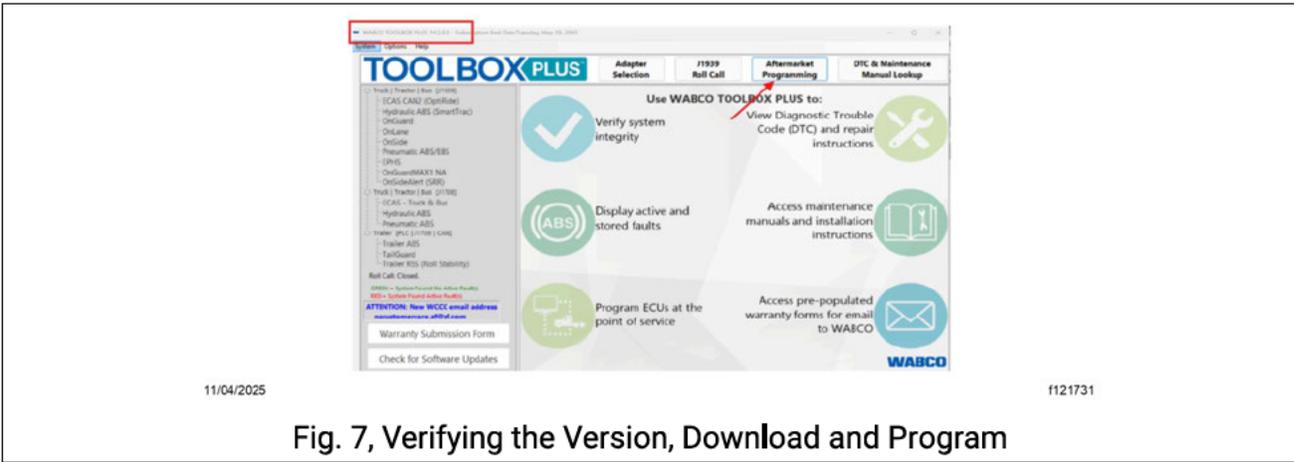
Fig. 7, Verifying the Version, Download and Program

8. Agree to the terms and place the order, then download and save the file. Open the WABCO Toolbox and ensure it is up to date. Select 'Aftermarket Programming' and confirm the pop-up, then choose the downloaded file to begin programming. Review the pass/fail result. If it passes, turn the keyswitch to the OFF position to allow the vehicle to save all the parameters correctly. See Fig. 7.

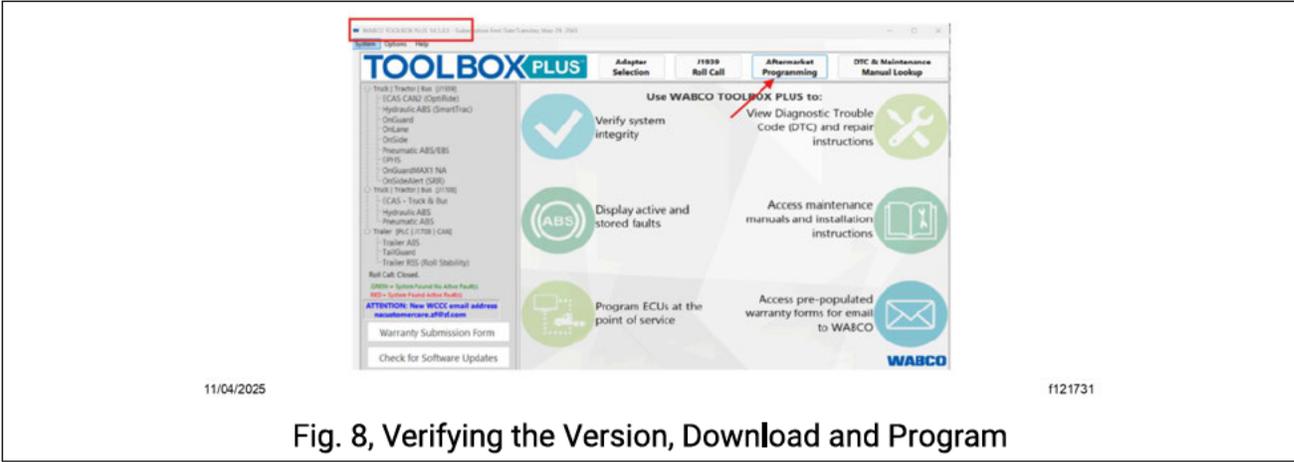
Fig. 8, Verifying the Version, Download and Program

10. The ABS ECU is now in the ESC calibration mode. Use WABCO TOOLBOX to perform the ESC calibration procedure. Complete the driving portion of the End of Line (EOL) procedure. After approximately 100 yards of straight-line driving and then a 90 to 180 degree turn is recorded by the ABS ECU, the stability lamp on the dash will turn off. See Fig. 8.
