**UPDATED JANUARY 23, 2026 – Added video tutorial for procedure.
Modified to further highlight modules to be updated.**

2024-2026 CX-90 and 2025-2026 CX-70
Engine Warning Light Illumination with DTC PODAB

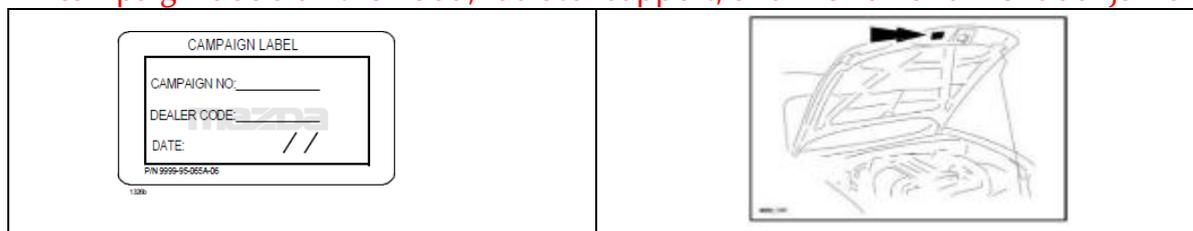
eMDCS - Warranty Vehicle Inquiry Results

2. If the vehicle is in the range above and MSP66 is in OPEN status in eMDCS, proceed to Step 2. If the vehicle does not have an OPEN MSP66 status, return the vehicle to the customer or inventory.
3. Perform an eMDCS Warranty Vehicle Inquiry and inspect the vehicle for a Campaign Label with MSP66 attached to the vehicle's hood, driver door or firewall.

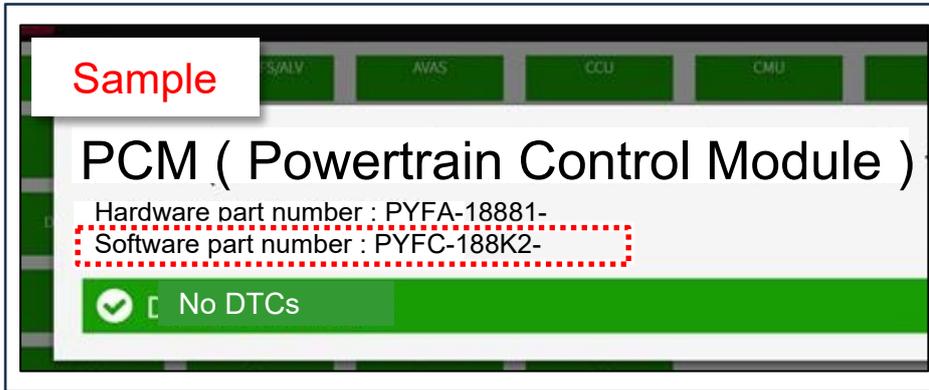
1. Check the file version of each ECU listed in the countermeasure repair procedure. Compare the software version of each ECU with the software version in the repair procedure.
 - a. If the vehicle software version is newer, do not perform reprogramming.
 - b. If the vehicle software version is older, perform reprogramming.

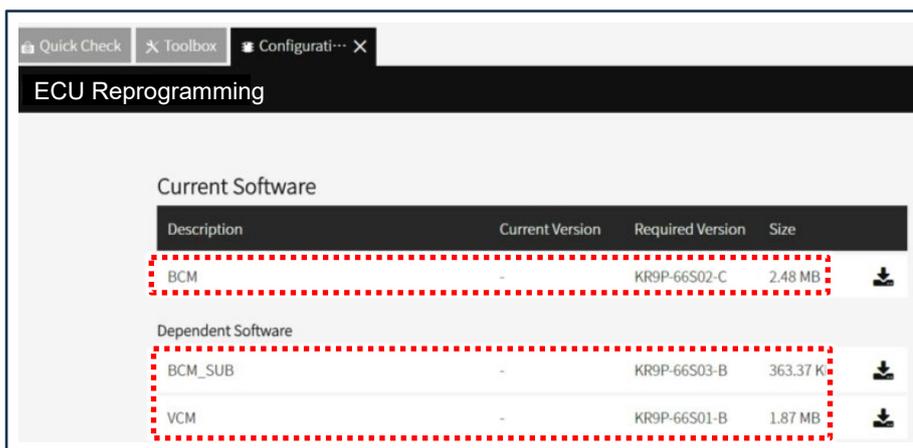
2. Select target ECU to be reprogrammed.
 - Required module
 - PCM
 - MHB

- MDARS automatically selects other ECUs related to the ECU to be reprogrammed. The selected ECUs may be reprogrammed together.
- Make sure that the ECU to be reprogrammed listed in the countermeasure repair procedure is displayed in MDARS.

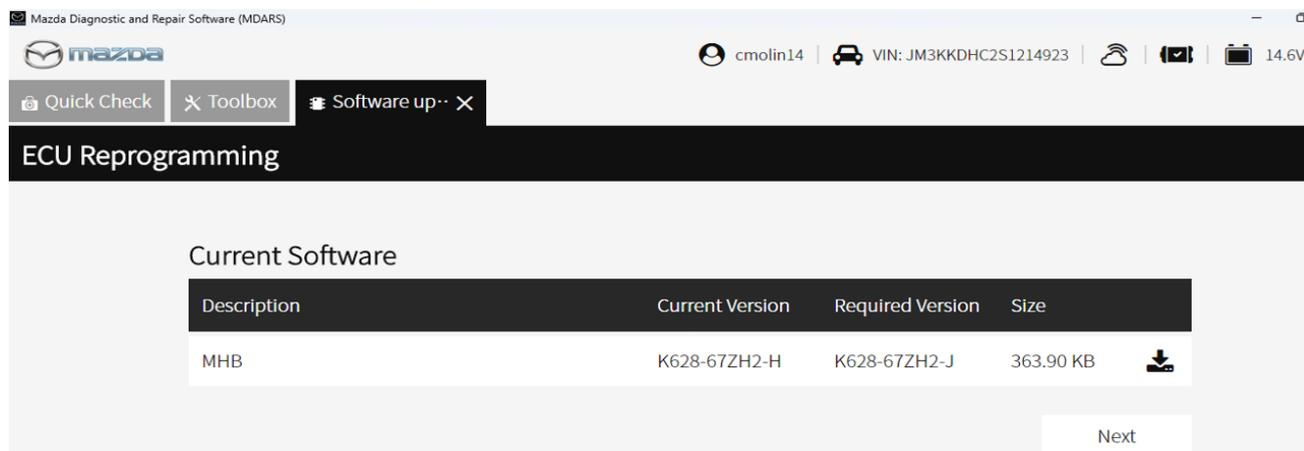
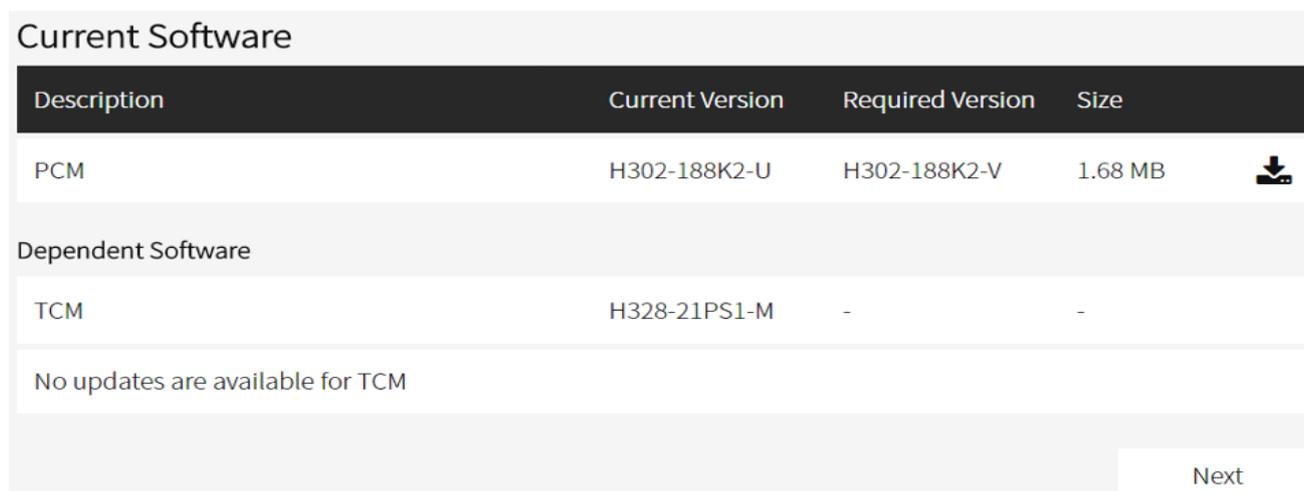
- Confirm the current and new software versions, click "Next". CX-90 Example shown. If the software is at the current level, do not stop repairing and continue with all remaining steps including Uploading ODR data and Campaign Label Installation.

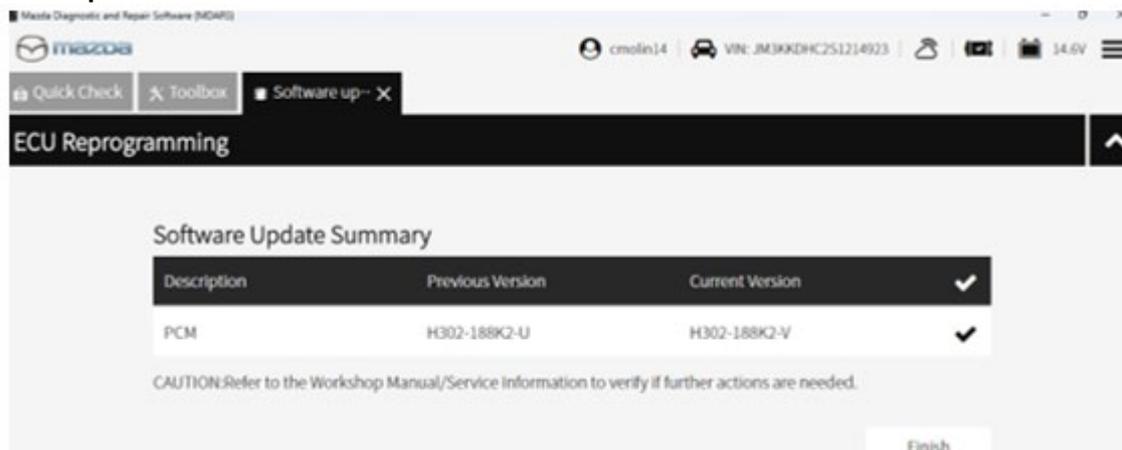
CX-90 Example

- Wait for the download and click "Next".
- After completion of software update, the previous and current software version are shown.
 - Check current version at "Calibration File information below".
 - Then, click on "Finish" to exit the ECU reprogramming.

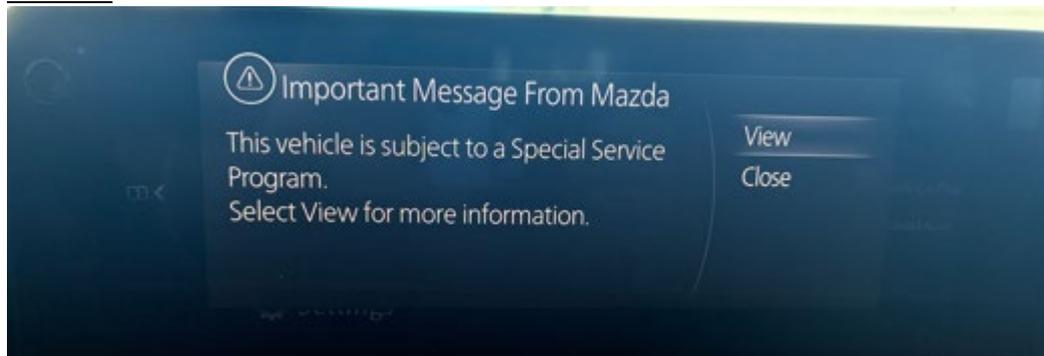
Photo 1

Step 1: Verify the message is in the View Status Monitor in Mazda Connect Inbox. Once at the main screen, select “View” then you will see photo 2.

IMPORTANT – Once you see a date you selected Request OFF as below in the red square, exit eMDCS and let the customer know the CV message (Photo 1) will go away within 24 hours.
