Technical Service Bulletin

Topic	MIB3 Telecom Infotainment MMI becoming stuck on the 'initialisation/loading' screen Bentayga Series 23MY
Market area	Bentley: worldwide (2WBE),China 796 VW Import Comp. Ltd (Vico), Beijing (6796)
Brand	Bentley
Transaction No.	2079175/4
Level	EH
Status	Released for publishing
Release date	Jan 6, 2026

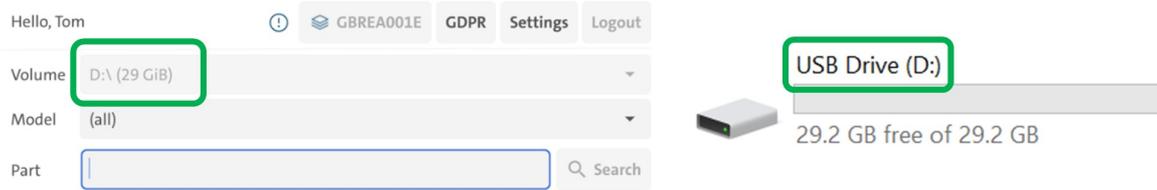
4) Using two USB-C sticks (ensure they are of a sufficient storage capability), place the USB into the PC and make sure the “Volume” matches the designator assigned through “Devices and Drives” within “This PC”.

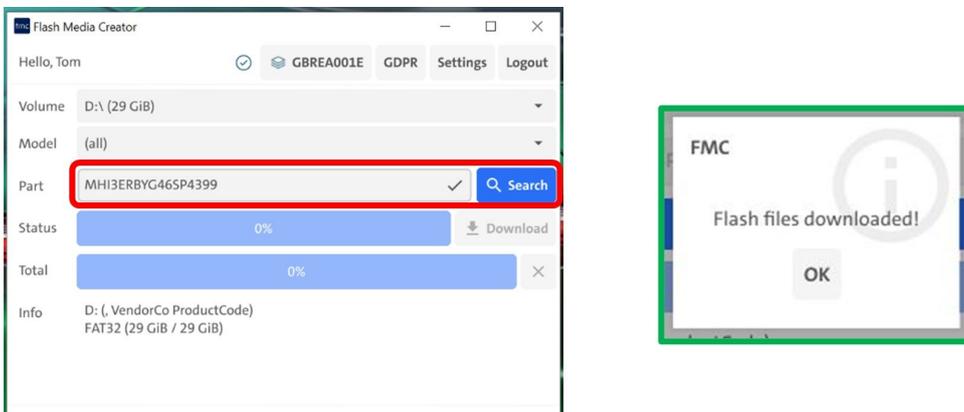
5) Referring to Table 1: MIB Software Part number Matrix, enter the correct Software part number into the “Part” Section.

Hint: Make sure the Part Number is Valid by getting the tick icon.

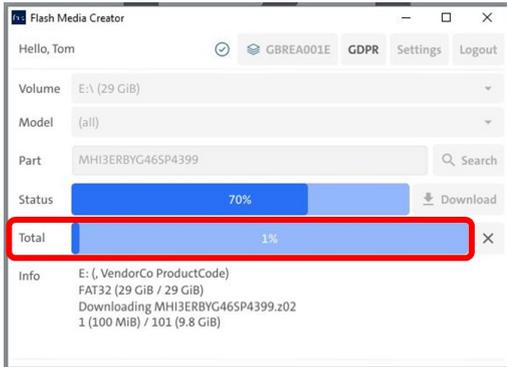
8) The data will begin to transfer from the mirror server to the USB stick, the progress can be monitored via the “Total” progress bar.

Hint: The process for larger files can take a long time (2-3hrs), dependent on network and USB data transfer speeds

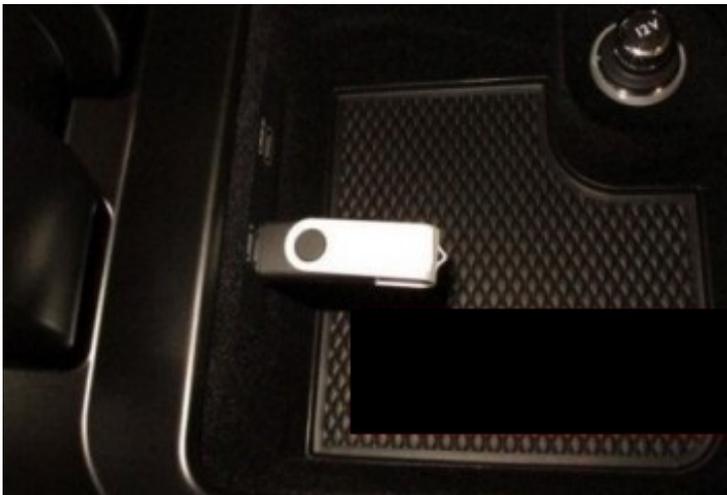
Figure 1

13. Insert the USB update stick with the instrument cluster software from **table 2** into the USB 1 socket (Figure 1).

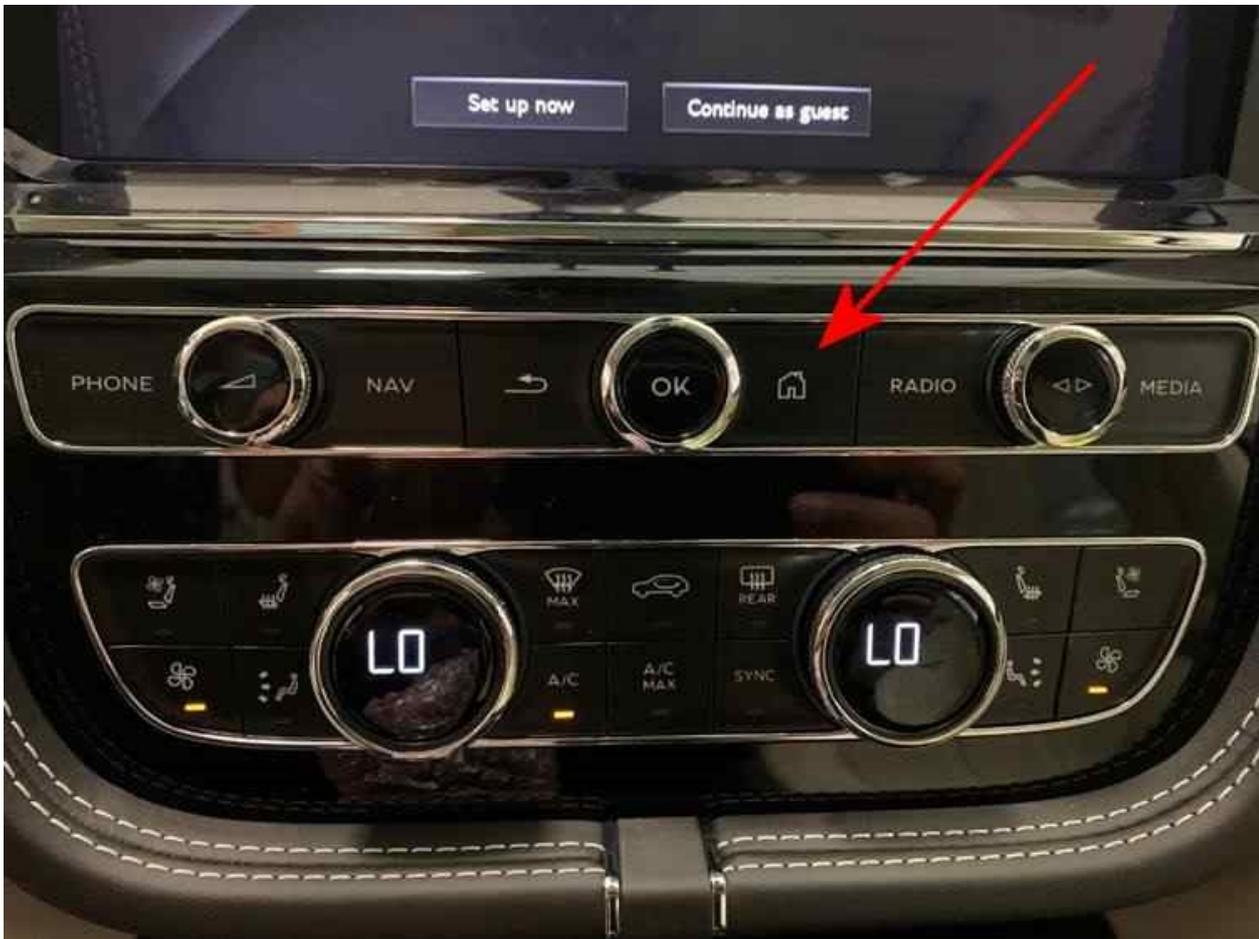
Figure 2

- Press the home screen button (Figure 2)

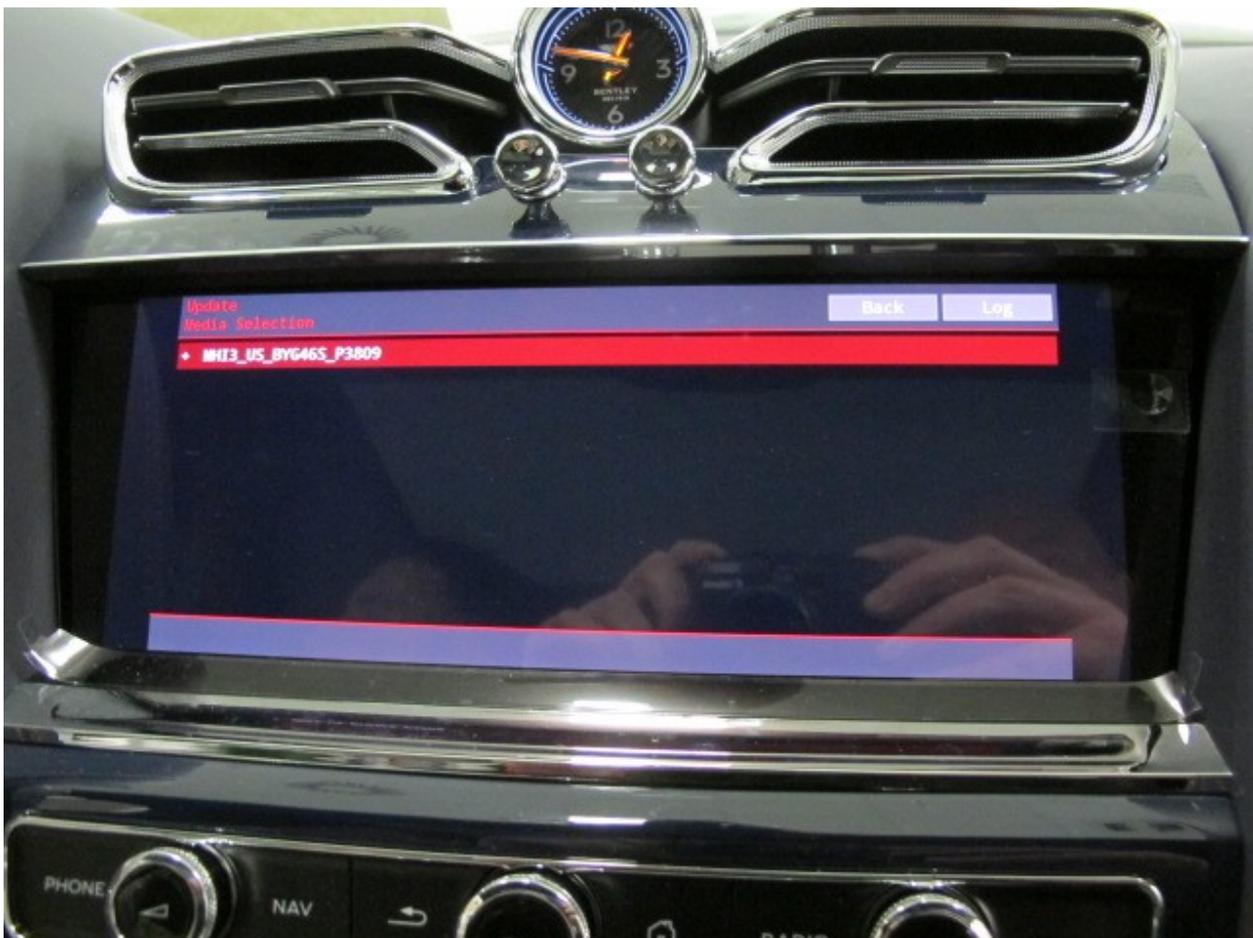
Figure 5

14. Select the suggested update. (Figure 5)

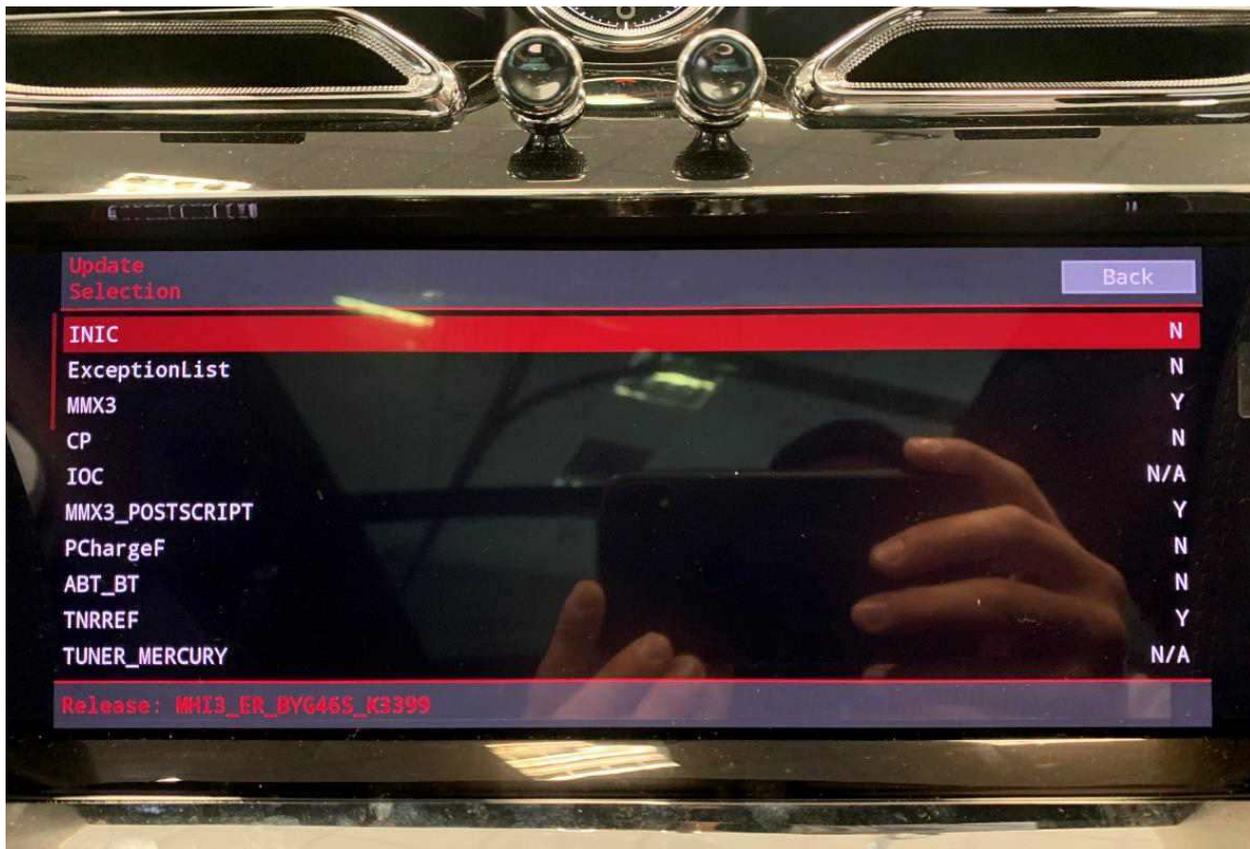
Figure 6

15. A summary of the proposed changes will then appear (Figure 6), scroll down and select 'Start update' (Figure 7)

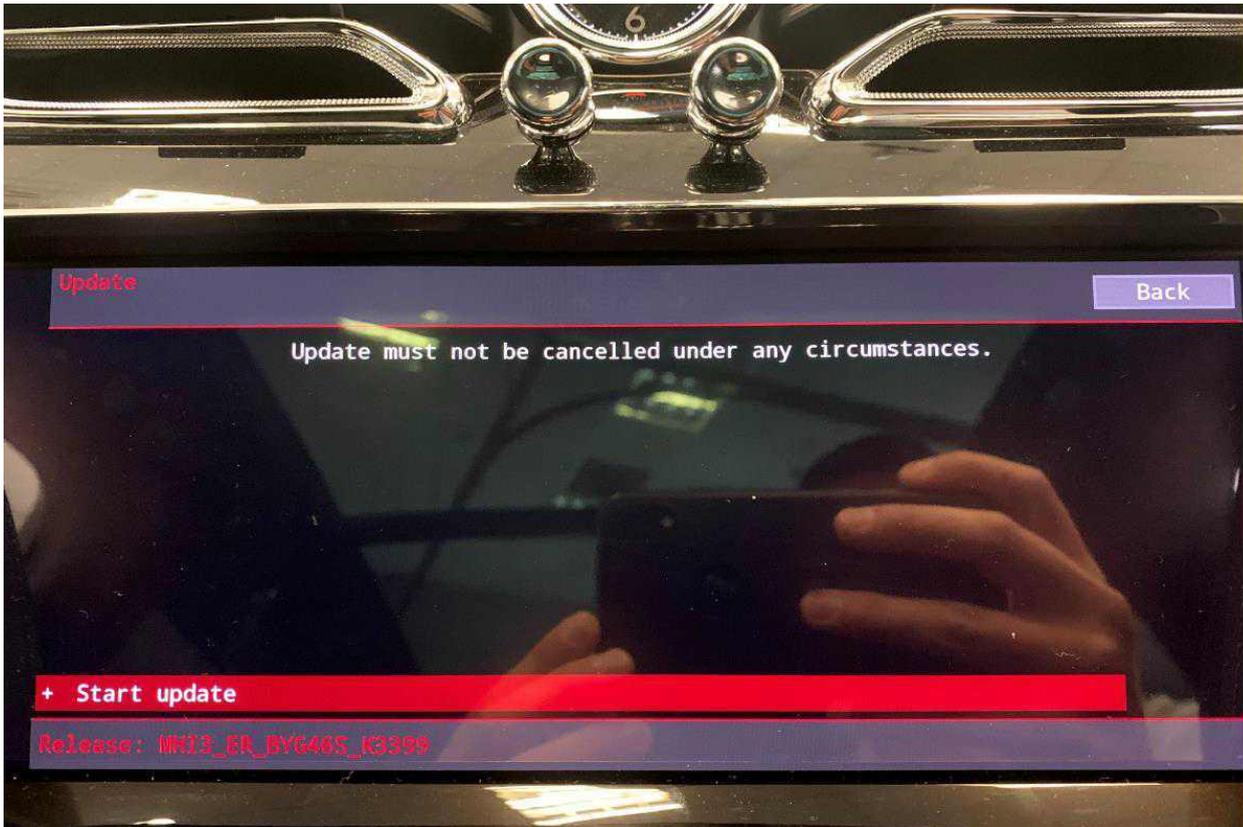
Figure 8

- Select 'Start update' again. (Figure 8)

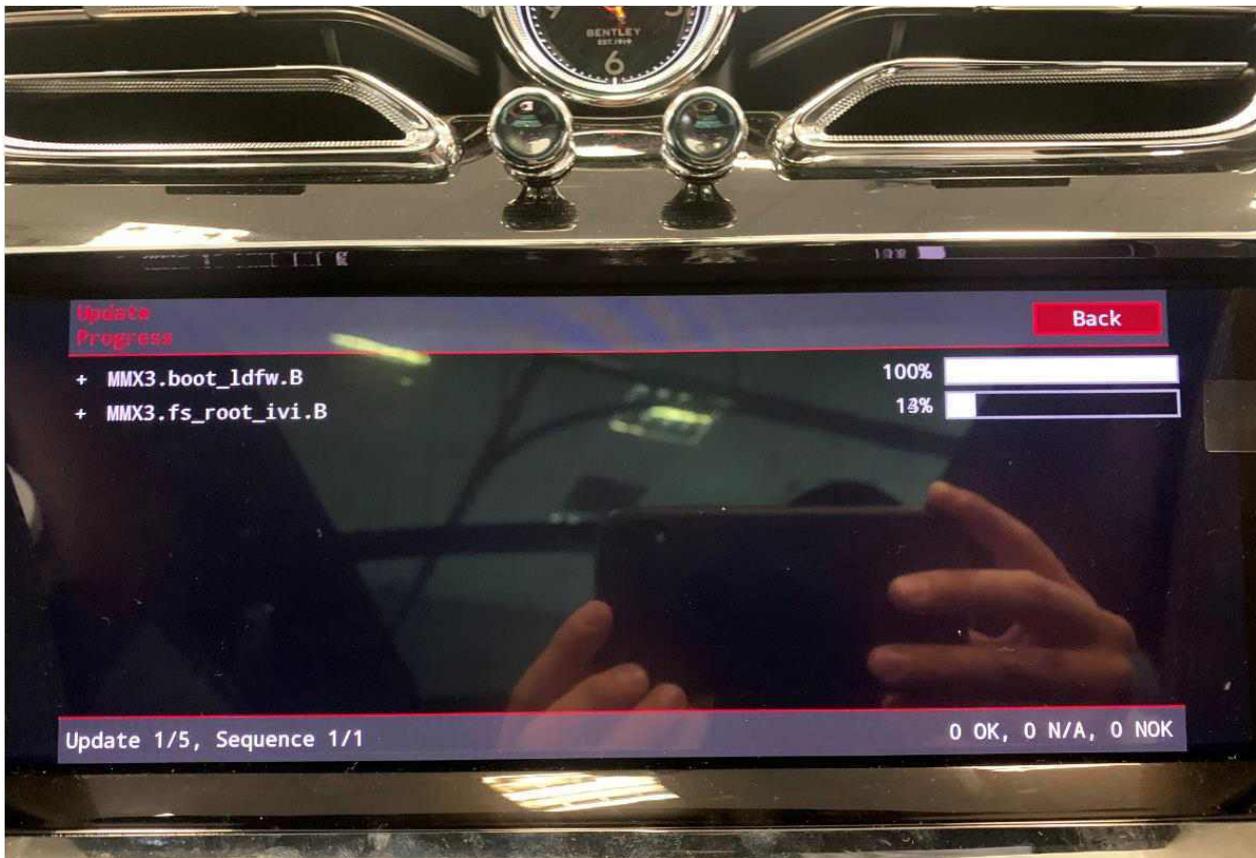
Figure 9

17. The software update will then begin (Figure 9)

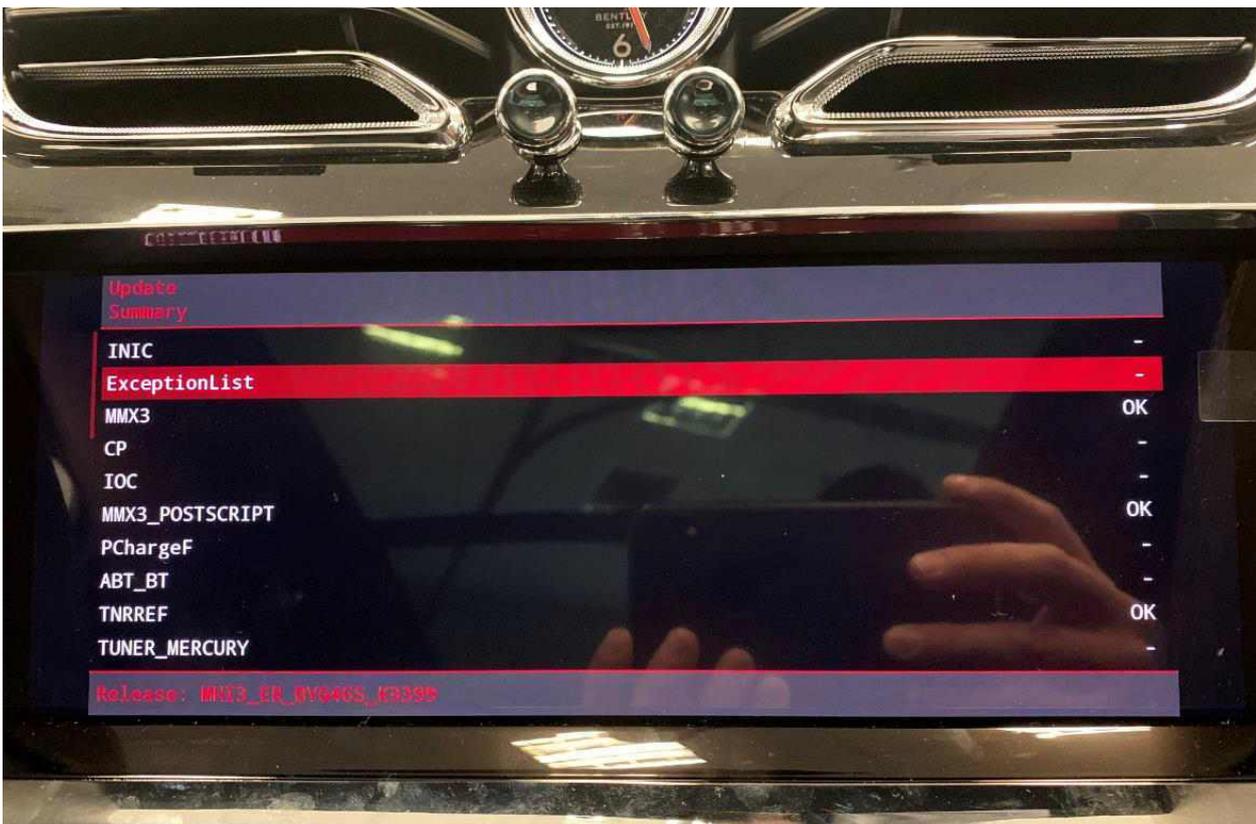
Figure 10

18. Once the update is complete a summary screen will be displayed. (Figure 10) Scroll down and press 'Resume' (Figure 11)

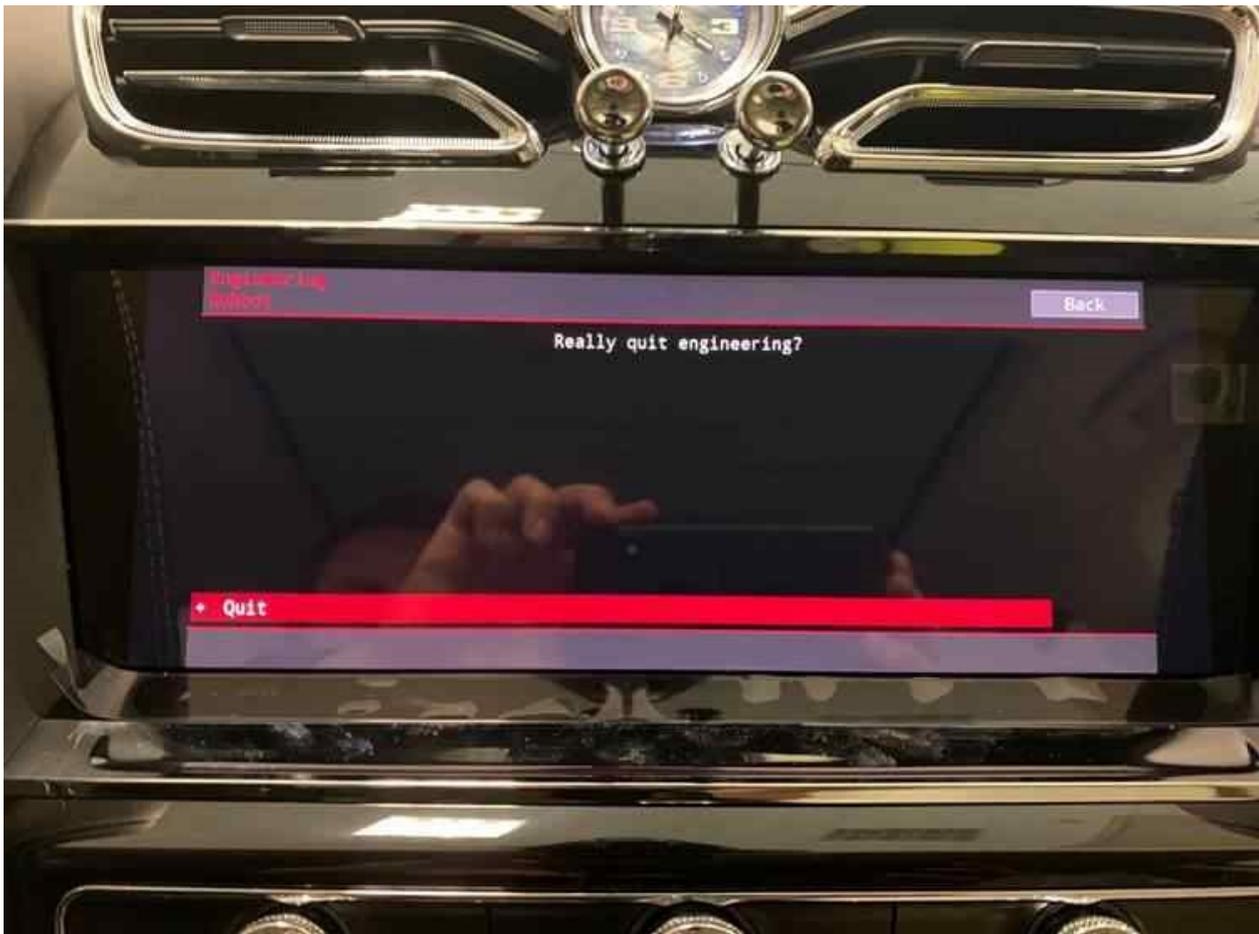
Figure 12

19. On the next screen select 'Quit' (Figure 12), the system will then reboot. Once the home screen is displayed, remove the USB update stick and carry out an ignition cycle.

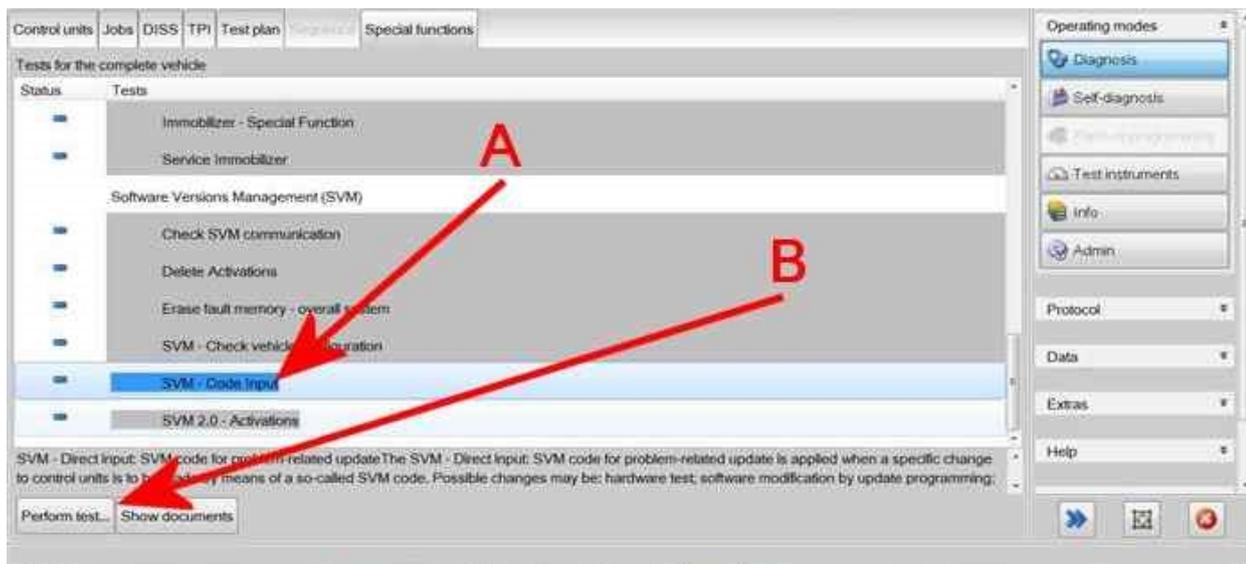
- Referring to Figure 13 - Within the Special functions tab select SVM – Code Input (A) then select Perform test (B)

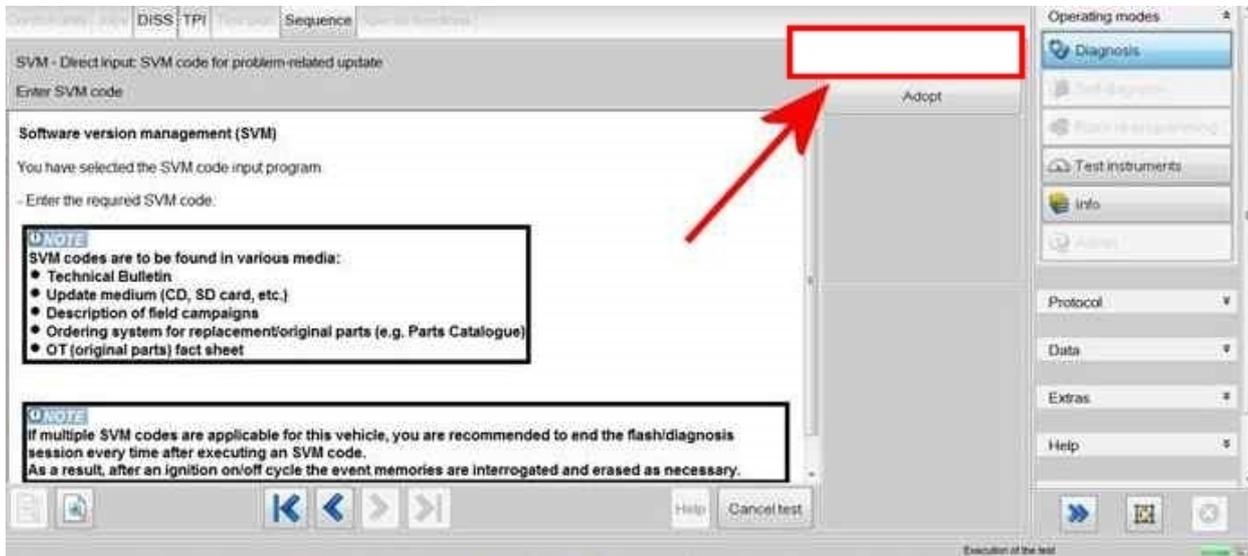
Figure 14

22. Navigate to 'SVM – Code Input' and enter the SVM Code and select adopt (Figure 14)

- If the vehicle is any variant of a Bentayga SWB, enter the SVM Code: 4V0CLUST37S2
- If the vehicle is any variant of a Bentayga EWB, enter the SVM Code: 4V1CLUST37S2

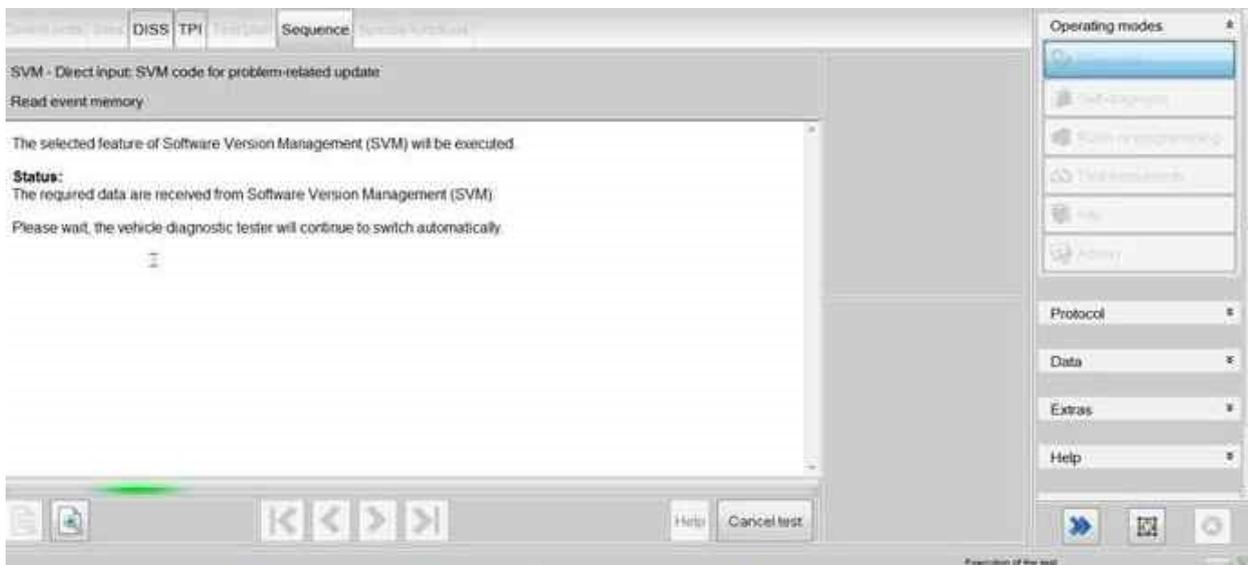
Figure 15

- All control modules will be interrogated
- The SVM action will then take place (Figure 15)

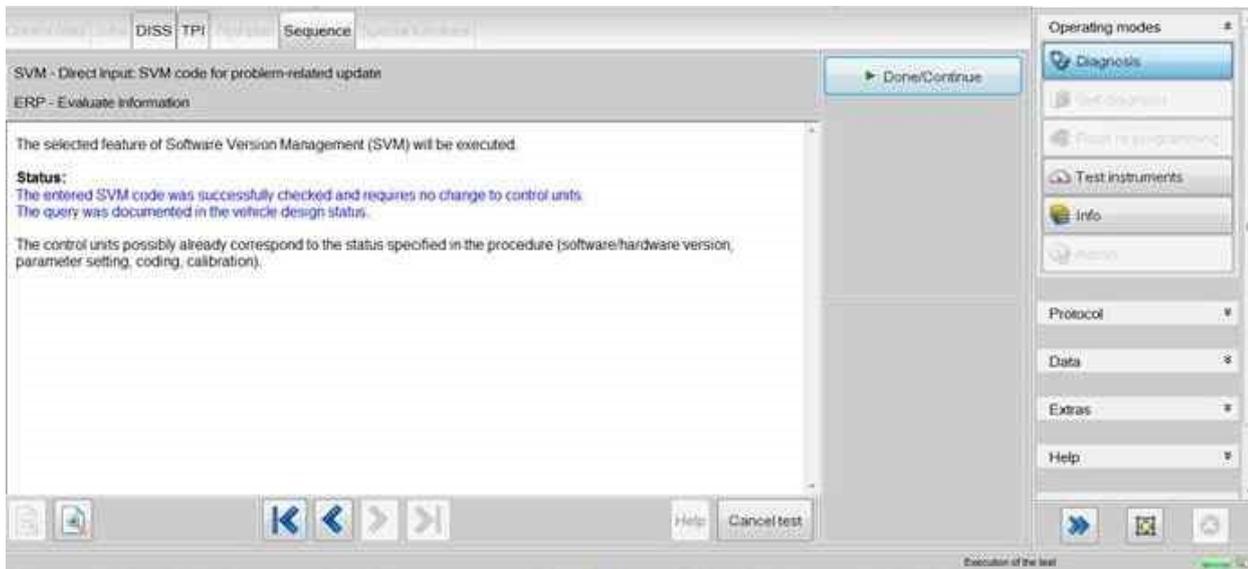
Figure 16

24. Once complete a summary screen will appear (Figure 16), this confirms successful completion - Follow any on screen prompts until program end
