## Technical Service Bulletin

<b>GROUP</b>	<b>NUMBER</b>
<b>CAMPAIGN</b>	<b>26-01-012G</b>
<b>DATE</b>	<b>MODEL(S)</b>
<b>JANUARY 2026</b>	<b>G80 (RG3)</b>

**SUBJECT:** DCU SOFTWARE UPDATE  
(SERVICE CAMPAIGN T73G)

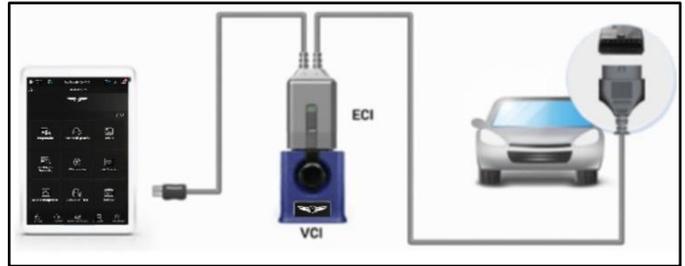
VCI 2 Connection (must use ECI kit with USB-C cable attachment):

1. Connect the ECI DLC connector to the OBD connector of the vehicle.
2. Connect the VCI to the receiver module on the ECI cable.
3. Connect the ECI cable with the USB-C connector cable attachment to the tablet.

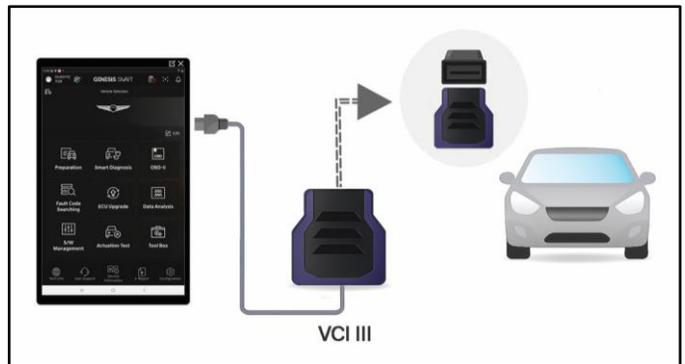
VCI 3 Connection (use VCI 3 cable):

1. Connect the 19-pin connector to the bottom of the VCI 3.
2. Connect the VCI to the OBD connector of the vehicle.
3. Connect the cable with the USB-C connector to the tablet.

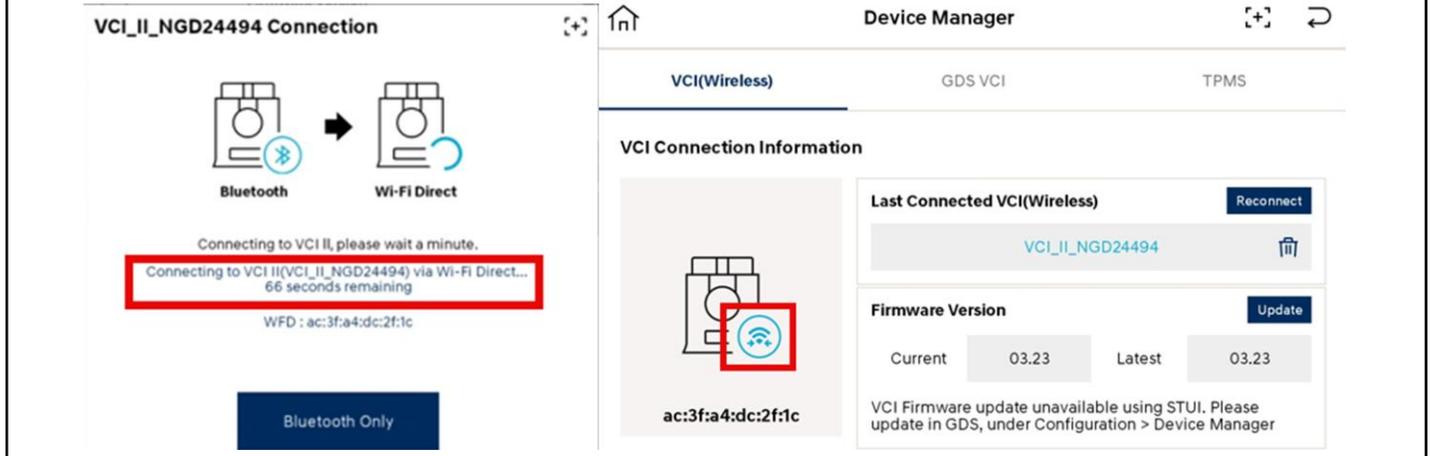
- If using VCI 2, please wait for the **Wi-Fi Direct** timer to complete to ensure the **Wi-Fi Direct** connection is established. Do **NOT** select **Bluetooth Only**.

1. Enter the following digits exactly as shown for IP address, DNS address, Netmask and Default gateway.

Ensure the following IP settings on your tablet matches the below before proceeding with the software update.

Select Ethernet device  
eth0

Connection type  
 DHCP  
 Static IP

IP address  
10.0.128.0

Netmask  
255.0.0.0

DNS address  
8.8.8.8

Default router  
10.0.128.0

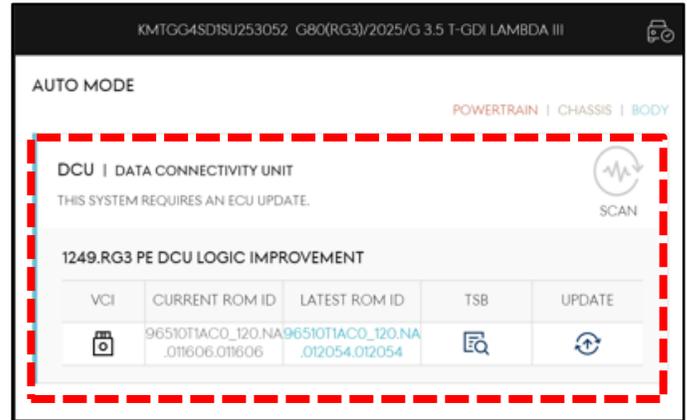
2. Perform the ECU update in **Auto Mode**.

ECU UPGRADE 1.307

SELECT ECU UPGRADE MODE

AUTO MODE

MANUAL MODE

- Verify the ROM ID by selecting the **DCU** system to scan the vehicle's current ROM ID.

Check the current ROM ID version and compare it to the ROM ID Information table before attempting to perform the software update.

- If the ECU update starts but then fails in Auto Mode, perform the update in Manual Mode to recover.

If the ECU update fails in Auto Mode, perform the update in Manual Mode using the password(s) below.

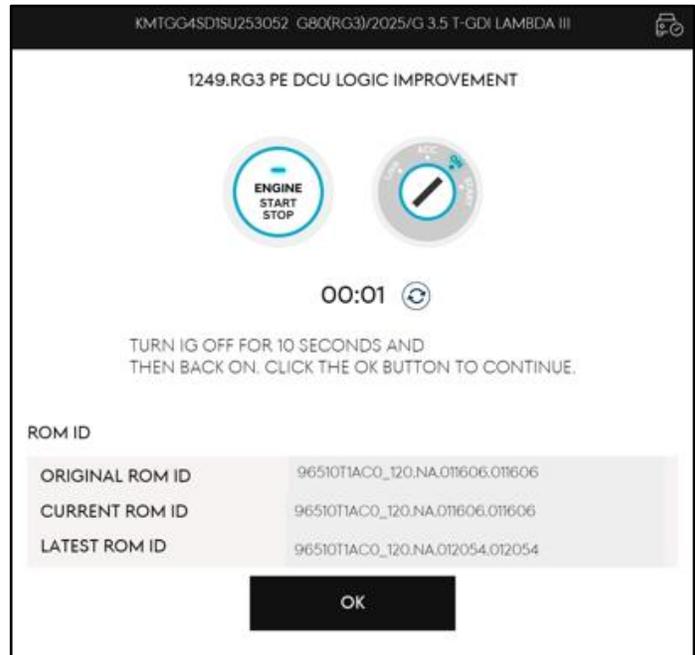
- After the ECU update process shows 100% complete, follow the prompts on the screen to cycle the ignition **OFF** for at least **10 seconds** to reset the control unit (certain models may take up to **30 seconds**).

Use the **Refresh** button to reset the timer.

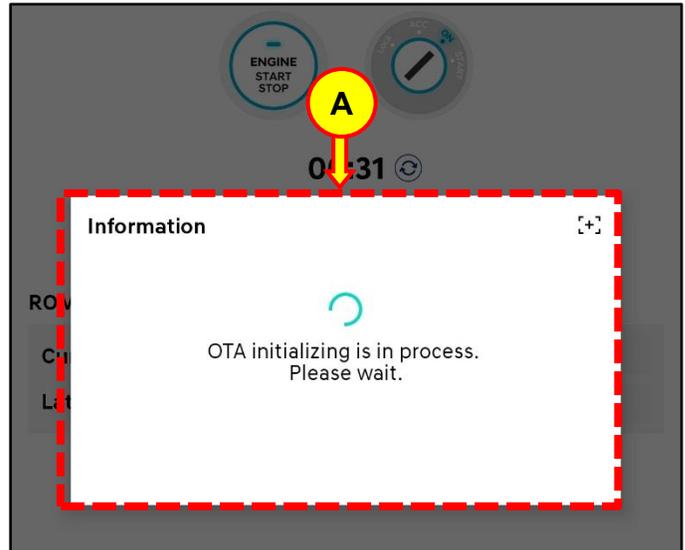
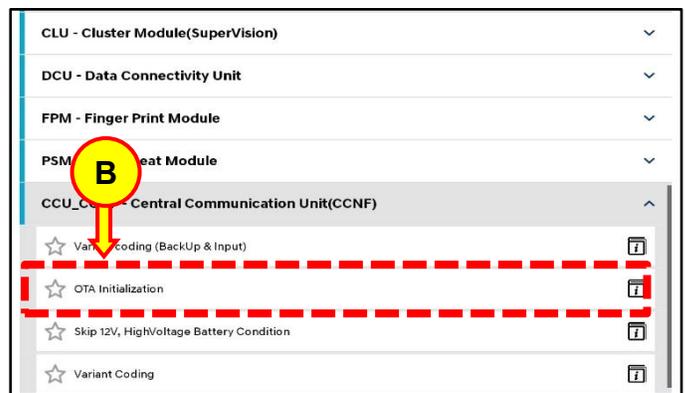
5. OTA initialization (A) should perform automatically:
  - If OTA initialization performs automatically, then proceed with the service procedure.
  - If the OTA initialization process fails, complete it manually under:  
**S/W Management > CCU\_CCNF - Central Communication Unit (CCNF) > OTA Initialization (B).**

Follow the instructions on the screen.

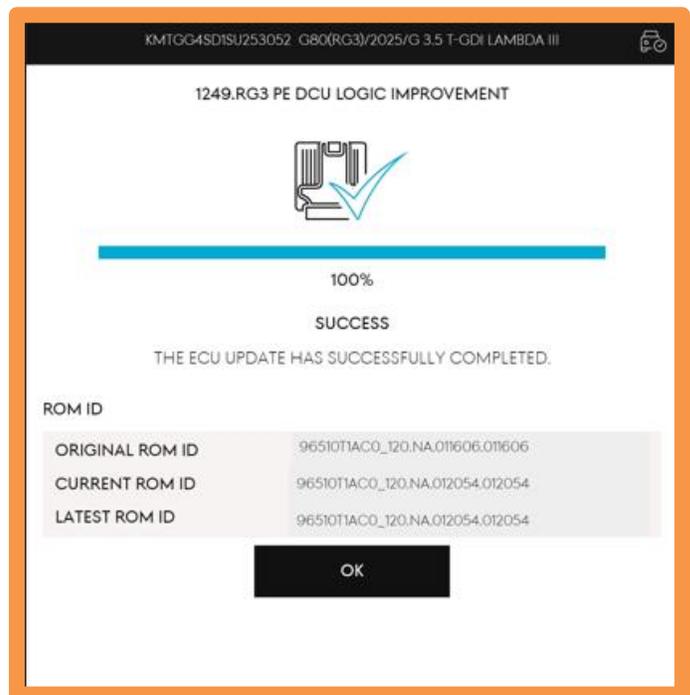
Using the tablet or GDS screen capture function, take a screenshot of the ECU Update "Success" result screen.

Upload the photo to STUI.

**NOTE:** The VIN/Date/Time/Mileage photo imprint is **NOT** required for GDS screenshots.

**NOTE 3:** This TSB includes repair validation photos. Op times include VIN, mileage, and photo capture of the ECU Update "Success" screen as outlined in the Digital Documentation Policy.

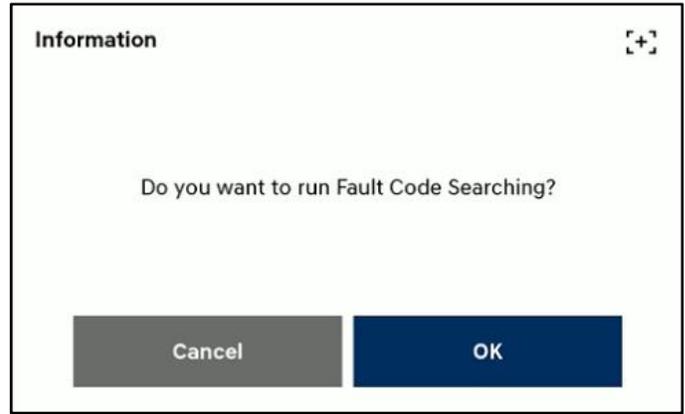
7. Perform an **All Systems Fault Code** search and erase DTC history that had incidentally occurred from the ECU update.
