Complaint – Charging Process is Cancelled / Check Engine Warning Light is Active: Re-Program High-Voltage Charger (OBC) Control Unit (36/21)

Vehicle Type: **Cayenne E-Hybrid (9YA/9YB)
Cayenne Turbo S E-Hybrid (9YA, 9YB)**

Concerns: **High-voltage charger 3.6 kW (M no. KB1) – (OBC) control unit**

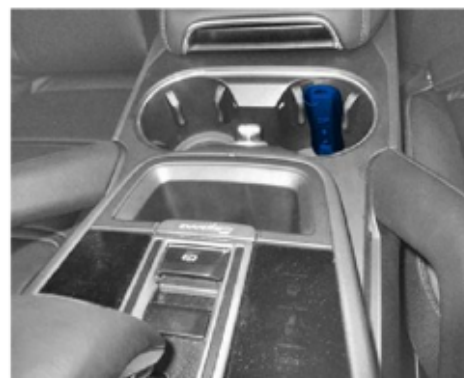
Emergency start tray

- Work Procedure:
- 1 Position the driver key in the rear area of the left cupholder in the center console between the holding struts (emergency start tray) in order to guarantee a permanent radio link between the vehicle and driver key ⇒ *Emergency start tray*.
 - 2 Carry out general preliminary work for control unit programming as described in ⇒ *Workshop Manual '9X00IN Basic instructions and procedure for control unit programming - section on "Preliminary work"*.

- **If the driver's key is not recognized in the vehicle, programming cannot be started or will be interrupted.**
- ⇒ **Place the driver's key with the back facing down into the front left storage compartment in the center console to guarantee a continuous radio link between the vehicle and the driver's key.**
