Head Unit Software Update (Denso)

A head unit software update is available for 2022 – 2023 model year GR86 vehicles equipped with Toyota Multimedia software version 10 or earlier. The software can be updated to version 11 with a USB update. This software update addresses following items:

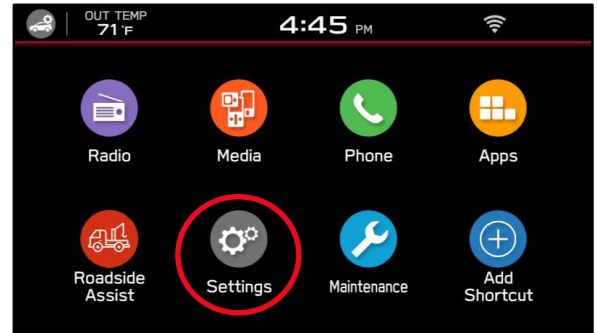
Figure 1.

1. Select Settings.

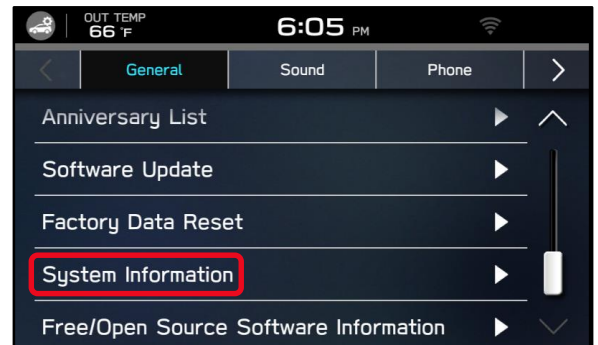
Figure 2.

2. Under the General tab, select System Information.

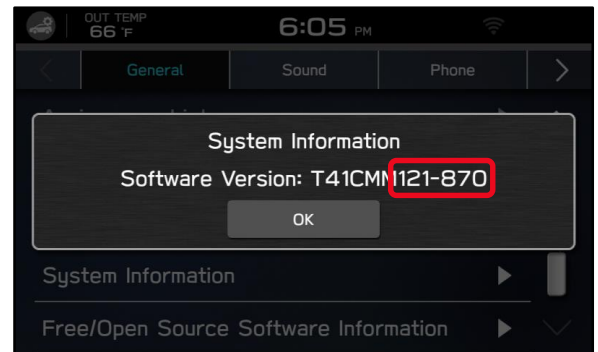
Figure 3.

3. Compare the last six digits of the Software Version number against Table 1.

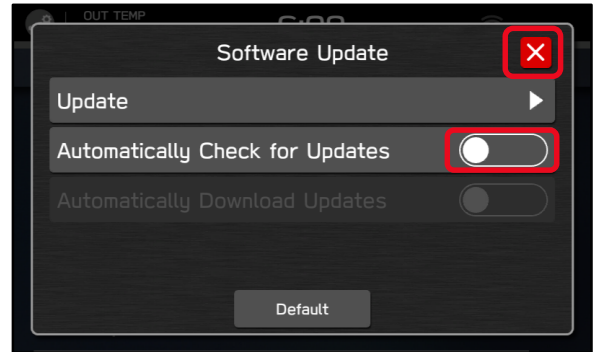
Figure 5.

1. Go to *Settings – General – Software Update* and confirm that *Automatically Check for Updates* is toggled OFF. Click the red X to close the screen.

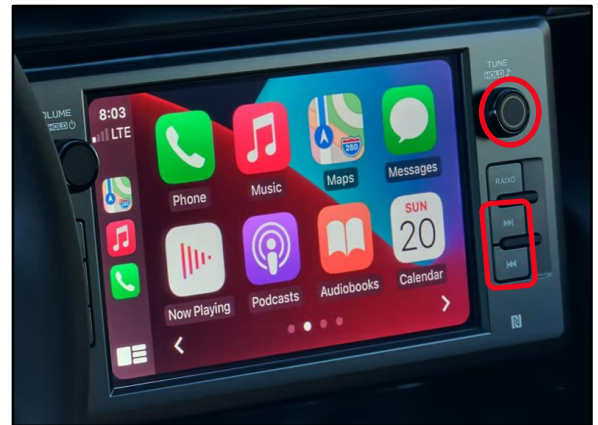
Figure 6.

2. Enter dealership mode by pushing the TUNE knob six times, while simultaneously pressing both SEEK switches.

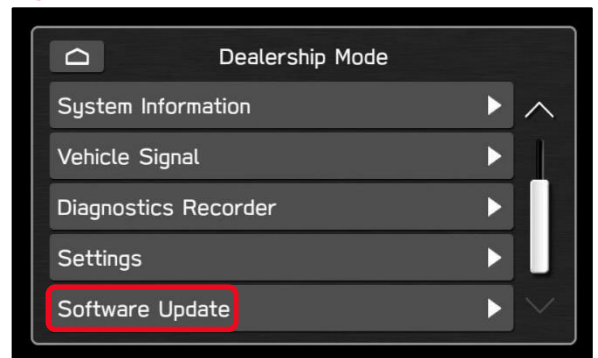
Figure 7.

3. Select Software Update.

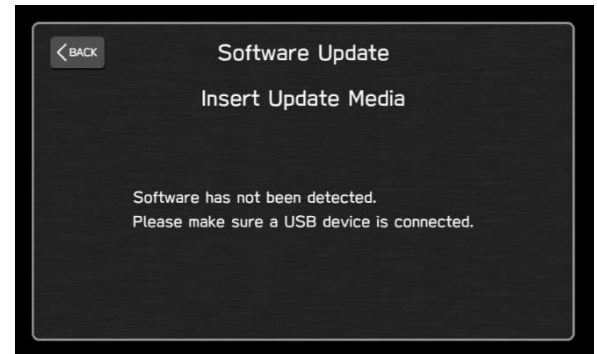
Figure 8.

4. Insert the prepared USB flash drive AFTER the Insert Update Media screen appears.

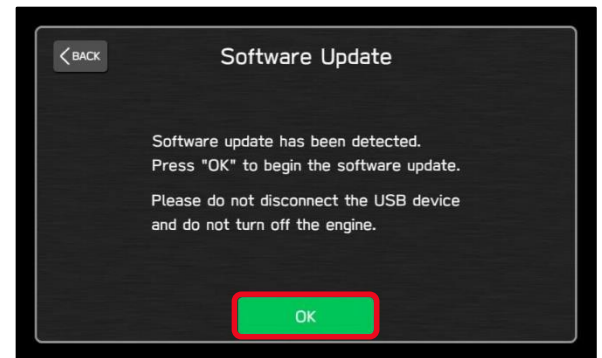
Figure 9.

5. Select OK.

If the screen displays a "Software Loading Unsuccessful" message, confirm that the USB device has been properly formatted, the software on the device matches the system being reprogrammed, and try again.

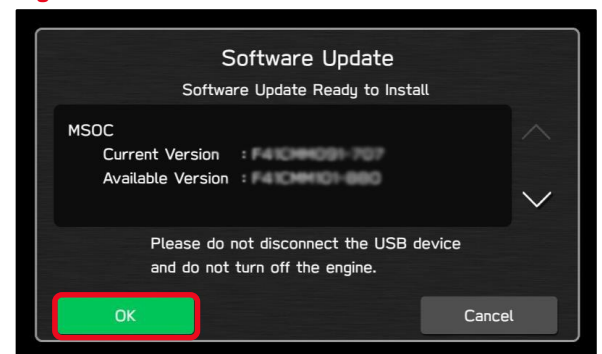
Figure 10.

6. Confirm the Available Version is version 12, per Table 1.

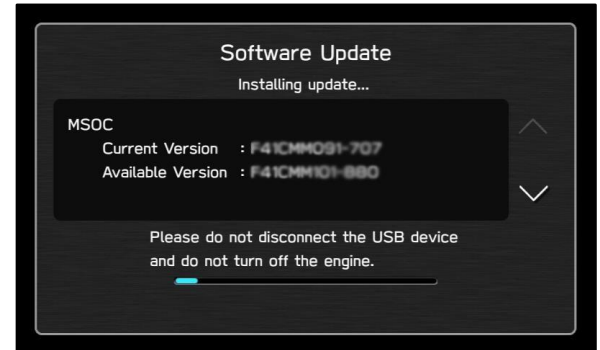
Figure 11.

8. Wait for the update to complete. This can take 5 – 10 minutes.

Do NOT turn the engine OFF during the software update.

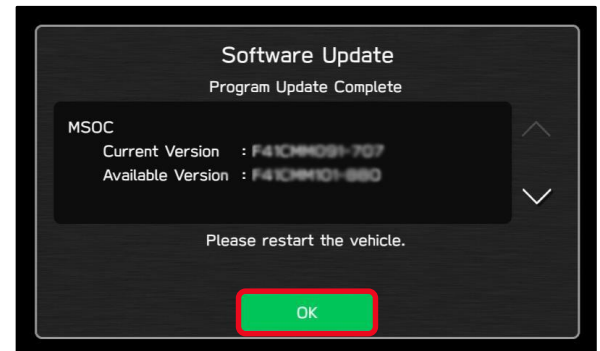
Figure 12.

9. Select OK after the update is complete.

If the screen says “incomplete” instead of “complete” continue to the next step and check the software version at the end of this process to confirm if the latest version is now installed. If the version is the latest, the repair is complete. If not, start the USB update process again.

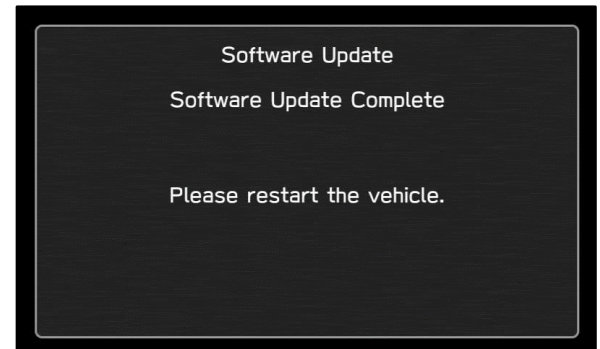
Figure 13.

10. After the screen shown in Figure 13 appears, perform the following procedure:

- Turn the engine OFF.
- Open the driver’s side door.
- Close the driver’s side door.
- Wait three minutes.
- Open the driver’s side door.
- Turn the engine ON.
- Check the software version to confirm the latest is installed.
- USB update is complete.

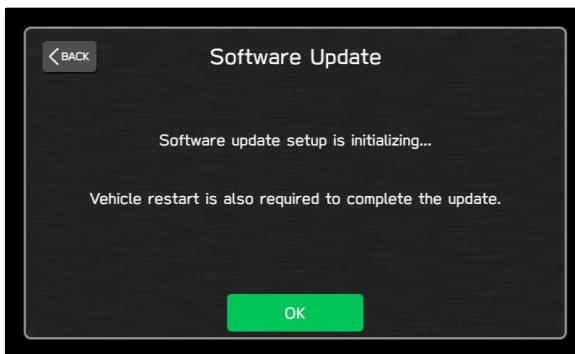
Figure 14.

11. Does the screen shown in Figure 14 appear?
 - **YES** — Wait for up to 15 minutes for initialization to complete. After initialization is complete Figure 15 appears. Then, repeat step 10.
 - **NO** — Continue to step 12.

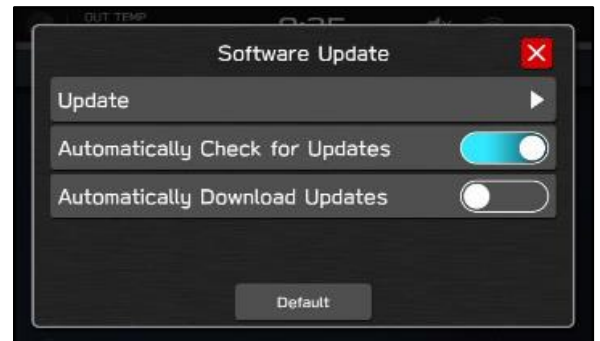
Figure 16.

12. Go to *Settings – General – Software Update* and confirm that *Automatically Check for Updates* is toggled ON. Click the red X to close the screen.

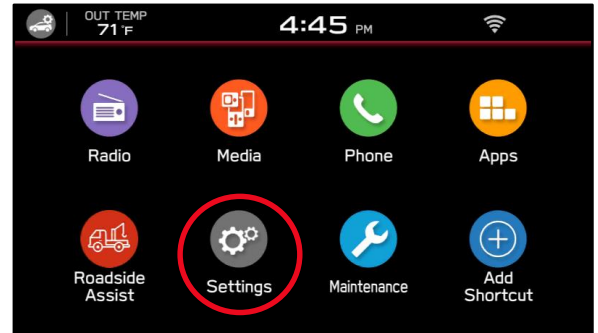
Figure 17.

1. Connect the vehicle to a Wi-Fi network.
 - A. Select Settings.

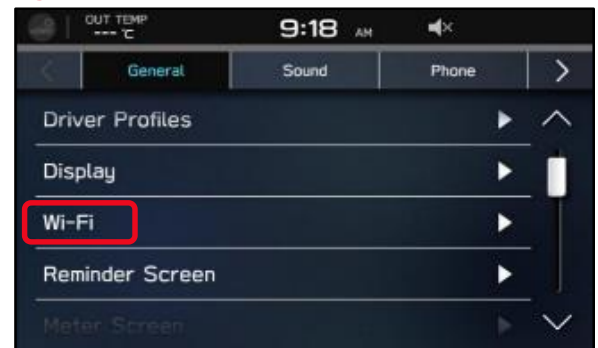
Figure 18.

- B. Under the General tab, select Wi-Fi.

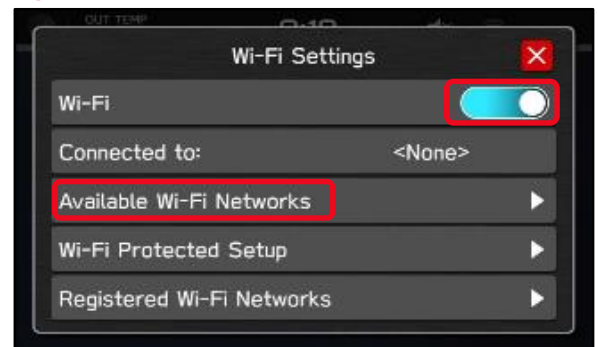
Figure 19.

- C. Toggle Wi-Fi ON and select Available Wi-Fi Networks.

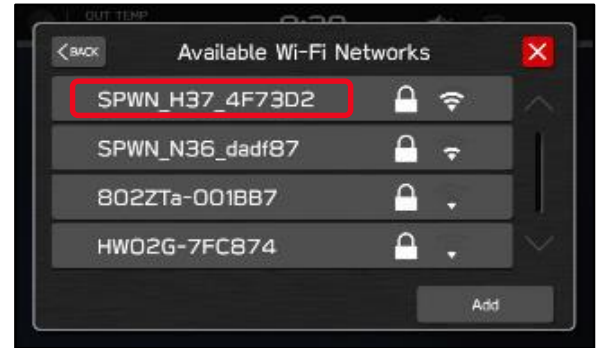
Figure 20.

D. Select an available Wi-Fi Network.

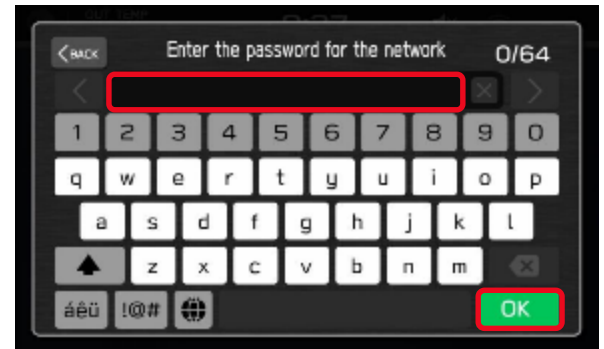
Figure 21.

E. Enter the password and select OK.

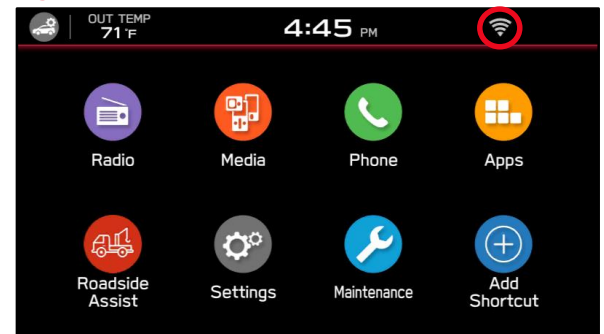
Figure 22.

- F. Once the desired network has been connected successfully, confirm that the Wi-Fi icon is present with a signal strength of two lines or more.
- (1) If the network signal strength is low (one line or less) the download will likely be very slow and may fail.
 - (2) AFTER securing a strong signal, do NOT move the vehicle until the software update process is complete.

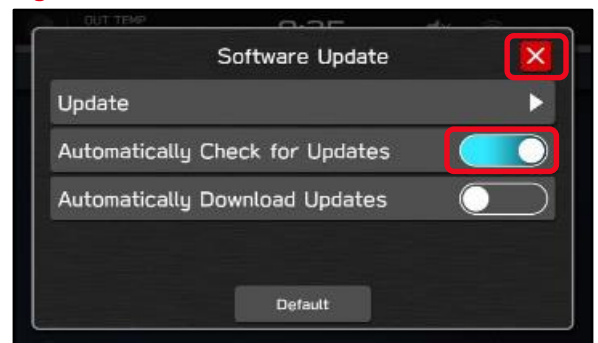
Figure 23.

- (1) Select Auto if not already selected.
 - (2) If the time and date do NOT auto update, select Manual to update the date and time manually.
- B. Go to *Settings – General – Software Update* and confirm that Automatically Check for Updates is toggled ON. Click the red X to close the screen.

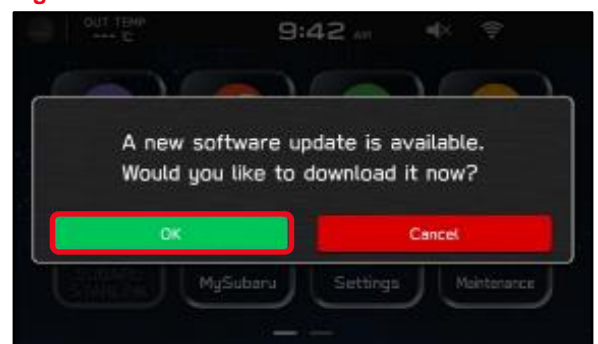
Figure 24.

- C. Select OK.

- If the Wi-Fi is connected within 30 minutes of Engine ON, this screen pops up 2 minutes after Wi-Fi connection.
- If the Wi-Fi is connected AFTER 30 minutes or more AFTER Engine ON, this screen will NOT pop up. If the screen does NOT pop up, start the software update manually by going to *Settings – General – Software Update*.

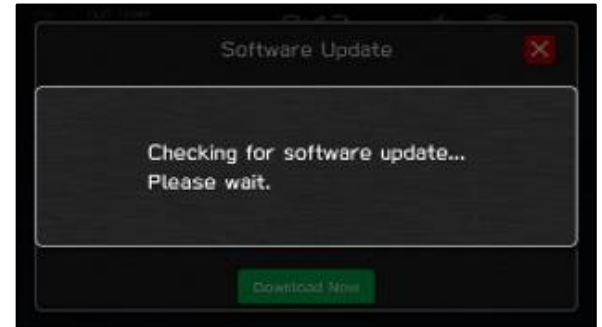
Figure 25.

D. Wait for the next screen to load.

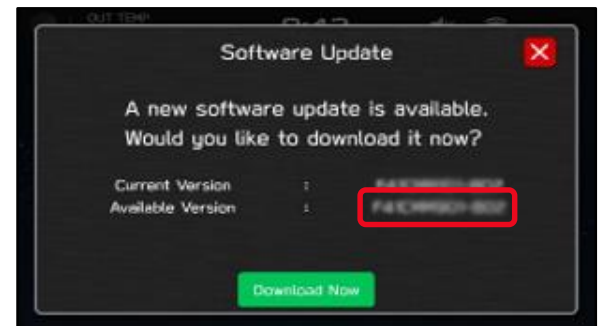
Figure 26.

E. Make note of the available version software number it should match Table 2.

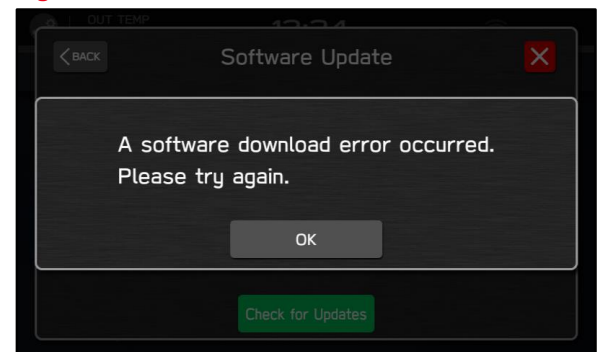
Figure 27.

If the message in Figure 27 appears after checking for an update, try one of the following:

- Restart the Wi-Fi device
- Try connecting to a different Wi-Fi device or network

If the message continues to appear after trying the above, wait for 5 minutes and try again.

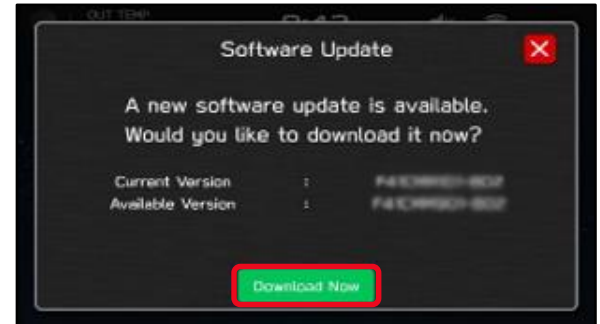
Figure 28.

3. Perform the OTA head unit software update.
 - A. Select Download Now.

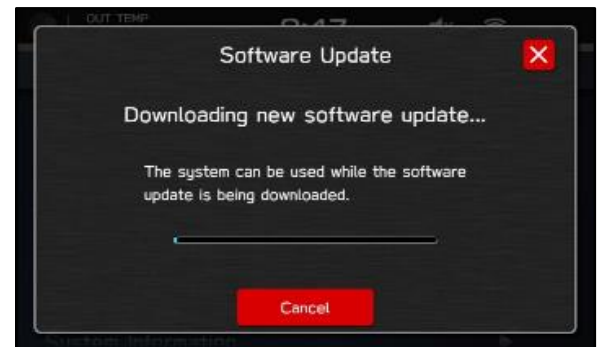
Figure 29.

- B. Wait for the update to download.

- Do NOT cancel the download process.
- Do NOT turn OFF the head unit.
- Do NOT turn OFF the vehicle.

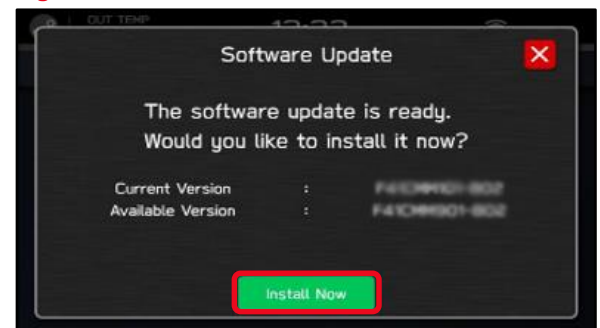
Figure 30.

- C. Select Install Now.

The installation can take 10 – 40 minutes.

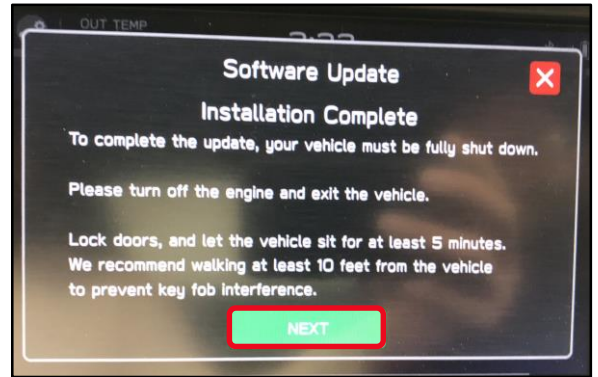
Figure 31.

D. Click Next.

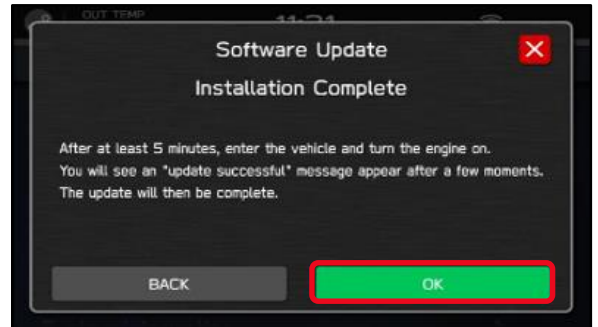
Figure 32.

E. Select OK.

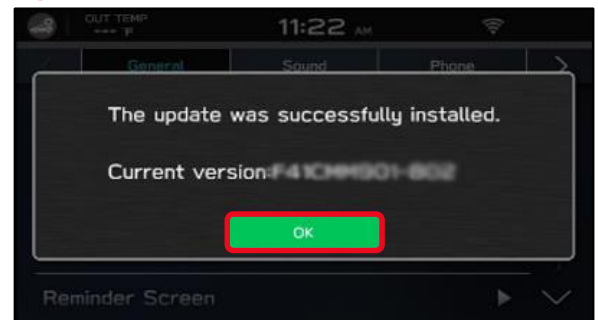
Figure 33.

5. Wait for the head unit to restart and for the screen shown in Figure 33 to appear.
 - A. Confirm that the software version has been updated per Table 2.
 - B. Select OK.
