GROUP	MODEL
ELE	2025MY EV6 (CV1, CV1a) 2026MY Sportage (NQ5, NQ5a, NQ5 P/HEV)
NUMBER	DATE
406 (Rev 1, 02/10/2026)	December 2025

TECHNICAL SERVICE BULLETIN

SERVICE ACTION: DCU OPERATION SOFTWARE LOGIC IMPROVEMENT (SA635)

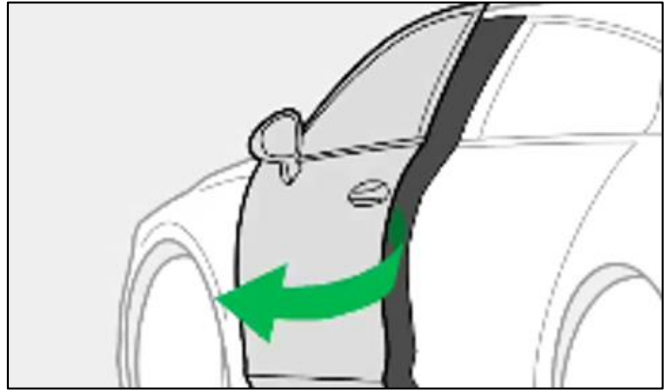
Keep the left driver door open throughout the following steps.

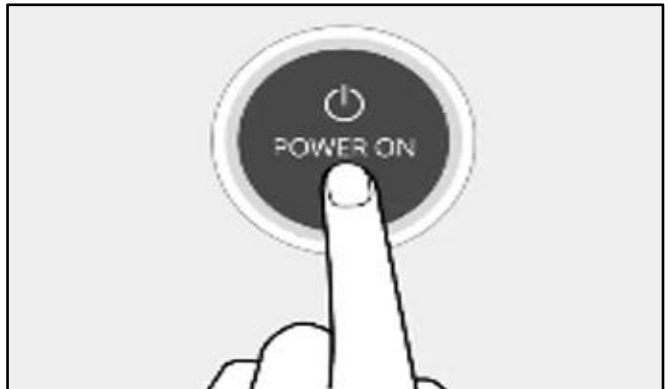
2. Press the ignition 'Power ON' button once (without depressing the brake pedal).

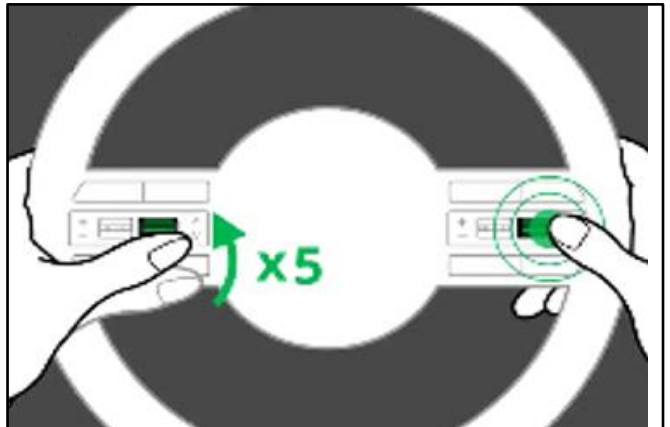
3. Press and hold the right side 'MUTE' button down on the steering wheel while pressing the left side 'UP/DOWN' button UPWARDS five (5x) times.

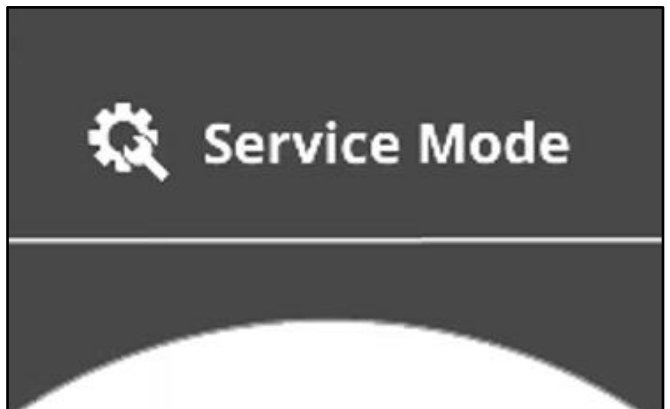
4. Confirm the vehicle is set to 'Service Mode' in the instrument cluster display.

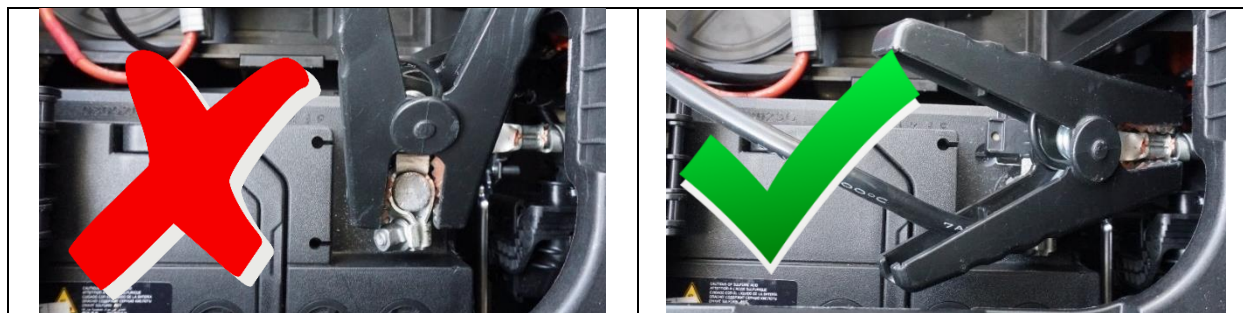
Connect the negative (-) terminal to the battery as shown below.

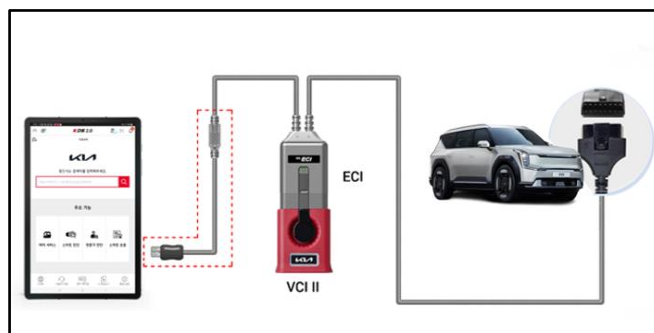
Using KDS + VCI-II and ECI Connection

1. Connect the ECI DLC connector to the OBD-II connector, located under the driver's side of the instrument panel.
2. Connect the ECI USB -C connector to the KDS tablet.
3. Connect the VCI II to the ECI OBD-II connector.

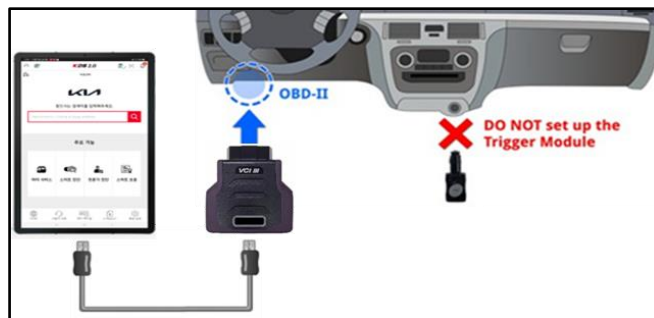
**Using KDS + VCI-III Connection**

1. Connect the VCI III USB-C connector to the KDS tablet.
2. Connect the VCI III to the OBD-II connector of the vehicle.

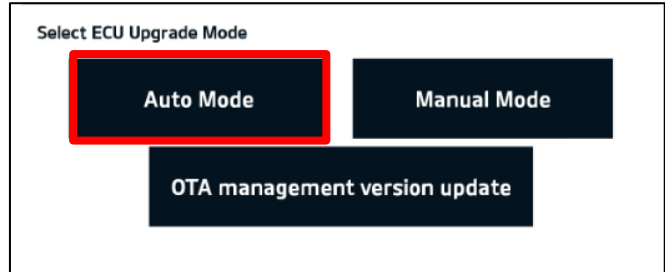
Software Information:

The required software must be installed by selecting the **'Auto Mode'** ECU Upgrade option.

Note: In some case, the 'Manual Mode' installation option may be required ONLY if the 'Auto Mode' function fails or is otherwise noted above.

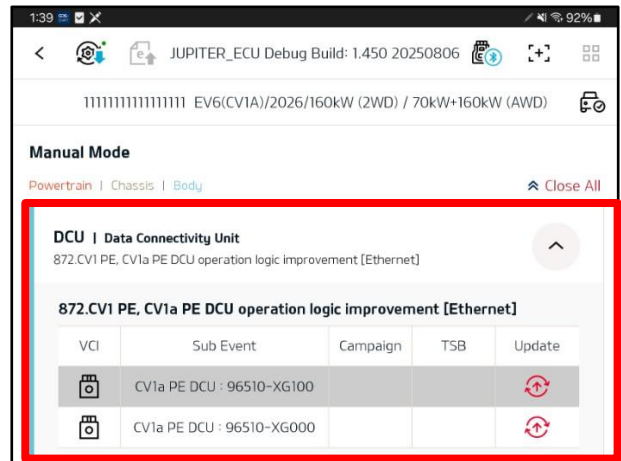
UPGRADE EVENT: EV6 (CV1a, CV1)

Select the applicable **'DCU'** system module and the Event Group.

- 872.CV1 PE, CV1a PE DCU operation logic improvement [Ethernet]

Verify the affected vehicle Calibration Identification of the applicable ECU ROM ID and reference the Information Table on page 3 as necessary.

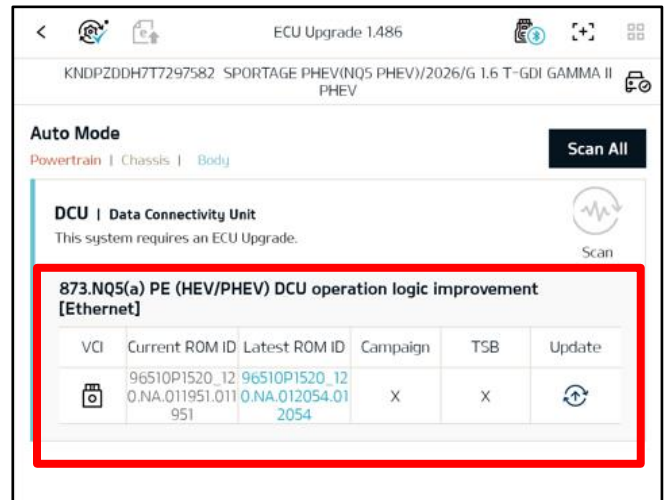
UPGRADE EVENT: Sportage (NQ5a, NQ5)

Select the applicable **'DCU'** system module and the Event Group.

- 873.NQ5(a) PE (HEV/PHEV) DCU operation logic improvement [Ethernet]

Verify the affected vehicle Calibration Identification of the applicable ECU ROM ID and reference the Information Table on page 4 as necessary.
