# Technical Service Bulletin

GROUP <b>CAMPAIGN</b>	NUMBER <b>26-01-015H</b>
DATE <b>FEBRUARY 2026</b>	MODEL(S) <b>SANTA FE (MX5A)</b>

**SUBJECT:** FPM SOFTWARE UPDATE  
(LIMITED COVERAGE CAMPAIGN LA6)

**Description:** Certain Santa Fe (MX5A) vehicles may experience a discharged battery condition due to the Fingerprint Module (FPM) not entering 'SLEEP' mode when the ignition is turned off. This bulletin provides instructions to perform a software update with revised logic for the FPM.

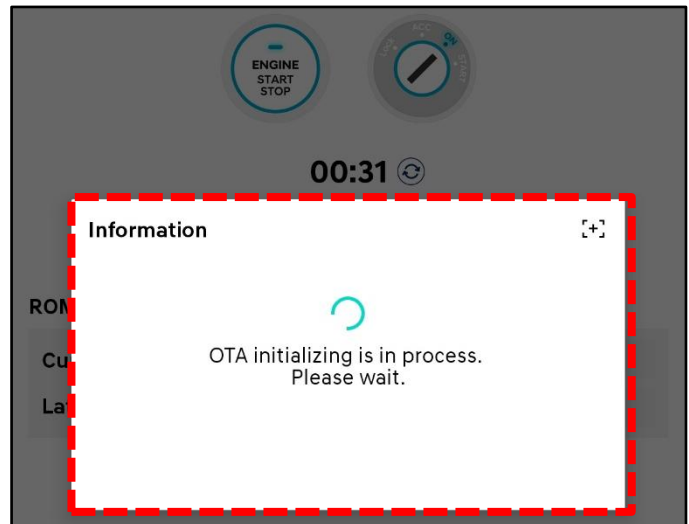
- OTA initialization should perform automatically:
  - If OTA initialization performs automatically, then proceed with the service procedure.

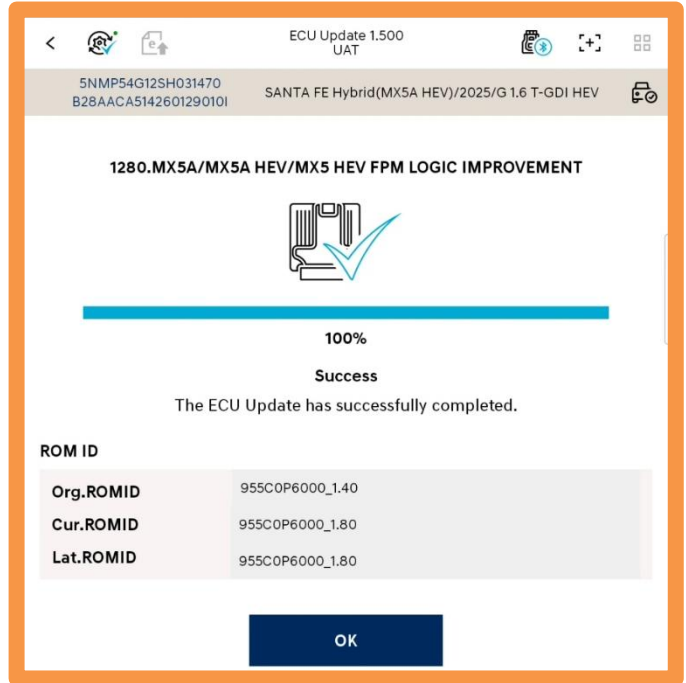
Using the tablet or GDS screen capture function, take a screenshot of the ECU update "Success" result screen.

Upload the photo to STUI.

**NOTE:** The VIN/Date/Time/Mileage photo imprint is **NOT** required for GDS screenshots.

**NOTE 3:** This TSB includes repair validation photos. Op times include VIN, mileage, and photo capture of the ECU Update “Success” screen as outlined in the Digital Documentation Policy.

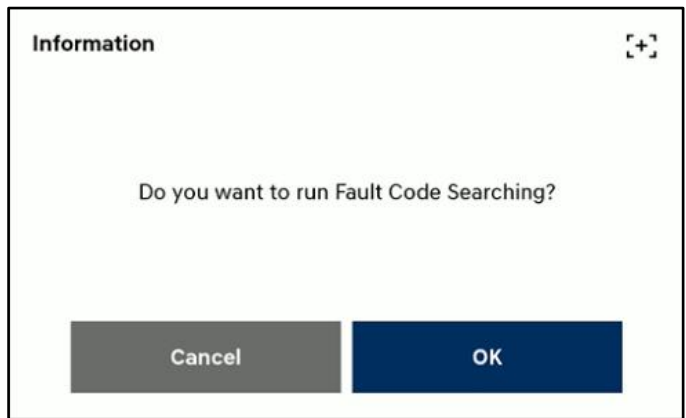
6. Perform an **All Systems Fault Code** search and erase DTC history that had incidentally occurred from the ECU update.
